SERVICE BULLETIN

Classification: EF&EC93-016	Section: Engine Fuel	Models: All models
Reference: TECHNICAL BULLETIN NTB93-176	Date: November 29, 1993

GREEN OR BLUE (TYPE 1M) RELAY CAUTION

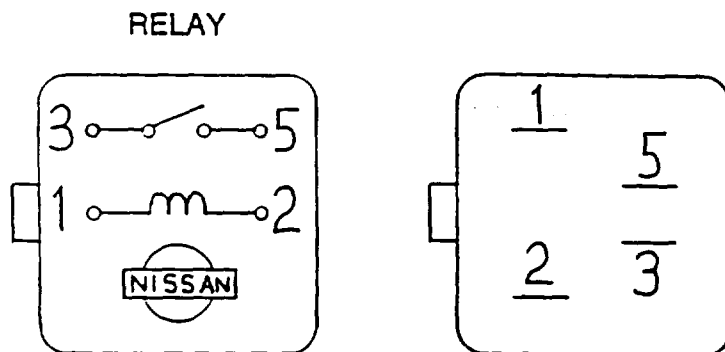
- Note that the schematic on the fuel pump relay is rotated 90 degrees from the orientation of the relay terminals in the relay connector (see diagram below):

NOTE: If terminals 2 or 3 (battery voltage) are connected to terminal 1, the ECM will become damaged if the circuit being tested has terminal 1 connected to the ECM.

- Exercise caution to ensure that the correct terminals are being probed at the relay connector during diagnosing / checking.
