SERVICE BULLETIN

Classification:	BR94-002	Section:	Brake	Models:	All models
Reference:	TECHNICAL BULLETIN NTB94-012			Date:	February 3, 1994

BRAKE JUDDER/STEERING WHEEL SHIMMY

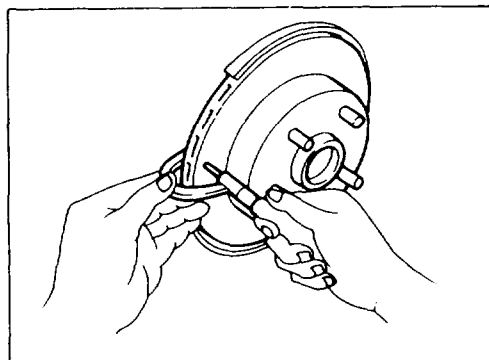
Rotor Thickness Variation (RTV) is the variation in thickness around the rotor. The *RTV* can be determined by measuring the rotor thickness with a micrometer at several locations around the circumference of the rotor. The *RTV* is the difference in thickness between the thickest and thinnest points on the rotor.

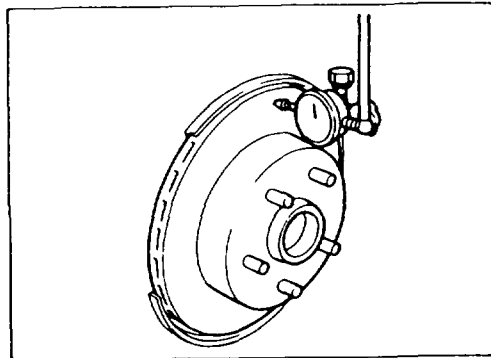
Rotor Run-Out is the distance that the rotor surface travels in and out, in relation to the vertical plane of the hub, as the rotor turns with the hub. The distance is measured with a dial indicator.

NOTE: *Rotor Run-Out* does not cause brake judder or steering wheel shimmy. However, excessive *Rotor Run-Out* does lead to rotor thickness variation as the rotor wears. It is the excessive rotor thickness variation that causes judder and/or steering wheel shimmy. This is described in more detail below.

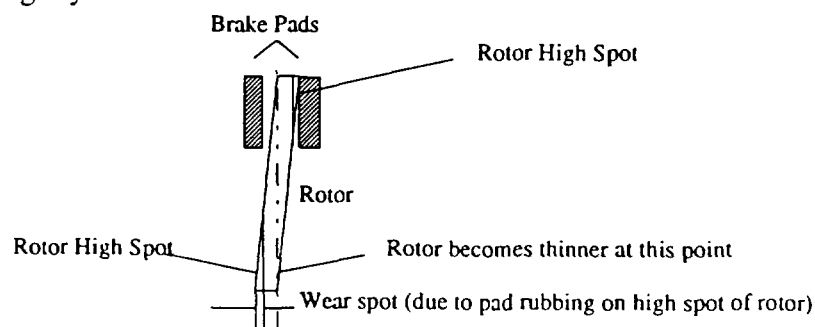
- * The brake rotor *run-out* exceeds specification limits.
- * As the brake pad rubs against the rotor while driving, the high spots on the brake rotor wear slightly.

* Rotor *thickness variation* may develop as the high spots on the brake rotor wear. If this *thickness variation* becomes large enough, brake judder/shimmy may occur.
