RECALL CAMPAIGN BULLETIN

NTB96-108b

VOLUNTARY RECALL CAMPAIGN FRONT SEAT BELT BUCKLE REPLACEMENT

APPLIED VEHICLE: 1994 Pathfinder (WD21)

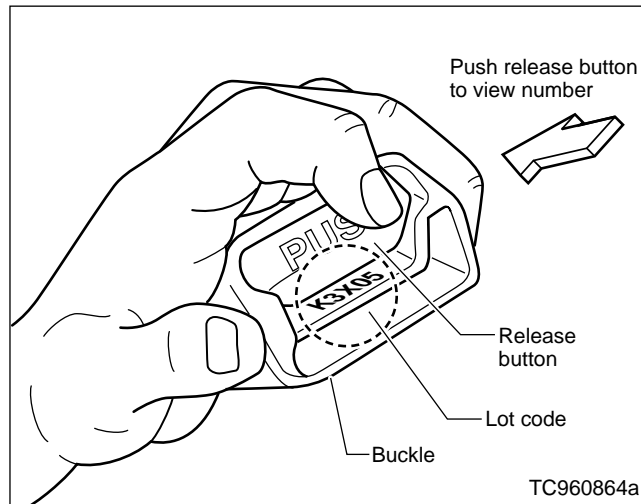
Figure 1

1. Hold the buckle in one hand and depress the release button.
2. Shine a small flashlight into the buckle and read the "lot code" as shown in Figure 1.

4. If the lot code on the buckle **does not** fall within the lot number ranges in the table on page 2, the buckle does not require replacement.
5. If the lot code **does** fall within the ranges in the above chart, proceed to step 6.
NOTE: You may find that only one buckle may fall into the range. If so, **only the affected buckle should be replaced.**
6. Move the bucket seat forward to access the seat belt buckle anchor bolt.
7. Replace the affected seat belt buckle assembly.
NOTE: The retractor and/or lap belt portion of the seat belt will **NOT** be replaced. Only the affected buckle portions need to be replaced.
8. Torque the anchor bolt to **26.4-33.6 ft-lbs** (35.8-45.6 N•m, 3.65-4.65 kg-m).
9. Check the seat belt operation by inserting and removing the tongue into the buckle three times to confirm that it latches properly.
