ITB00-066

## VOLUNTARY SAFETY RECALL CAMPAIGN - 2000-01 QX4 IGNITION KEY LOCK CYLINDER

**CAMPAIGN I.D. # / NHTSA #:** R0006 / 00V-410

**APPLIED VEHICLE:** 2000-01 QX4 (JR50)

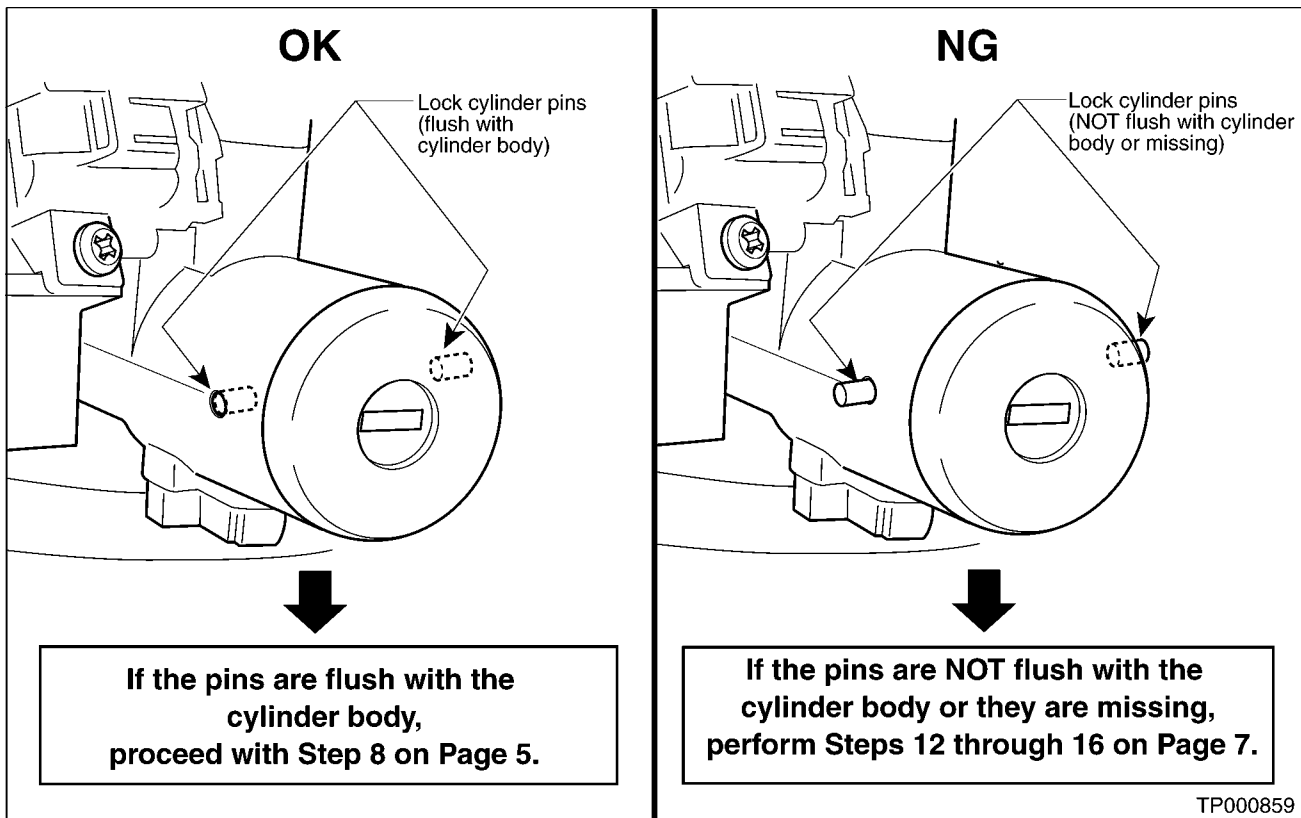
Figure 6

- Carefully remove the NATS IMMU from the ignition key lock cylinder (without disconnecting the vehicle wire harness from the NATS IMMU) and lay it to the side (see Figure 5b).
- Inspect the ignition key lock cylinder pins located on each side of the lock cylinder. See Figure 6.

**IMPORTANT:** Steps 12 through 16 below ONLY apply to those vehicles where the lock cylinder pins are NOT flush with the surface of the lock cylinder body (i.e., the pins are sticking out of the lock cylinder body) or they are missing.

**WARNING:** Do NOT attempt to re-insert the pins in the ignition key lock cylinder.

12. Replace the ignition key lock cylinder\* and install plastic clip (P/N D8791-00002) on the new cylinder according to step 8 on page 5.

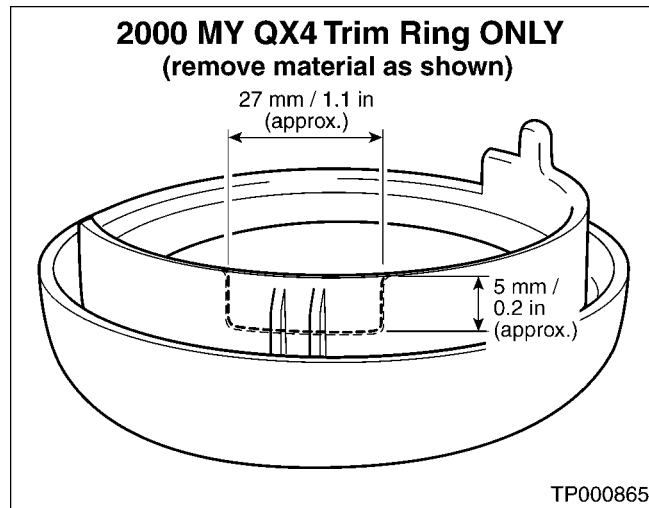
**NOTE:** The purpose for removing a section of the trim ring is to allow clearance between the trim ring and the newly installed plastic ring clip (on the ignition key lock cylinder). The dimensions given in Figure 9 below are general guidelines and may need to be adjusted to achieve sufficient clearance with minimal material removal.

A. Remove a section of the trim ring as shown in Figure 9.
