SERVICE BULLETIN

Classification: BT08-002	Reference: NTB08-031	Date: March 6, 2008
-----------------------------	-------------------------	------------------------

2008 ROGUE; CREAKING NOISE FROM CONSOLE FINISHER

APPLIED VEHICLE: 2008 Rogue (S35)

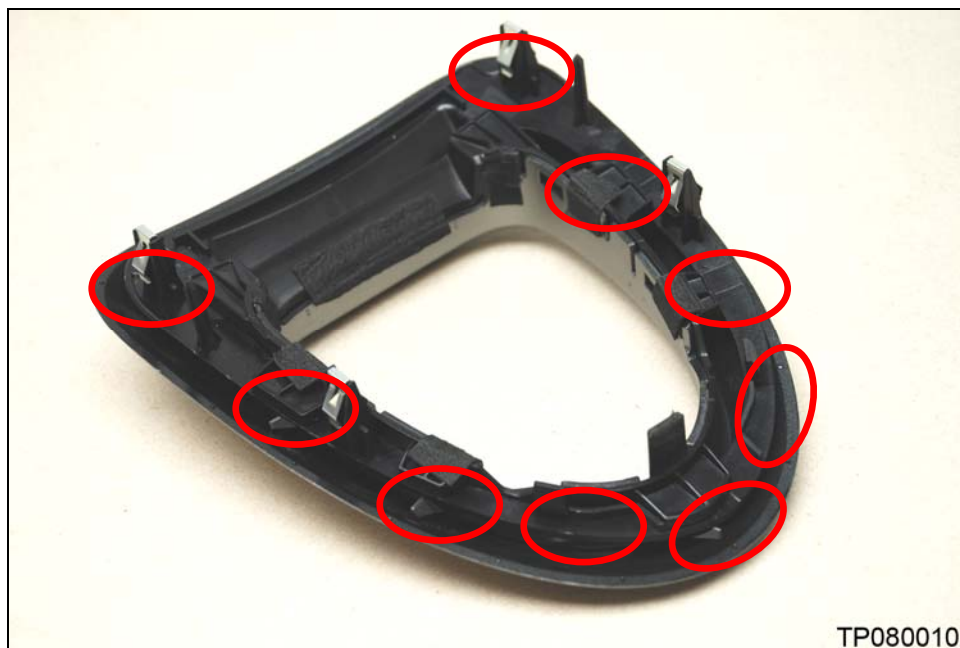
Figure 1

There is a creaking noise coming from the console finisher assembly when making turns.

- Remove the console finisher assembly.
- Put tape from the squeak and rattle kit on the 9 ribs located on the upper half of the console finisher assembly. See Figure 1.

NOTE: Some models only have 7 ribs.
