CONTENTS

FRONT PROPELLER SHAFT

Revision: July 2007 PR-9 2005 Armada

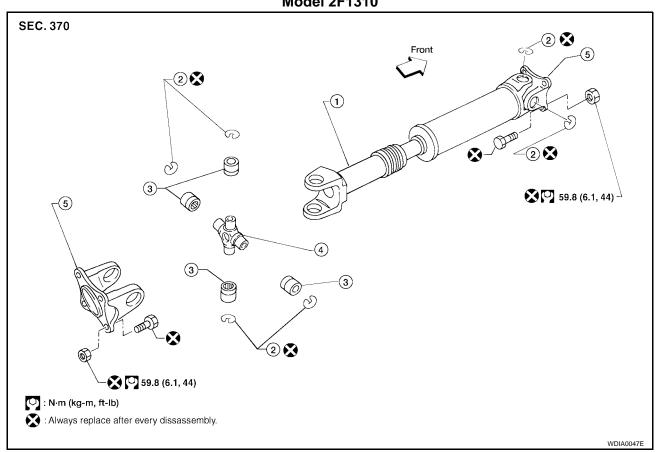
Model 2F1310

- Propeller shaft tube
- Snap ring

Journal bearing

Journal

5. Flange yoke

1. Put matching marks on the front propeller shaft flange yoke and the companion flange of the front final drive as shown.

While holding the flange yoke on one side, check axial play of the joint as shown. If the journal axial play exceeds the specification, replace the propeller shaft assembly.

1. Put matching marks on the front propeller shaft and flange yoke as shown.

2. Remove the snap ring.

3. Push out and remove the journal bearing by lightly tapping the yoke with a hammer, taking care not to damage the journal or yoke hole.

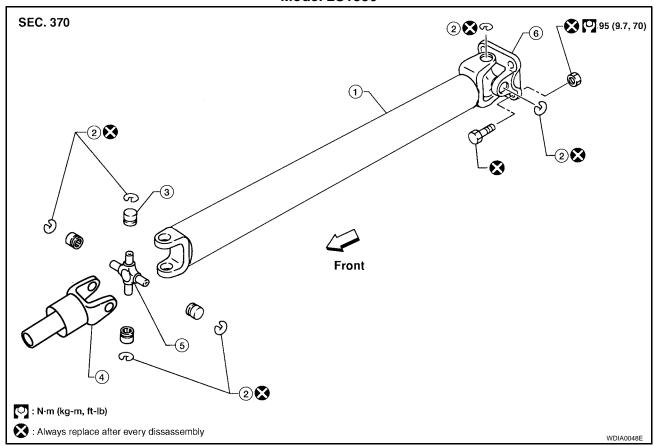
Model 2S1350

- Propeller shaft tube
- Snap ring

6. Flange yoke

Journal bearing

Sleeve yoke

Journal

- 1. Move the A/T select lever to the N position and release the parking brake.
- 2. Put matching marks on the rear propeller shaft flange yoke and the companion flange of the rear final drive as shown.

While holding the flange yoke on one side, check axial play of the joint as shown. If the journal axial play exceeds the specification, replace the propeller shaft assembly.

1. Put matching marks on the rear propeller shaft and flange yoke as shown.

2. Remove the snap ring.

3. Push out and remove the journal bearing by lightly tapping the yoke with a hammer, taking care not to damage the journal or yoke hole.
