SERVICE BULLETIN

| Classification: RS99-005 | Reference: NTB99-028 | Date: April 15, 1999 |

NISSAN FRONT SEAT BELT SLOW RETRACTION

APPLIED VEHICLES: All Nissan Vehicles

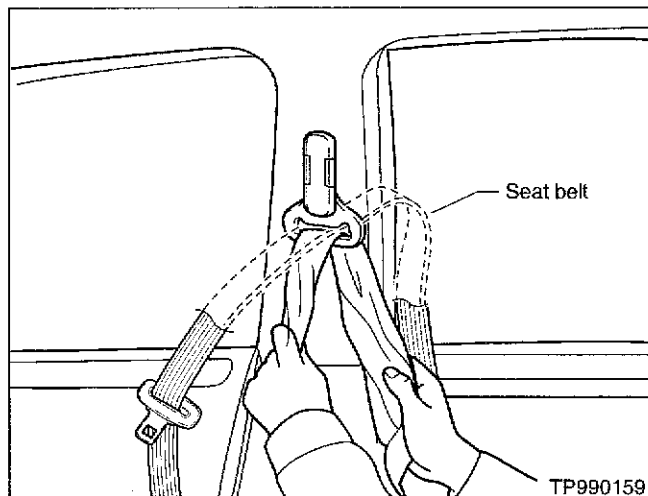
Figure 1.

If a Nissan vehicle experiences slow retraction of the seat belt assembly (such as the latch plate hanging up on clothing, becoming stuck in the door, and/or not returning to the fully retracted position), it may be due to a residue build up on the seat belt D ring located on the B pillar. If residue build up causes seat belt slow retraction, use the service procedure in this bulletin to resolve the incident.

1. Sitting in the seat, extend and buckle the seat belt in it's normal restraining position. Release the belt, allowing it to retract.
2. If the seat belt retracts slowly or does not return to the fully retracted position, inspect the D ring located on the B pillar for residue buildup on the underside of the belt.
 - A. If there is no residue buildup, this bulletin does not apply.
 - B. If there is residue buildup, continue with this service procedure.
3. Insert a piece of cheese cloth or a piece of cotton gauze (such as found in a First Aid Kit) under the seat belt, between the belt and the D ring, then slide it back and forth over the D ring where it contacts the seat belt (see Figure 1) until all residue is removed.

WARNING: DO NOT use solvents to clean seat belt assemblies, the seat belt material will be damaged.
