# SECTION PR **PROPELLER SHAFT** С

## FRONT PROPELLER SHAFT

# Removal and Installation COMPONENTS

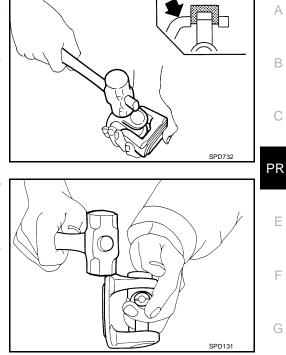
3. Push out and remove the journal bearings by lightly tapping the flange yoke with a hammer, taking care not to damage the journal or flange yoke hole.

4. Push out and remove the remaining journal bearings at the opposite side by lightly tapping the flange yoke with a hammer, taking care not to damage the journal or flange yoke hole.

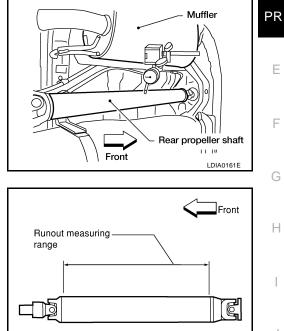
LDIA0121E

1. Measure the runout of the propeller shaft tube at several points by rotating the final drive companion flange with your hands.

Propeller shaft runout limit2WD: 1.02 mm (0.0402 in) or less4WD: 0.6 mm (0.024 in) or less

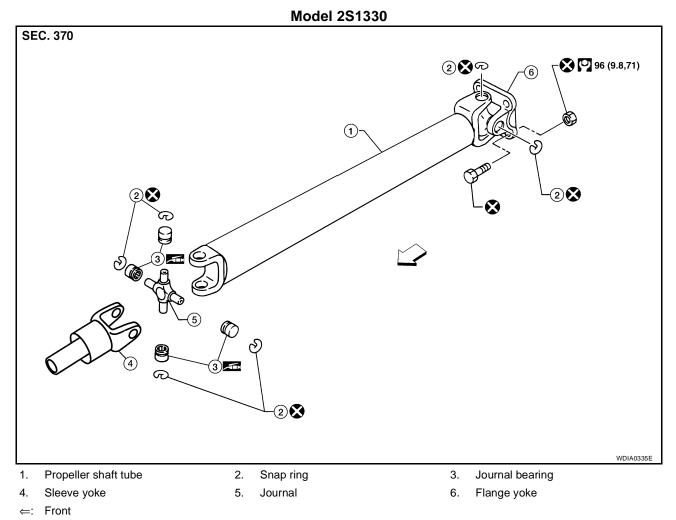
# Removal and Installation COMPONENTS

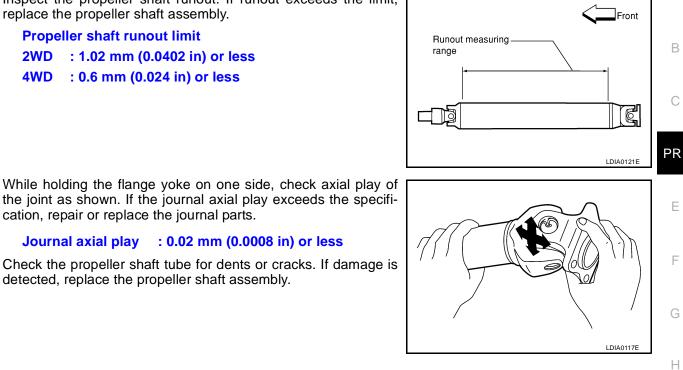
Inspect the propeller shaft runout. If runout exceeds the limit, replace the propeller shaft assembly.

the joint as shown. If the journal axial play exceeds the specifi-

Journal axial play : 0.02 mm (0.0008 in) or less

cation, repair or replace the journal parts.
