# RECALL CAMPAIGN BULLETIN

NTB11-064a

## VOLUNTARY SAFETY RECALL CAMPAIGN 1996-2004 PATHFINDER IN SALT STATES LEFT FRONT STRUT HOUSING CORROSION

**CAMPAIGN ID #:** R1107  
**NHTSA #:** 11V-244  
**APPLIED VEHICLES:** 1996 – 2004 Pathfinder (R50)

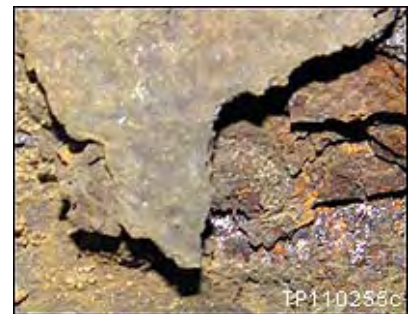
Figure 5 is an example of “scab corrosion” (flaking and raised rust).

If there is **scab corrosion** (flaking or raised rust) in area 2:

- Retain the vehicle at the dealer. (The vehicle is not repairable.)
- Supply the customer with a rental car.
- Fax a completed Non-Repairable Report to Morley (see page 53).

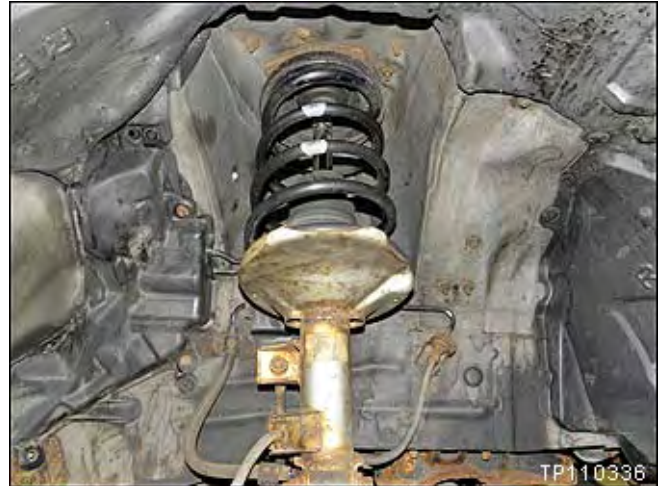
Figure 6

2. Visually inspect for corrosion and rust on the wheel housing panel and the strut housing panel (driver and passenger side).
  - Inspect for corrosion and rust on the panels only.

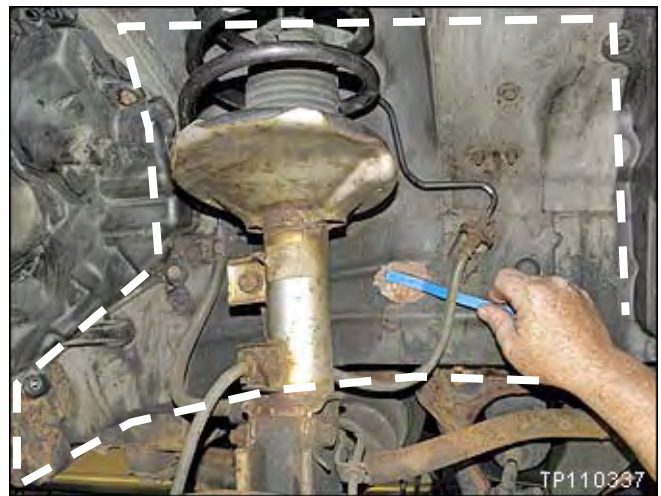
Figure 7

1. Use a wire brush to remove loose rust in the area shown with dashed line.

2. Clean dust, dirt, or other debris from the wheel housing and strut housing area.

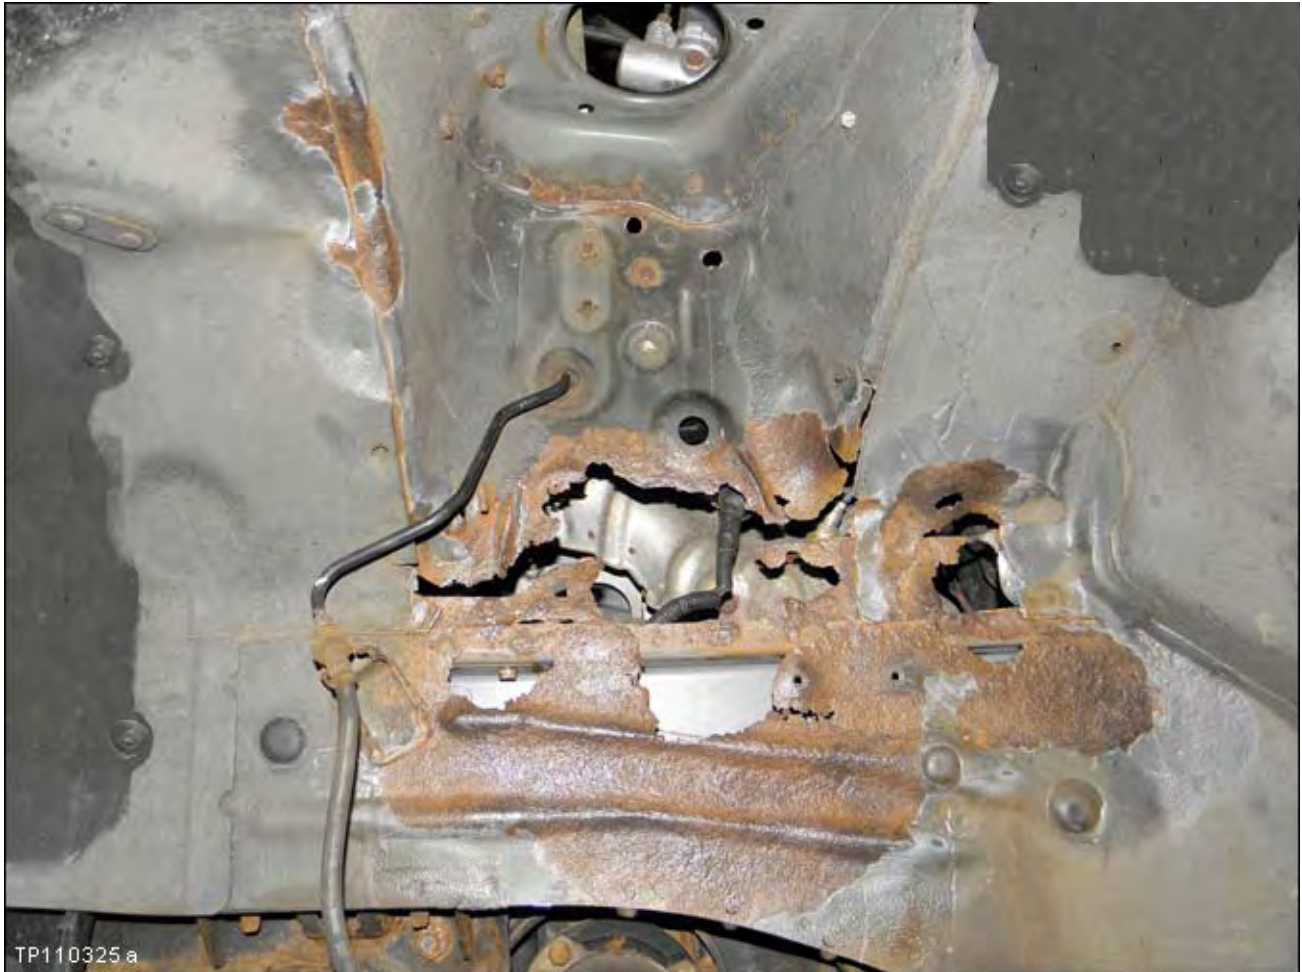
Figure RB3

4. Clean all the loose rust from the strut housing and wheel house areas (see Figure RB3).
  - Use an abrasive pad or other suitable tool.

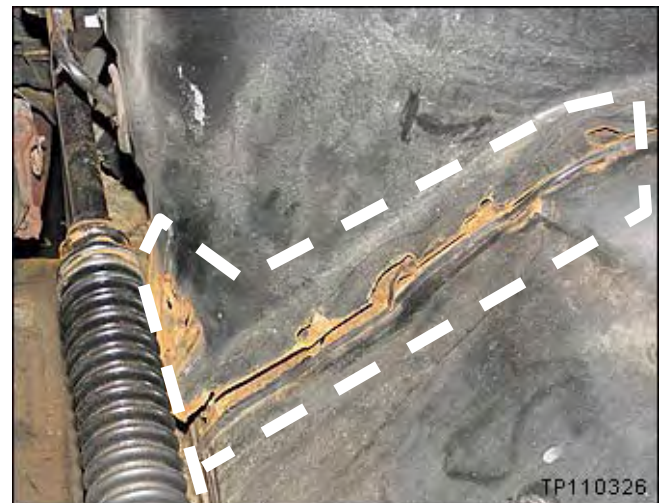
Figure RB5

7. Only if the strut housing panel is separated as show in Figure RB5:

Use a wire brush to clean any loose rust, paint, or other debris from the area shown with dashed line.

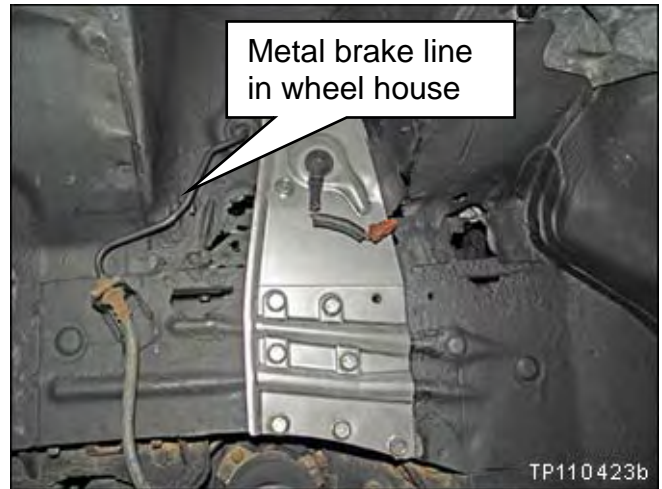
Figure RB26

30. Inspect the metal brake line for damage. If there is damage, replace the line.

- Inspect the line in the wheel house area (see Figure RB26).

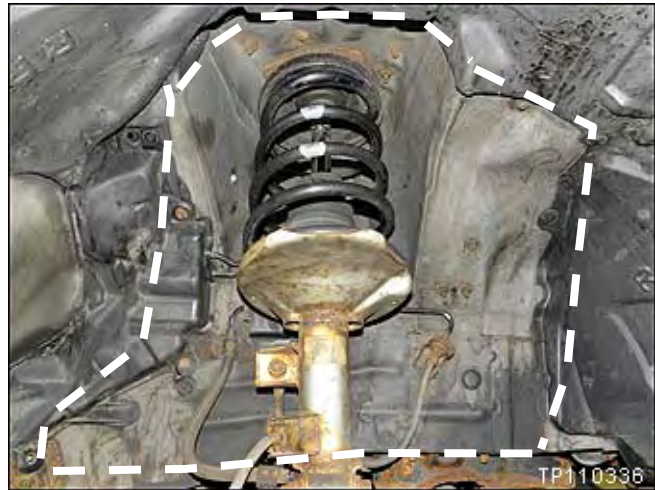
Figure PS1

- This repair is **only** used if there is metal perforation on the passenger side in the area show in Figure PS1.
- If there is no perforation, go to Level 1 repair on page 11.
- For 4WD vehicles: If the drive shaft boot is ripped, it should be covered to prevent debris from entering the drive shaft joint.

1. Clean all loose rust from the perforated area and other areas in the wheel house, and strut housing.
  - Use an abrasive pad or other suitable tool.
  - **Only if necessary** to access the perforated area, remove the right front strut. Refer to Strut Removal on page 13.
2. Use low pressure compressed air to blow off dust and debris from the cleaned area.
3. Use isopropyl alcohol to clean/wipe down the area.

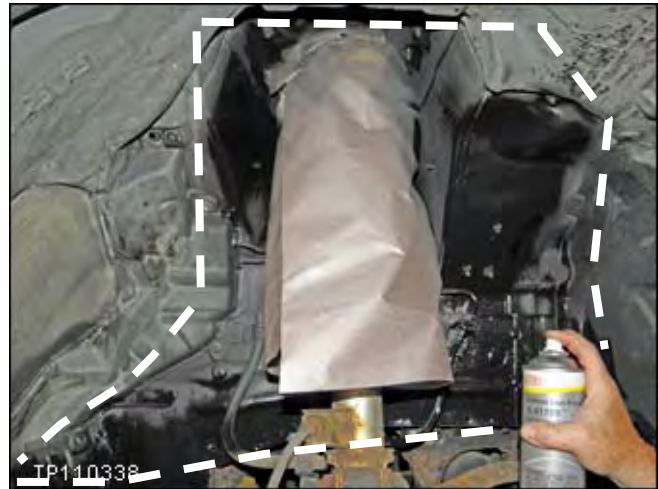
Figure PS2

4. Completely and liberally coat the strut housing and wheel house area with self etching primer (see Figure PS2).
  - Use Dupont Etch Primer (P/N A-4119S™) or equivalent.
  - Follow all product instructions.
  - Coat all of the exposed metal areas on the strut housing and wheel house panels.
  - A second coat may be needed for heavy rust spots.
  - Let each coat dry for 5 minutes.
