SERVICE CAMPAIGN BULLETIN

NTB05-050

VOLUNTARY SERVICE CAMPAIGN 2005 PATHFINDER VEHICLE DYNAMIC CONTROL (VDC)

APPLIED VEHICLE: 2005 Pathfinder (R51) – 2WD & 4WD

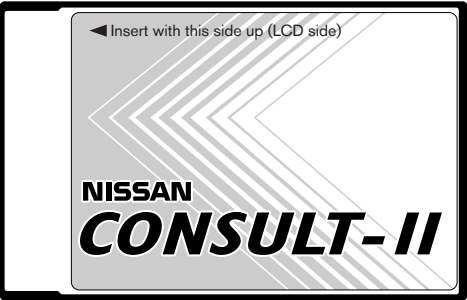
<p>8 MB (Orange) Reprogramming Card</p> <p>OK</p> <p>(USE THIS CARD FOR THIS CAMPAIGN)</p>

<p>The image shows a standard 8 MB orange reprogramming card. It features a large white arrow pointing left with the text "Insert with this side up (LCD side)" above it. At the bottom, it says "NISSAN CONSULT-II".</p>	<p>16 MB (Orange) QR25 Campaign ECM Software Card</p> <p>NG</p> <p>(DO NOT USE THIS CARD FOR THIS CAMPAIGN)</p>

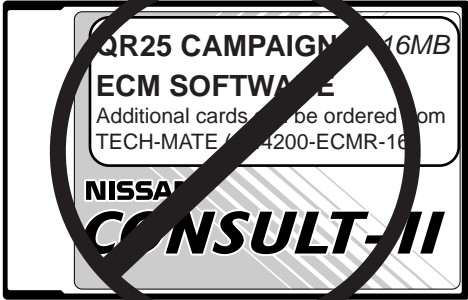
<p>The image shows a 16 MB orange QR25 campaign ECM software card, which is crossed out with a large black circle and slash. The card text includes "QR25 CAMPAIGN 16MB ECM SOFTWARE", "Additional cards can be ordered from TECH-MATE (#J-44200-ECMR-16)", and "NISSAN CONSULT-II".</p>
--	---

CAUTION: Do NOT use the 16 MB (orange) “QR25 Campaign ECM Software” Card (#J-44200-ECMR-16). If you use this card, it will be reformatted to an 8 MB card.

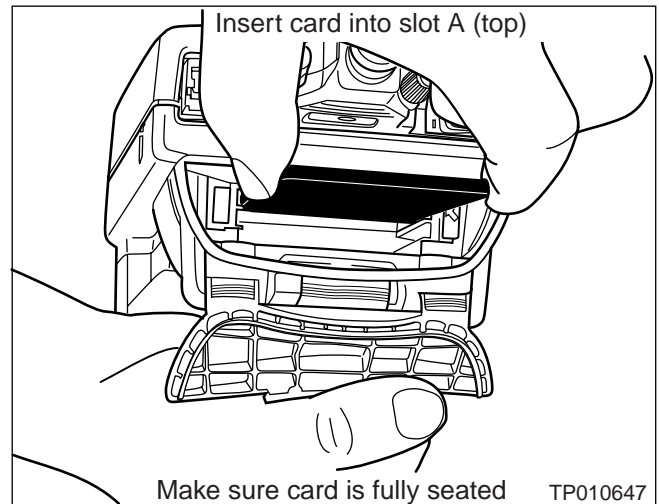
Figure 1

1. Install the standard **8 MB (orange)** Reprogramming Card into CONSULT-II.
 - Use slot A—top slot (see Figure 1).

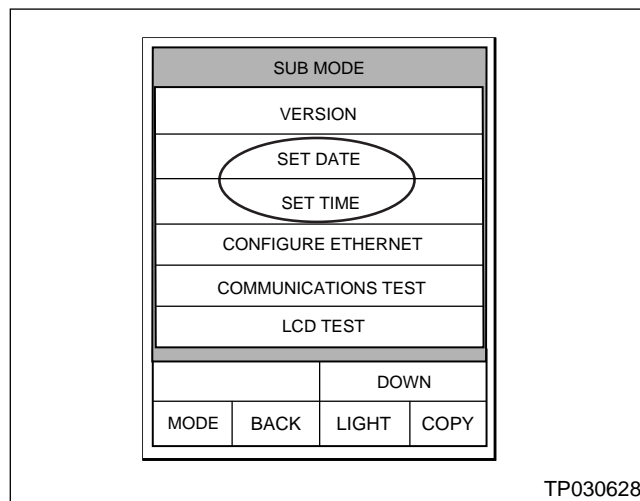
Figure 2

- a. With the **8 MB (orange)** Reprogramming card in slot A, turn “ON” CONSULT-II.
- b. Touch **SUB MODE**.
- c. Touch **SET DATE** (see Figure 2).
 - 1) If the date is not correct, touch the **MONTH**, **DAY** or **YEAR** as needed. Then adjust it by using arrow keys. Once done, press **SAVE**, press **BACK**, and go to step D.
 - 2) If the date is OK, press **BACK** and go to step D.

- d. Touch **SET TIME** (see Figure 2).
 - 1) If time is not correct, touch the **HOUR**, **MINUTE** or **AM/PM** as needed. Then adjust it by using arrow keys. After you are done, press **SAVE**, press **BACK** and go to step 5, next page.
 - 2) If time is OK, press **BACK** and go to step 5, next page.

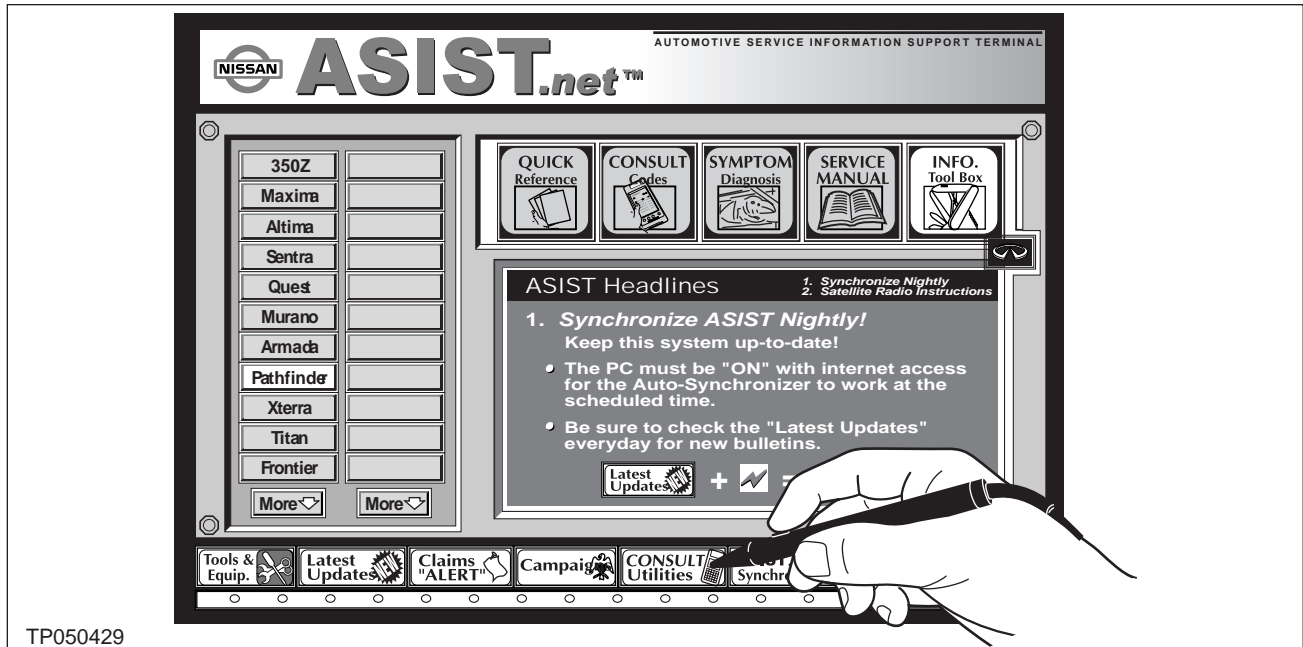
Figure 3

5. From the ASIST PC main menu screen, select "**CONSULT UTILITIES**" (see Figure 3).

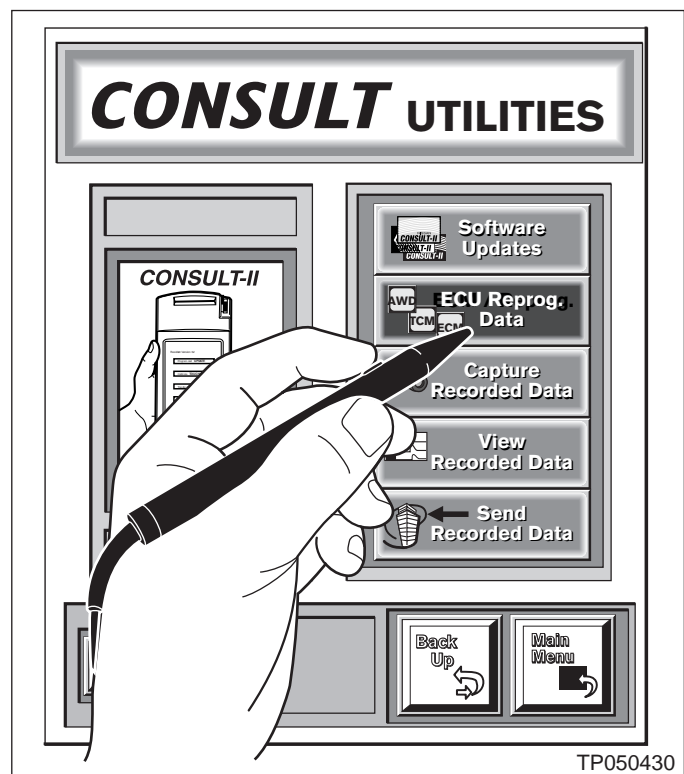
Figure 4

6. From the "**CONSULT UTILITIES**" screen, select "**ECU Reprog. Data**" (see Figure 4).

- After you select "**ECU Reprog. Data**", the "ECU Reprogramming Data" screen will be displayed (see Figure 5, next page).

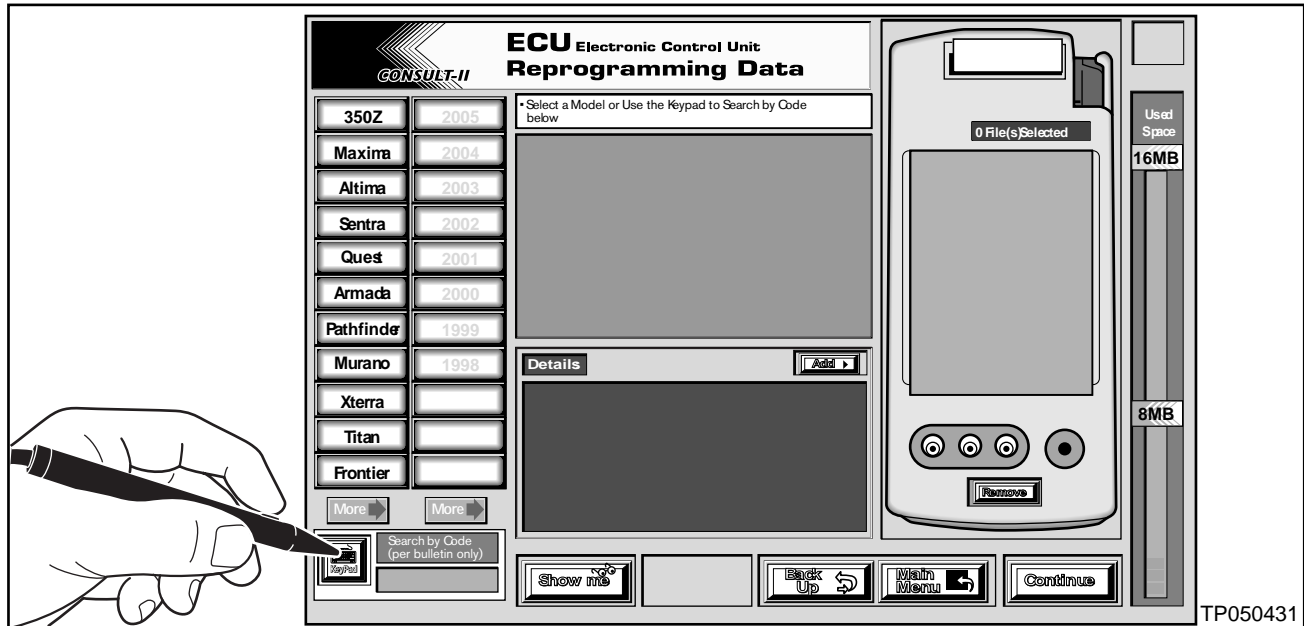
Figure 5

- a. Click on the Keypad button (see Figure 5).

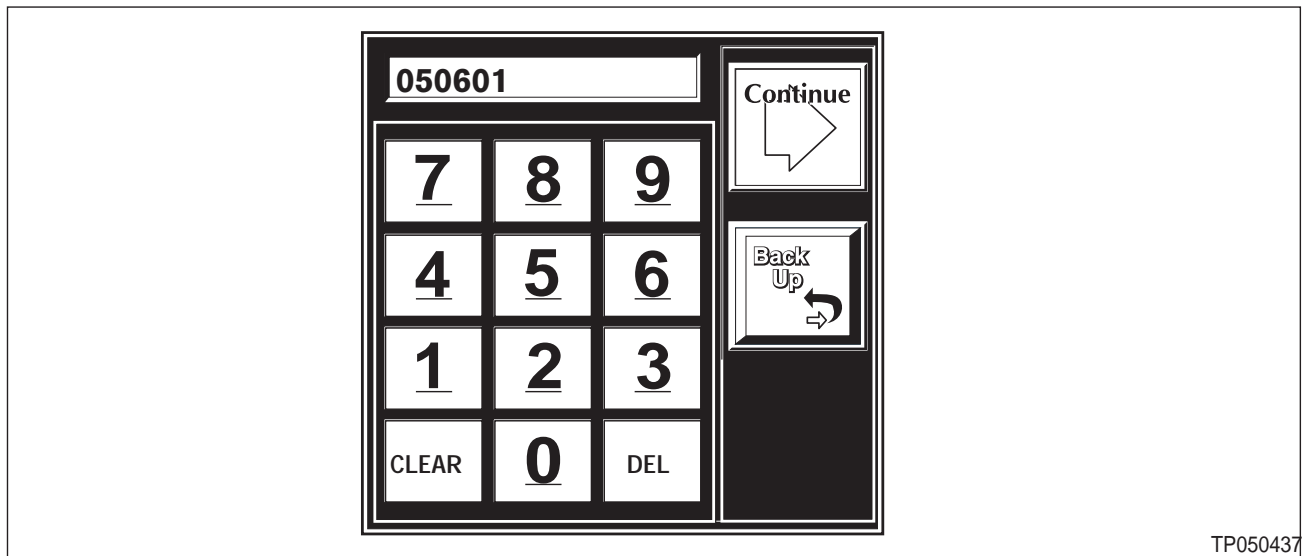
Figure 6

- b. A Keypad will appear (see Figure 6)

- c. Using the digit keys on the keypad, enter ID Code 050601.
- d. Then click the "Continue" button on the keypad.
 - After you click "Continue", the "CAUTION" screen will appear (see Figure 7, next page).

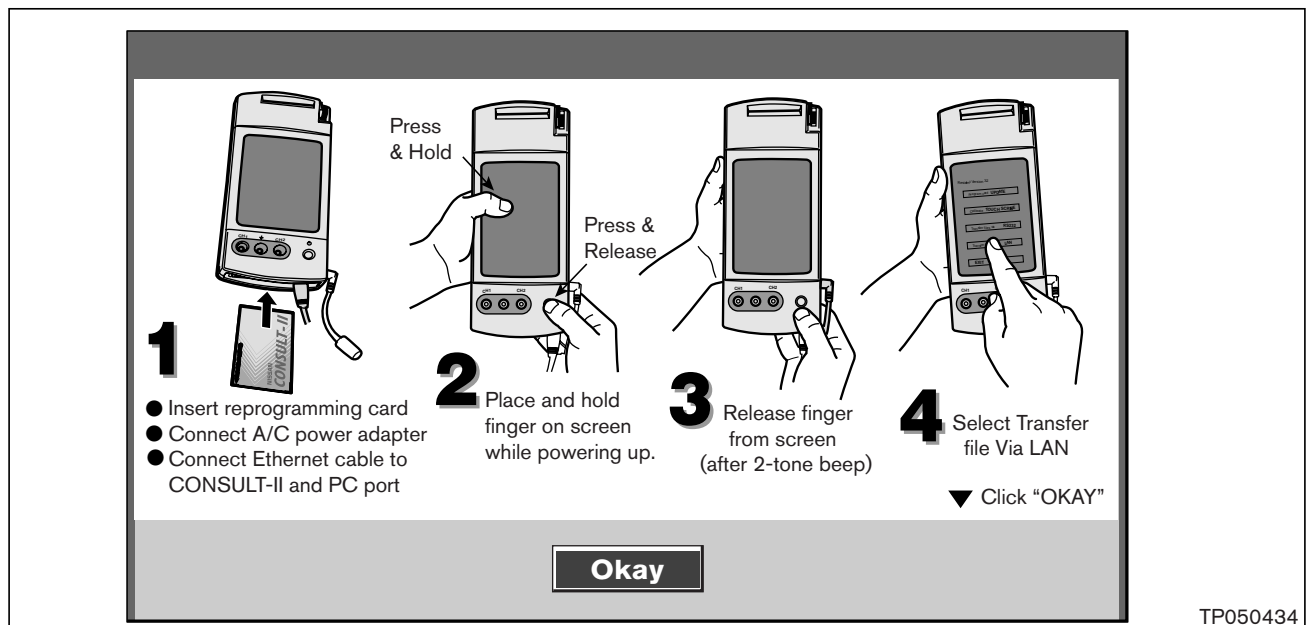
Figure 8

- CONSULT-II is “OFF”.
- The **8 MB (orange)** Reprogramming Card is inserted into CONSULT-II (see Figure 8).
- The A/C Power Adapter is securely connected to CONSULT-II (see Figure 8).
- The Ethernet Cable is securely connected to CONSULT-II and the PC port (see Figure 8).

b. Turn CONSULT-II “ON” (see Figure 8).

c. Select “Transfer Files via LAN” (see Figure 8).

NOTE: If you accidentally choose a menu option other than "Transfer Files via LAN"; turn CONSULT-II “OFF”, and then back “ON” as shown in Figure 8.

a. On the ASIST screen, click on "OKAY" (see Figure 8, previous page).

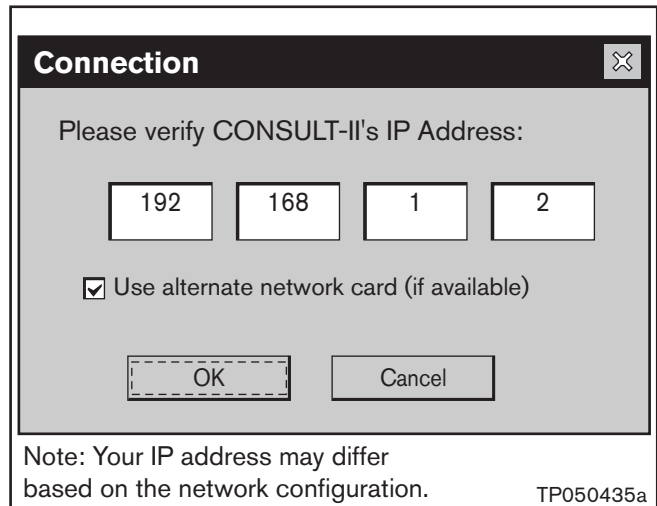
Figure 9

b. Verify CONSULT-II IP Address (see Figure 9). Then click on “OK”.

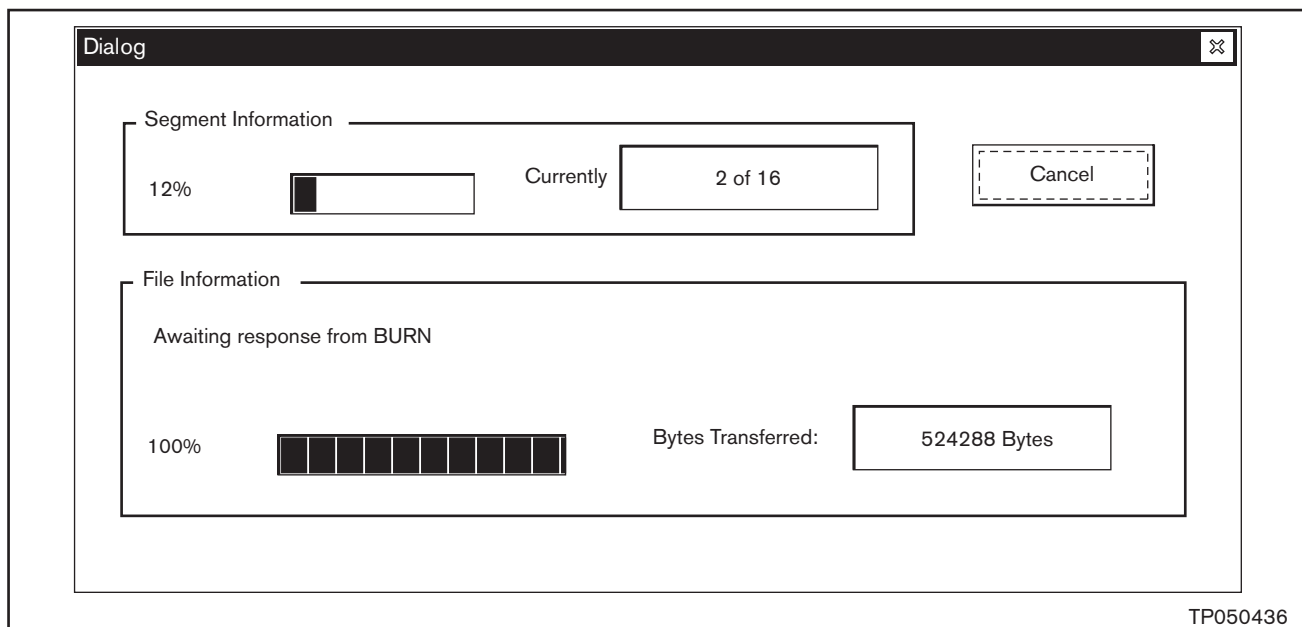
- **Your IP address may differ based on the network configuration.**
- After you click on “OK”, an ASIST screen will appear that shows the data transfer progress (see Figure 10 below).

CAUTION: DO NOT DISCONNECT THE ETHERNET CABLE UNTIL THE DATA TRANSFER IS COMPLETE (SEE FIGURE 10 BELOW).

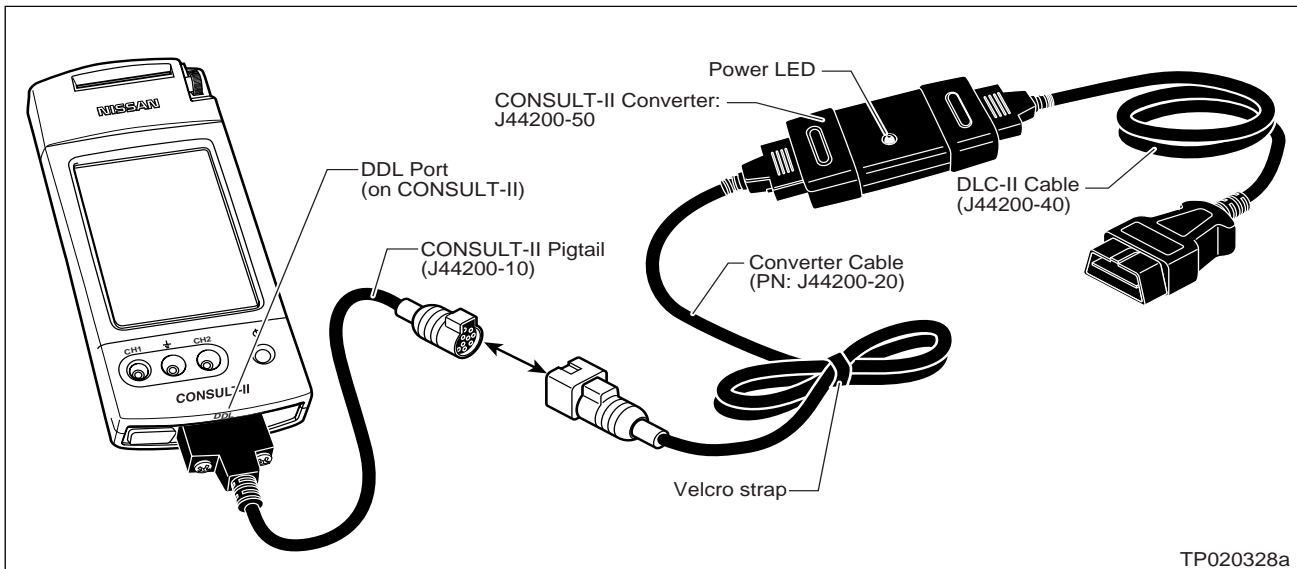
3. Connect CONSULT-II to the vehicle using the DLC-II cable with black Converter Box (see Figure 11).

- Make sure the DLC-II is pushed in straight and fully plugged in to the vehicle connector.
- Make sure all other DLC-II cable connections (as shown in Figure 11) are connected properly.

- Nissan requires the use of essential tools shown in Figure 11 when performing VDC reprogramming.
- J44200-10 "Pigtail" should not be removed from the CONSULT-II DDL Port. This "Pigtail" allows use of the stronger "quick disconnect" cable set.
- If cables are very often changed at the DDL Port (base) of the CONSULT-II unit, cable connector pin damage may result.
- If there is connector pin damage, VDC reprogramming may fail. Permanent damage to the VDC system can occur.

3. As mentioned, the “Charger Input” reading **MUST** be above 12 volts (see Figure 15, previous page).
 - A reading above 12 volts confirms;
 - a. The DLC-II is properly connected to the vehicle,
 - b. The vehicle battery voltage is sufficient for VDC reprogramming, and
 - c. CONSULT-II has a sufficient power supply to perform VDC reprogramming.
 - If the vehicle’s battery voltage (“Charger Input”) is below 12 volts, one or more of the following may be the cause:
 - a. The battery charger you hooked up in section 1 is not charging the battery (poor connection or it is not working).
 - b. The DLC-II does not have a good connection to the vehicle (not straight).
 - c. The DLC-II cable may have a malfunction (damaged wire or pins).
 - d. The CONSULT-II Converter (J44200-50 / black box) is not working correctly (see Figure 11).

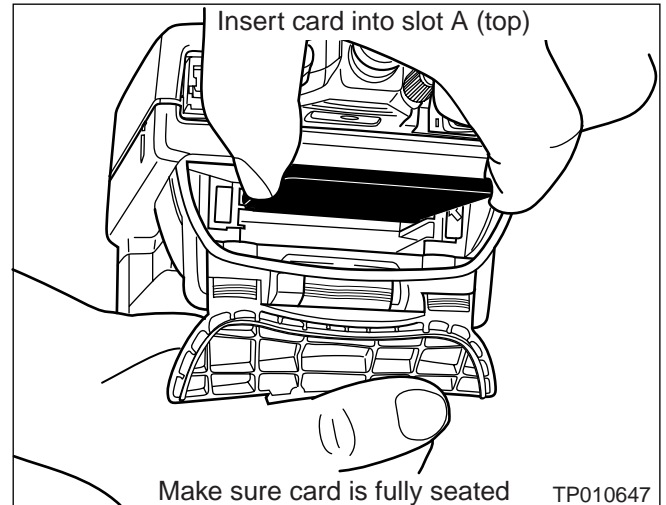
Figure 12

2. Install the 16 MB (red/white) Diagnostic Card into Slot A (top slot) of CONSULT-II (see Figure 12).

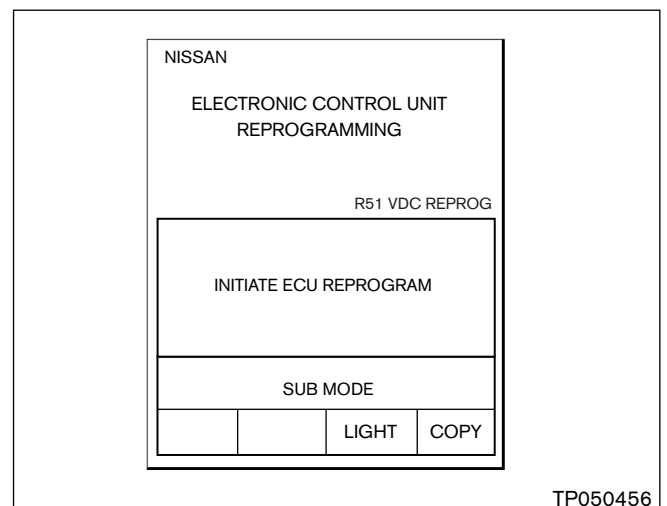
Figure 13

- CONSULT-II will turn “ON” automatically (see Figure 13).
- Confirm that all electrical loads* (except for the ignition) are "OFF".

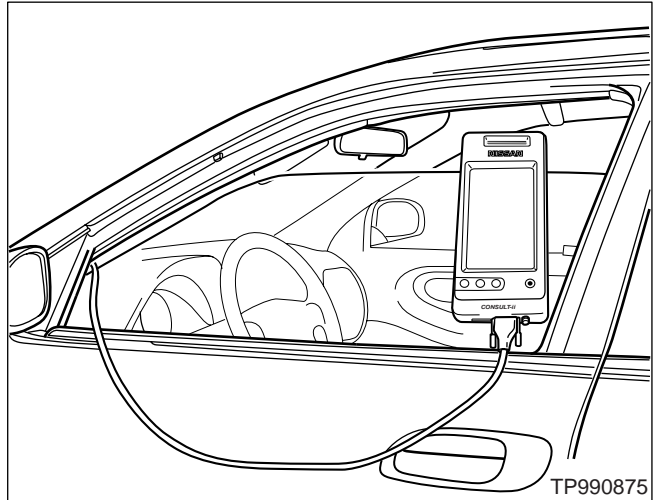
Figure 14

8. Roll down the driver's window part way, exit the vehicle, close the door, and hang the CONSULT II unit on the outside of the window (see Figure 14).
- This step is necessary to make sure the CONSULT-II and DLC-II cable will not be disturbed during reprogramming.

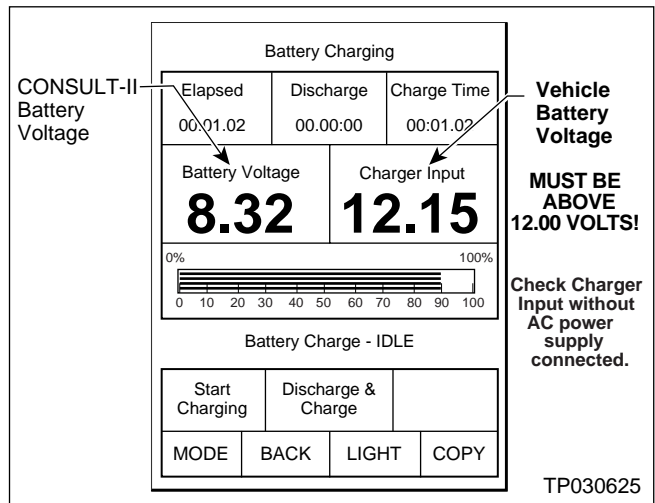
Figure 15

1. Press **SUB MODE**, then select **BATTERY CHARGE**.
2. Check the CONSULT-II's "Charger Input" reading (see Figure 15).

- Do not attempt VDC reprogramming if the vehicle’s battery voltage is below 12 volts.
- Permanent VDC damage can occur if the vehicle battery does not maintain the minimum voltage during VDC reprogramming.
- If “Charger Input” is above 12 volts, power from the vehicle battery will keep CONSULT-II’s power supply at the correct level during reprogramming (see Figure 15).

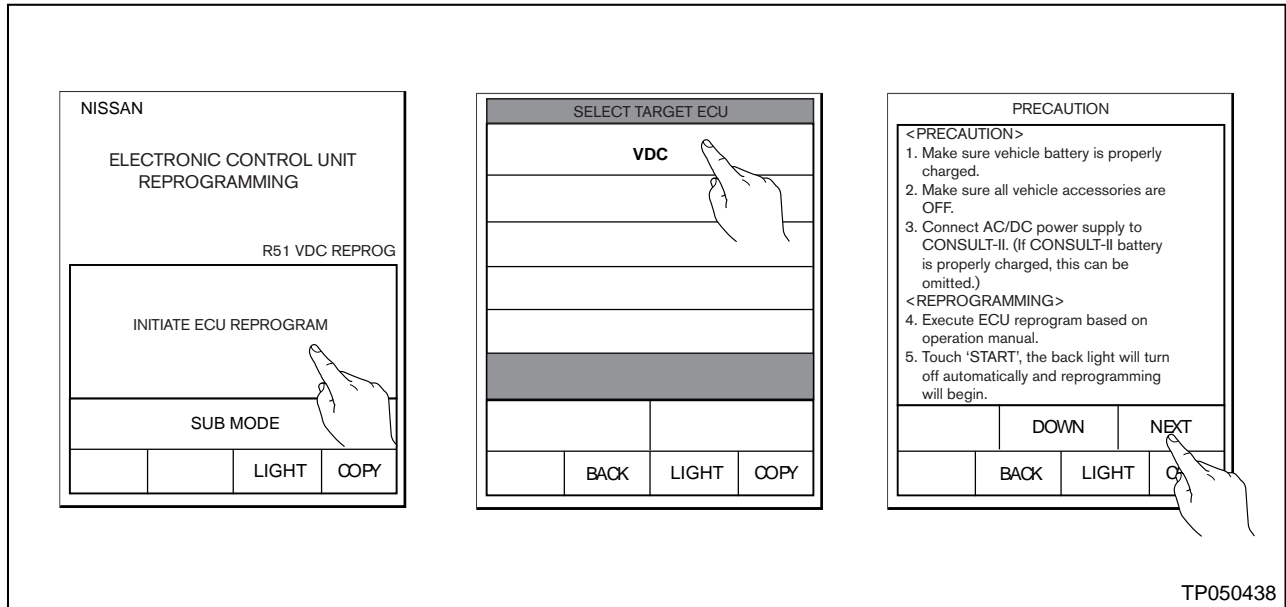
Figure 16

1. Press **BACK** two times.
2. Press **INITIATE ECU REPROGRAM** (see Figure 16), then
 - a. Press **VDC**
 - b. Review all precautions.
 - c. Press **NEXT**

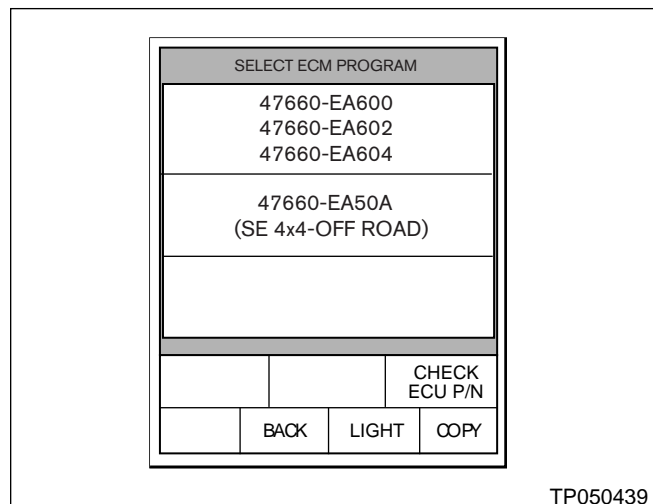
Figure 17

3. Select the applicable VDC program to install (see Figure 17):
 - If you're working on a "SE 4x4-OFF ROAD" model, select the lower box: **"47660-EA50A"**
 - For all other models, select the upper box: **"47660-EA600 / 47660-EA602 / 47660-EA604"**

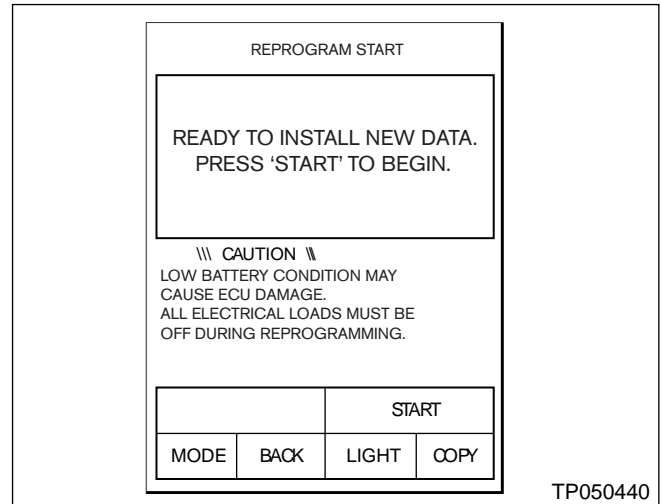
Figure 18

4. The "**REPROGRAM START**" window should appear (see Figure 18).

5. Press **START**. See Figure 18, previous page.

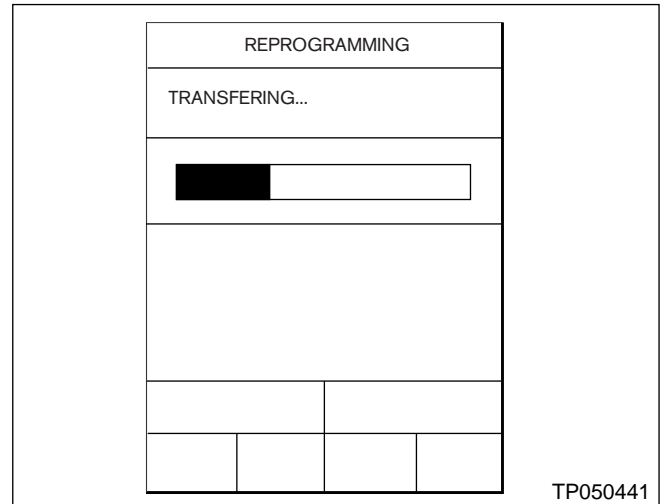
- After a few seconds, the window shown in Figure 19 will appear.
- The screen backlight in CONSULT-II will now turn “OFF”.
- When the screen backlight goes “OFF”, VDC reprogramming has started.

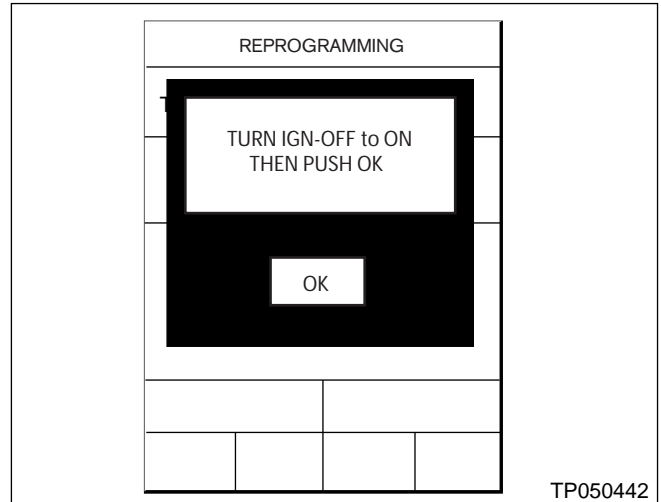
Figure 20

- a. CONSULT-II will display the screen shown in Figure 20.
- You'll need to turn the ignition key "OFF" for at least **one full second** and then turn the key back "ON". Then press "OK" on the CONSULT-II screen.

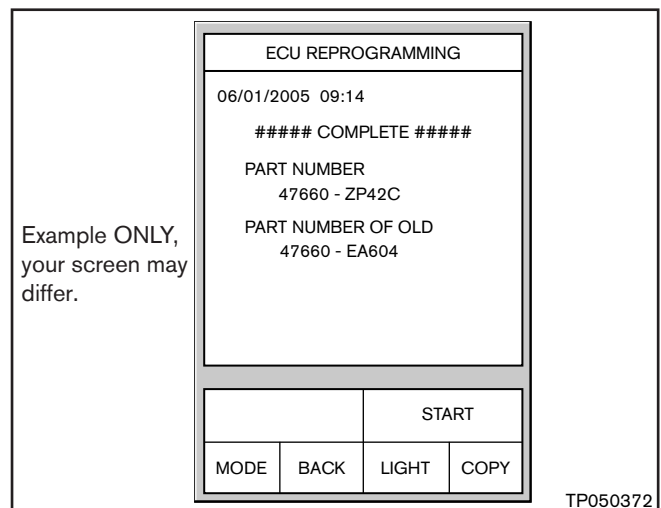
Figure 21

b. CONSULT-II will automatically print out a report (see Figure 21).

- Attach the print-out report to the Repair Order for future reference.
