Revision: June 2012 IP-3 2011 Altima GCC

# **INSTRUMENT PANEL ASSEMBLY**

## **INSTRUMENT PANEL ASSEMBLY**

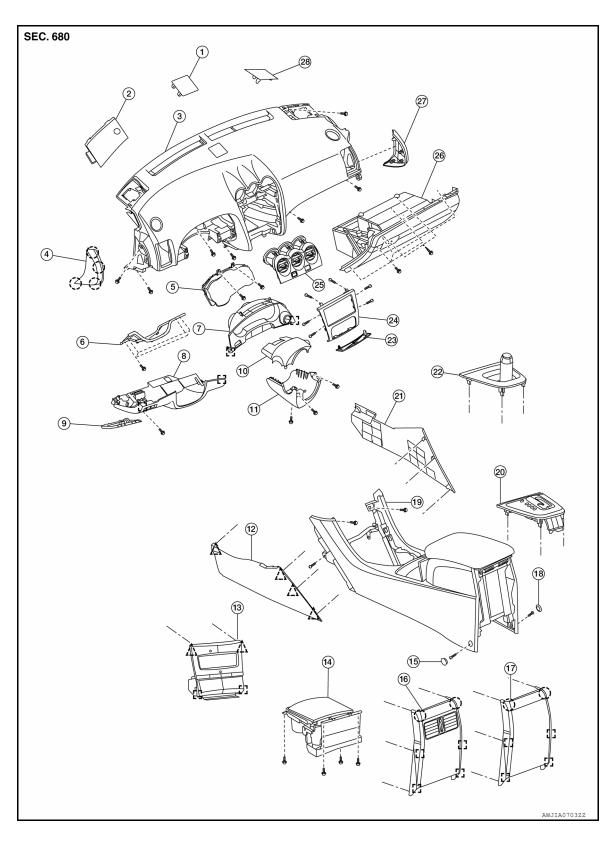
Exploded View

1.	Center speaker grille	2.	Tweeter speaker grille (LH)	3.	Instrument panel
4.	Instrument side finisher (LH)	5.	Combination meter	6.	Lower knee protector (LH)
7.	Cluster lid A	8.	Instrument lower cover (LH)	9.	Fuse block cover
10.	Steering column cover upper	11.	Steering column cover lower	12.	Console side finisher (LH)
13.	Finisher/storage bin	14.	Cup holder	15.	Console screw cover (LH)
16.	Console rear finisher (with rear duct)	17.	Console rear finisher (without rear duct)	18.	Console screw cover (RH)
19.	Console	20.	CVT finisher	21.	Console side finisher (RH)
22.	M/T finisher	23.	Cluster lid D	24.	Cluster lid C
25.	Center ventilator grilles	26.	Glove box assembly	27.	Instrument side finisher (RH)
28.	Tweeter speaker grille (RH)	<u>^</u> \	Clip	[ ]	Metal clip
/ <sup>-</sup> \	Pawl

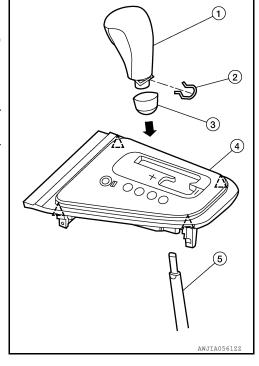
- 1. Place the shift selector (5) into the drive (D) position.
- 2. Remove the shift selector handle (1).
- a. Using a suitable tool, release the shift selector handle cover (3) from the base of the shift selector handle (1).
- b. Remove the shift selector handle clip (2).
- c. Pull upward and remove the shift selector handle (1).
- 3. Release the clips using a suitable tool, then lift the CVT finisher (4) upward.
- 4. Remove the CVT finisher illumination bulb from the CVT finisher and remove the CVT finisher (4).

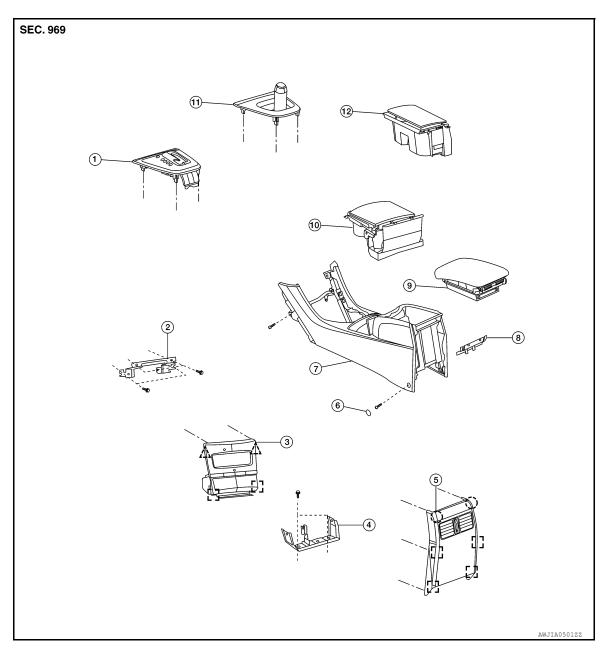
Exploded View

- 1. CVT finisher
- 4. Console floor bracket
- Console
- 10. Cup holder CVT
- ( Clip

- 2. Finisher/storage bin bracket
- 5. Console rear finisher
- 8. Console lid assembly bracket
- 11. M/T finisher
- ,^、Pawl
