**SECTION IP**  
**INSTRUMENT PANEL**

### INSTRUMENT PANEL ASSEMBLY

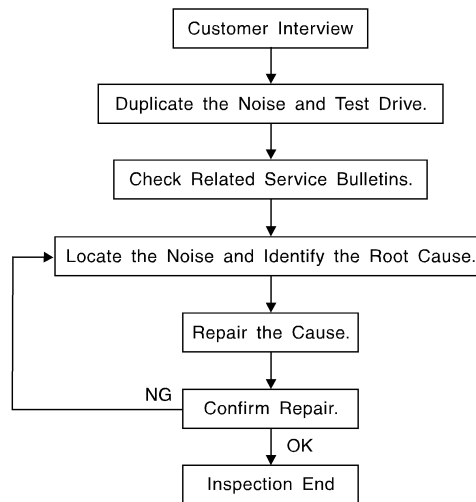
SBT842

#### CUSTOMER INTERVIEW

Interview the customer if possible, to determine the conditions that exist when the noise occurs. Use the Diagnostic Worksheet during the interview to document the facts and conditions when the noise occurs and any customer's comments; refer to [IP-9, "Diagnostic Worksheet"](#). This information is necessary to duplicate the conditions that exist when the noise occurs.

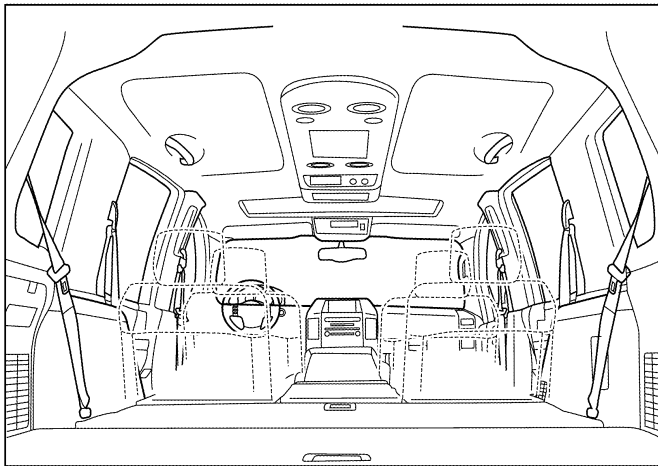
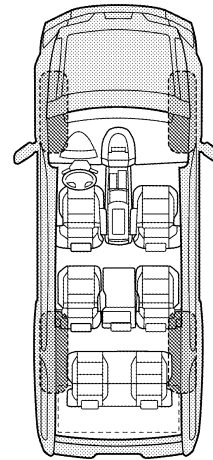
#### I. WHERE DOES THE NOISE COME FROM? (circle the area of the vehicle)

The illustrations are for reference only, and may not reflect the actual configuration of your vehicle.
