SECTION **IP** INSTRUMENT PANEL

CONTENTS

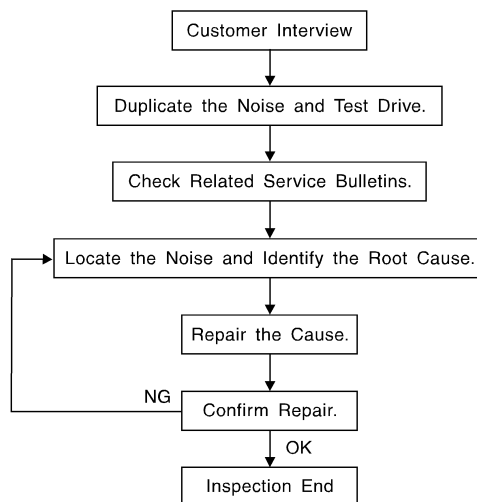
SBT842

Work Flow

CUSTOMER INTERVIEW

DUPLICATE THE NOISE AND TEST DRIVE

LOCATE THE NOISE AND IDENTIFY THE ROOT CAUSE

REPAIR THE CAUSE

CONFIRM THE REPAIR

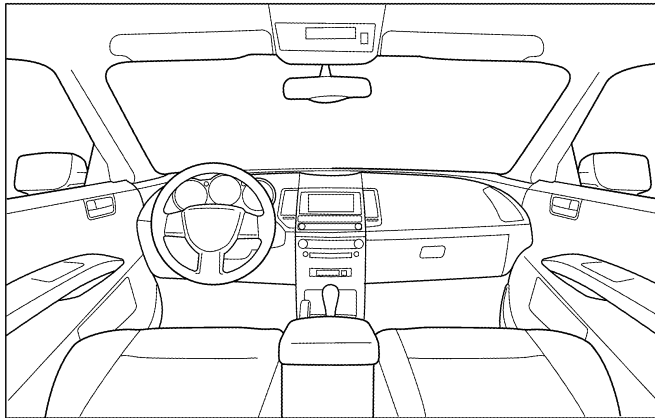
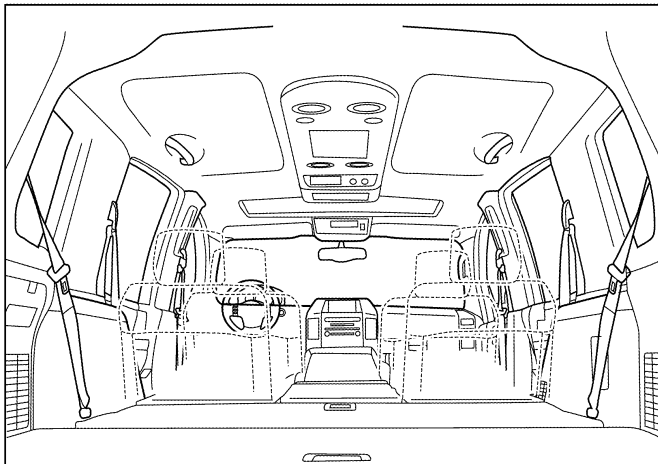
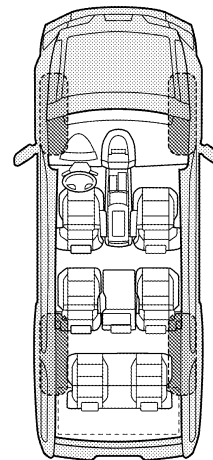
I. WHERE DOES THE NOISE COME FROM? (circle the area of the vehicle)

The illustrations are for reference only, and may not reflect the actual configuration of your vehicle.

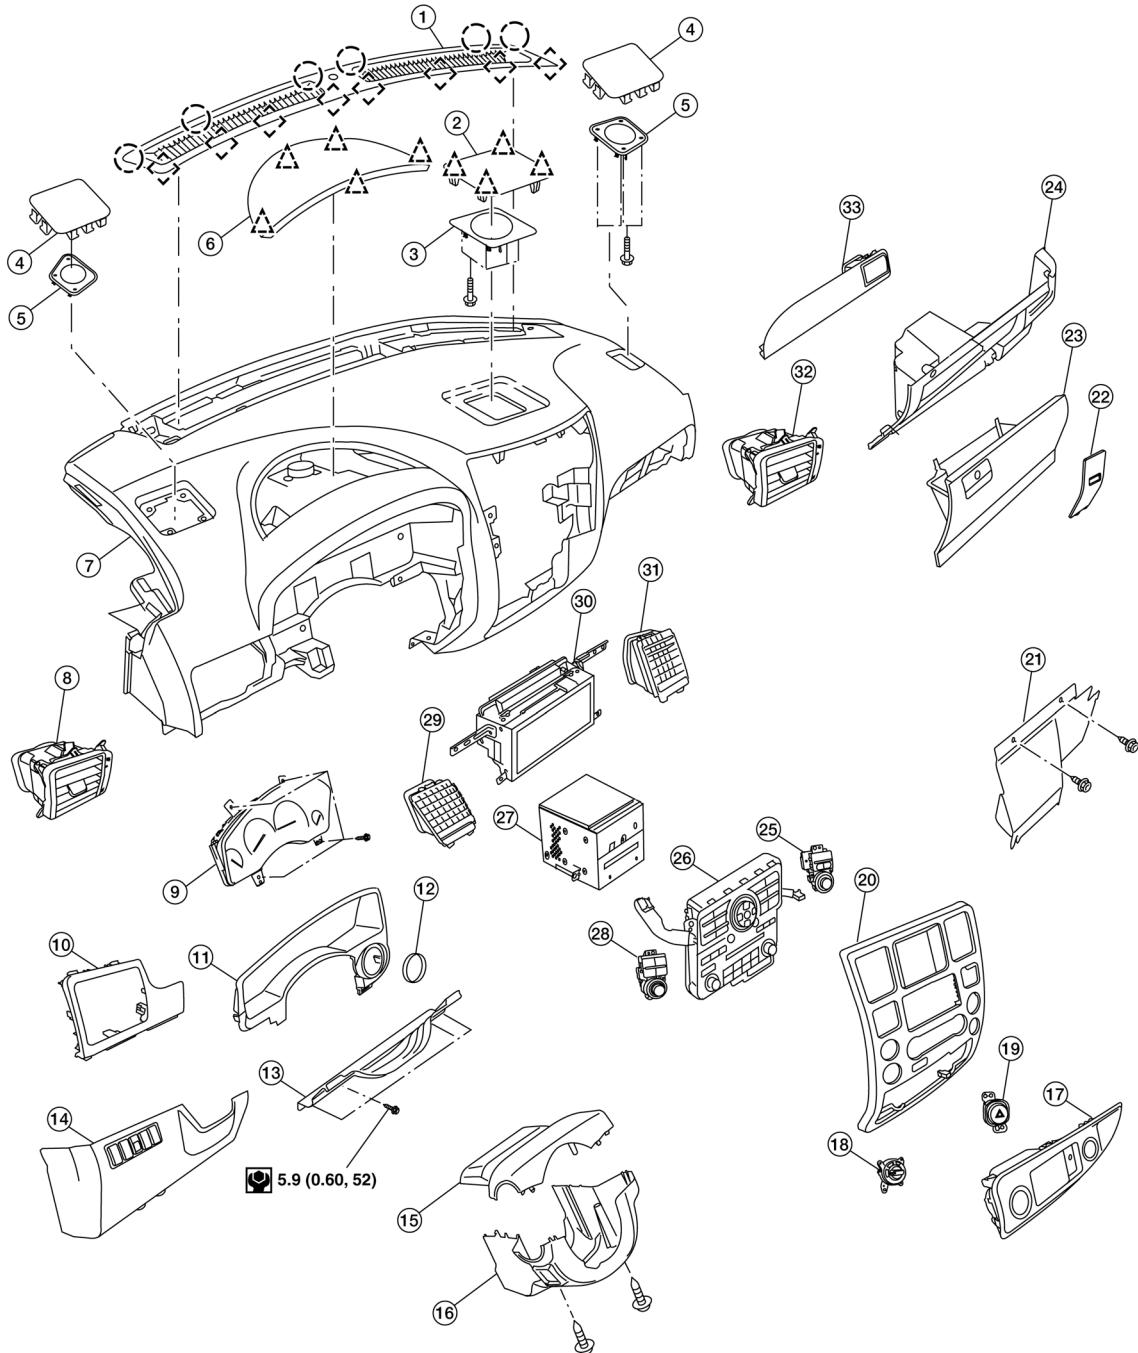
AWJIA0792GB

SEC. 280 • 284 • 487 • 680 • 685

INSTRUMENT PANEL ASSEMBLY

| 1. Defroster grille | 2. Center speaker grille | 3. Speaker center |
| 19. Hazard switch | 20. Cluster lid C | 21. Instrument lower cover RH |

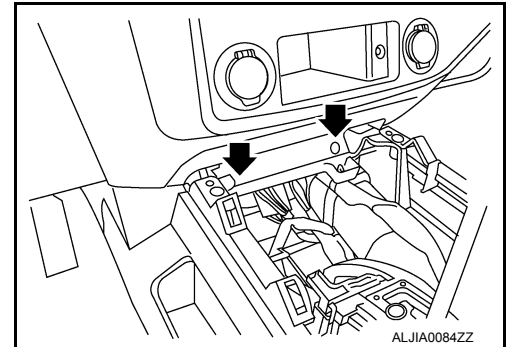
1. Disconnect the negative and positive terminals, then wait at least three minutes.
2. Remove A/T finisher. Refer to [IP-19, "Removal and Installation"](#).
3. Remove the front center console assembly upper screws.

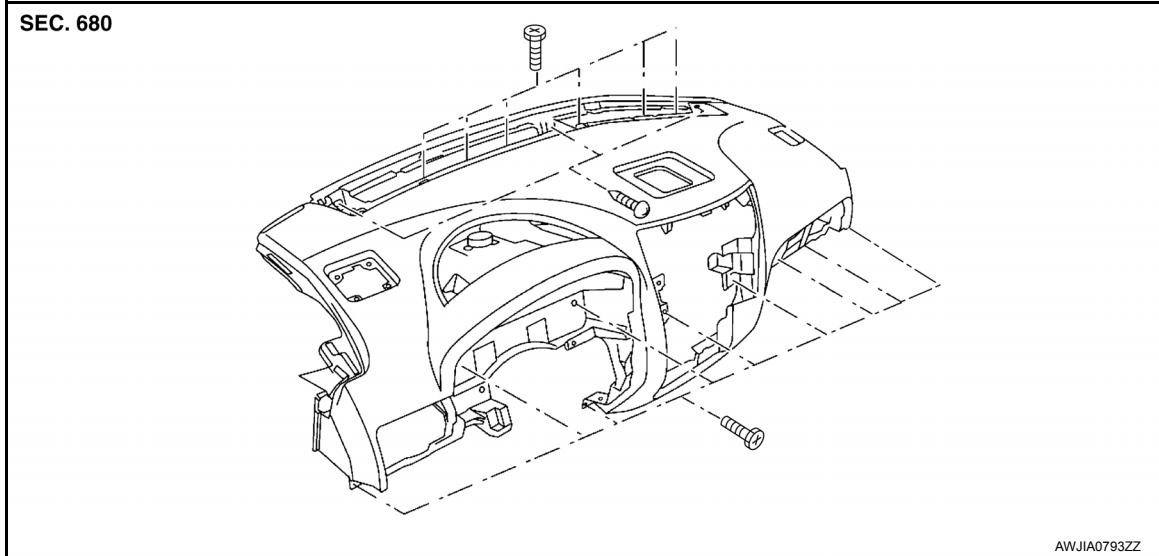
20. Disconnect remaining optional equipment harness connectors (if equipped).
21. Remove instrument panel and pad assembly bolts and screws.

22. Release instrument panel and pad assembly lifting rearward away from steering member, then carefully remove through front door opening.

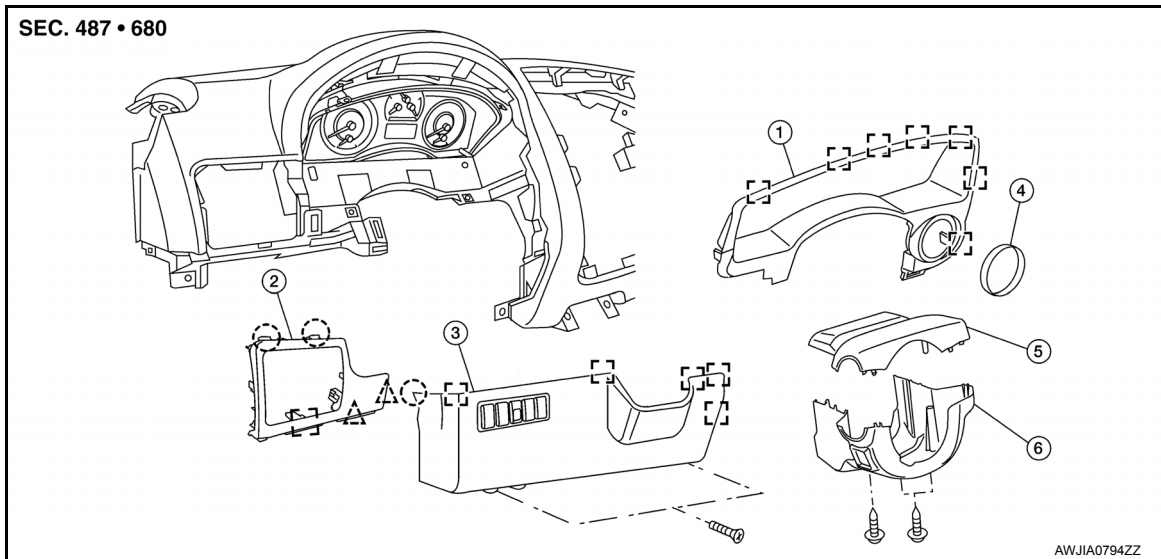
Exploded View

| 1. Cluster lid A | 2. Instrument upper panel LH | 3. Instrument lower panel LH |

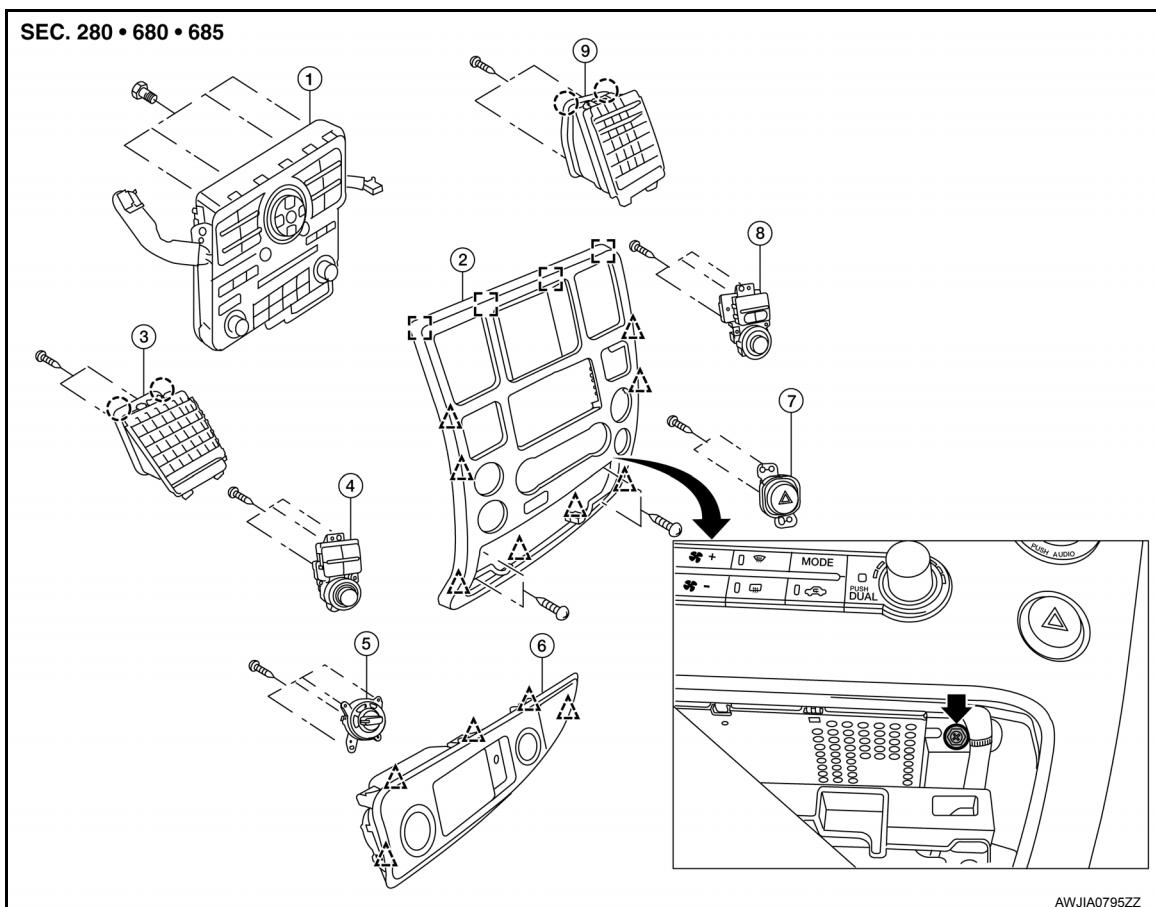
Exploded View

| 1. A/C and AV switch assembly | 2. Cluster lid C | 3. Center ventilator grille LH |
| 7. Hazard switch | 8. Audio switch RH | 9. Center ventilator grille RH |

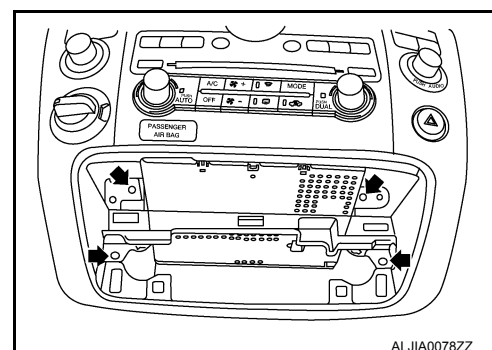
1. Disconnect battery negative terminal.
2. Release the clips and remove cluster lid C lower.
3. Remove the upper and lower cluster lid C screws.
4. Release the clips, then pull cluster lid C rearward to release from instrument panel and pad assembly.
5. Disconnect harness connectors.

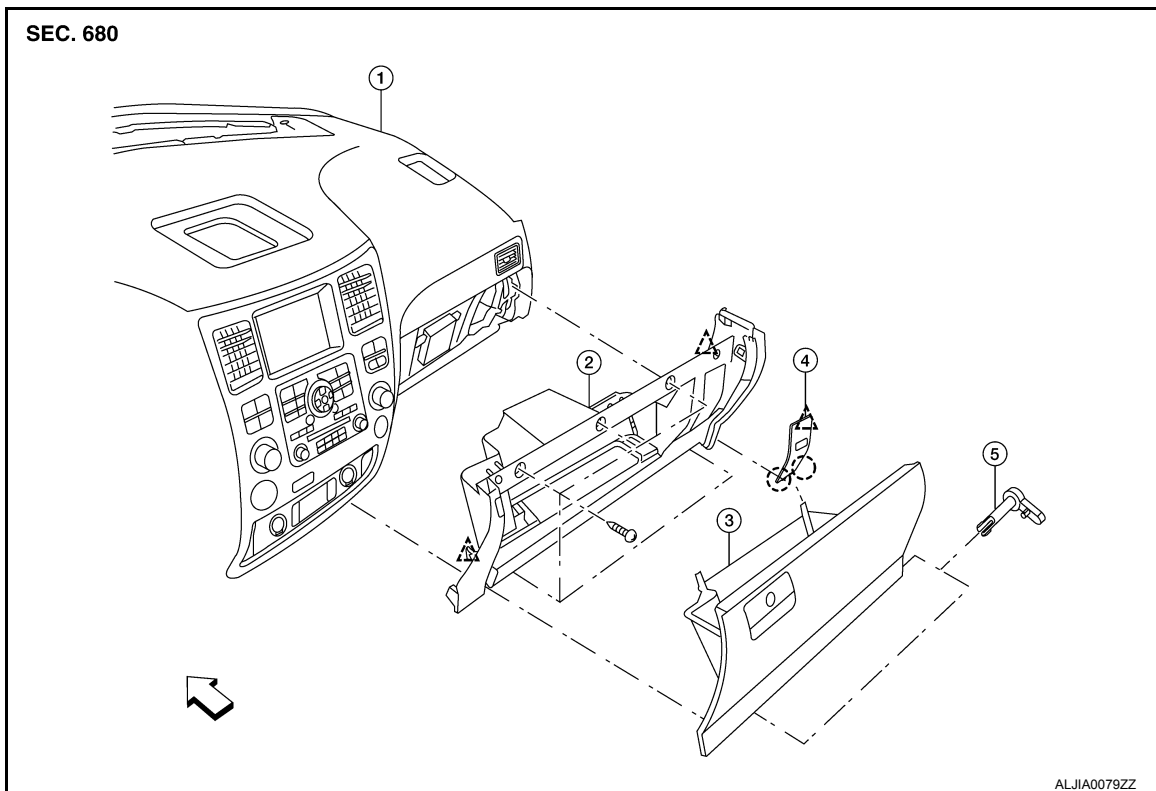
Exploded View

| 1. Instrument panel and pad assembly | 2. Instrument lower panel RH | 3. Glove box |

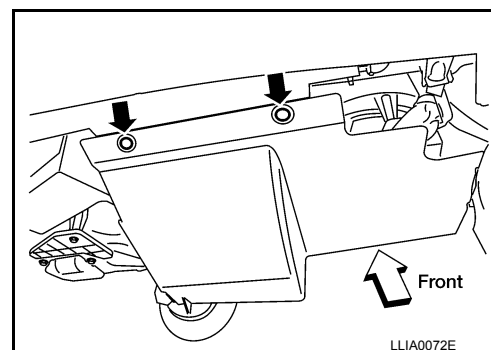
1. Remove the instrument lower cover RH.
2. Remove the instrument lower panel RH screws.
3. Release the clips and remove instrument lower panel RH and glove box from instrument panel and pad assembly.
4. Release the clips and remove fuse access cover.
5. Remove glove box pivot pins and damper clip, then remove glove box from instrument panel RH.

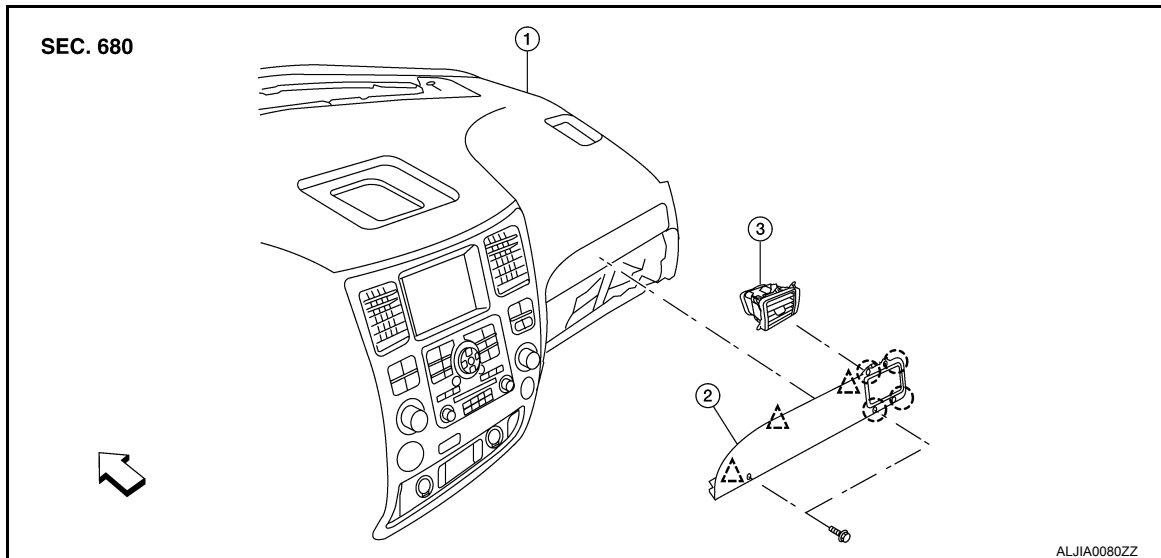
Exploded View

| 1. Instrument panel and pad assembly | 2. Instrument upper panel RH | 3. Side ventilator assembly RH |

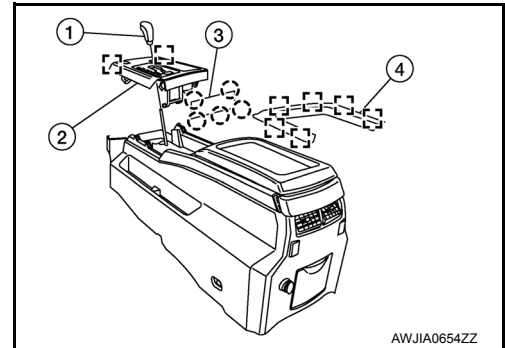
Pawl
4. Remove the A/T finisher (2).
 - a. Pull up on A/T finisher (2) to release the metal clips and access the A/T finisher switch harness connectors.
 - b. Disconnect A/T finisher switch harness connectors and remove the A/T finisher (2) from the front center console assembly.

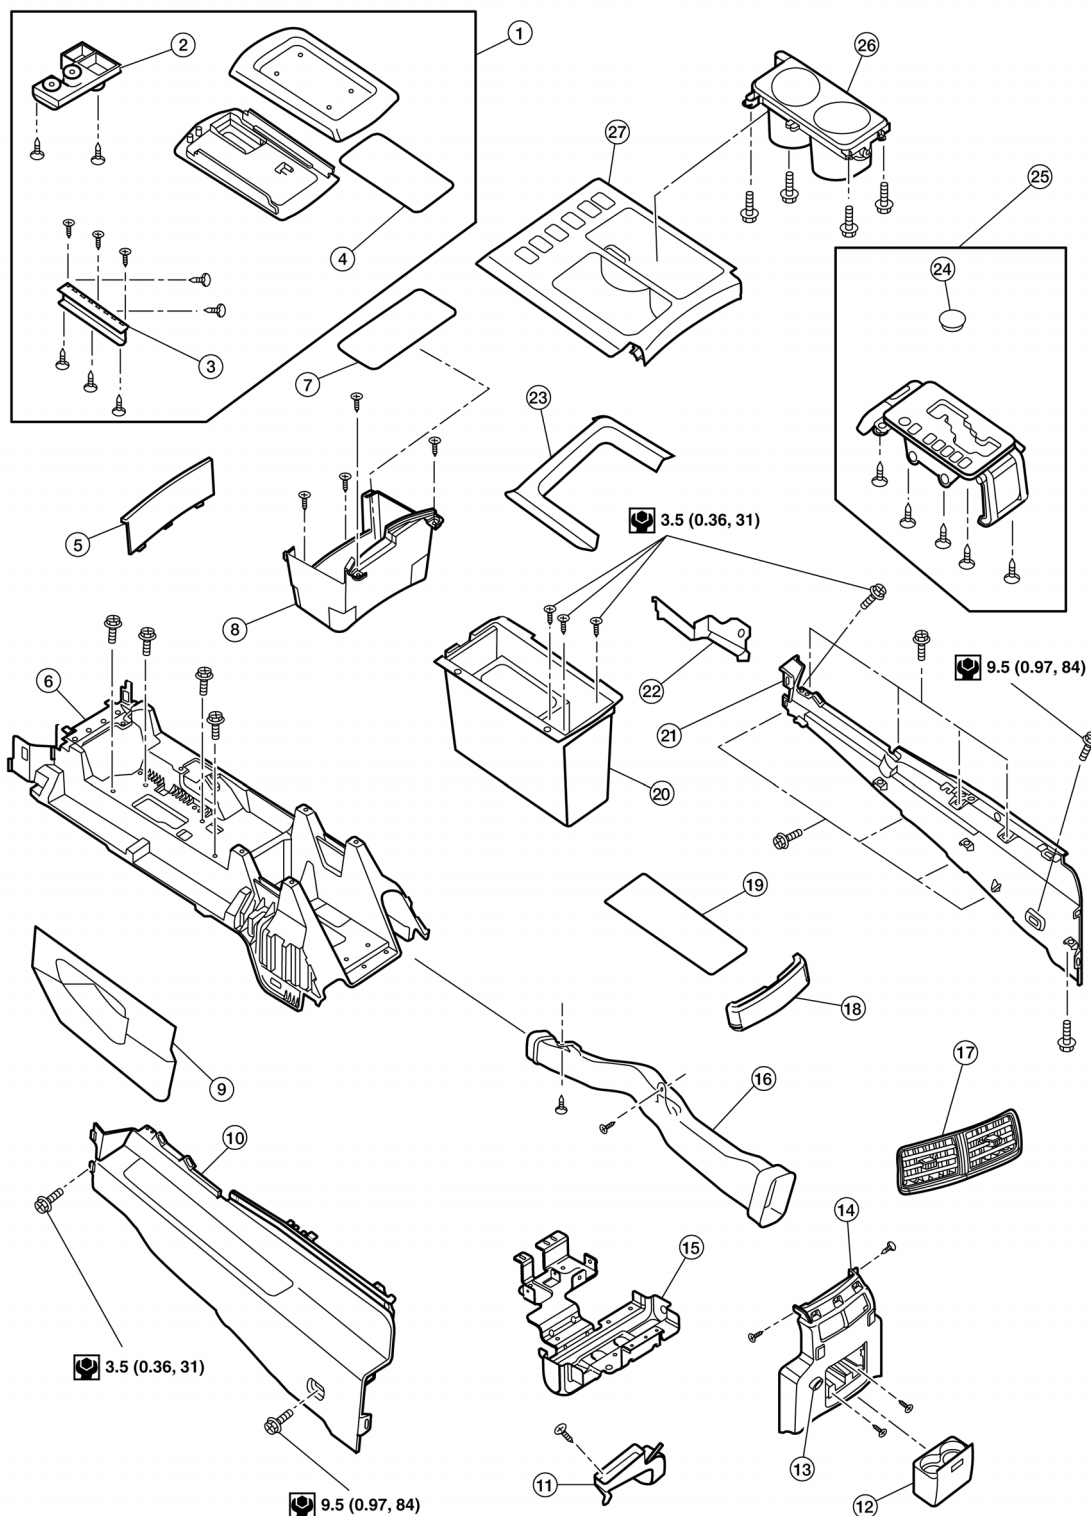
AWJIA0940ZZ

SEC.969 • 680

1. Console lid assembly
4. Console lid bin mat
7. Storage compartment bin mat

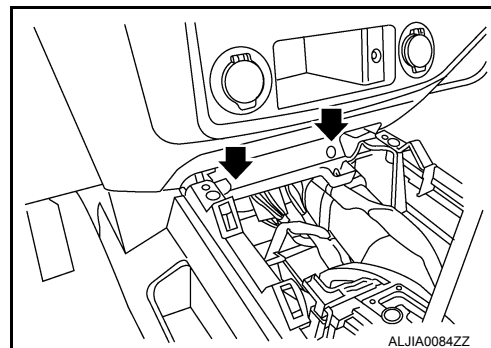
1. Remove A/T finisher. Refer to [IP-19, "Removal and Installation"](#).
2. Remove the front center console upper screws.
3. Remove shift selector assembly. Refer to [TM-175, "A/T Shift Selector Removal and Installation"](#).
4. Remove instrument lower panel RH and glove box assembly. Refer to [IP-17, "Removal and Installation"](#).
5. Remove center console lower cover (LH/RH), then remove front center console lower screws.
6. Open the console lid assembly and remove console bin mat, then remove the rear inside screws.
7. Move front seats forward.
8. Remove lower front center console screws at the rear.
9. Release front center console from floor and tilt to disconnect harness connectors.
10. Carefully remove front center console assembly through rear door opening.

Always use an assistant to steady the front center console assembly during removal from vehicle interior.

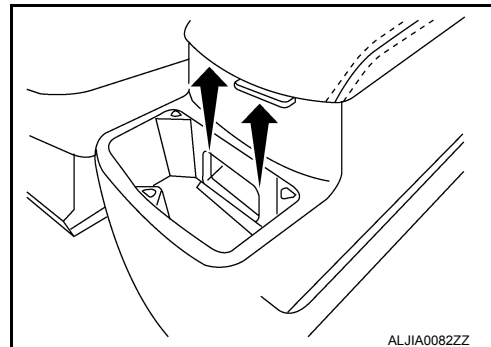
1. Remove cup holder insert.
2. Release latch and remove rear center console assembly.

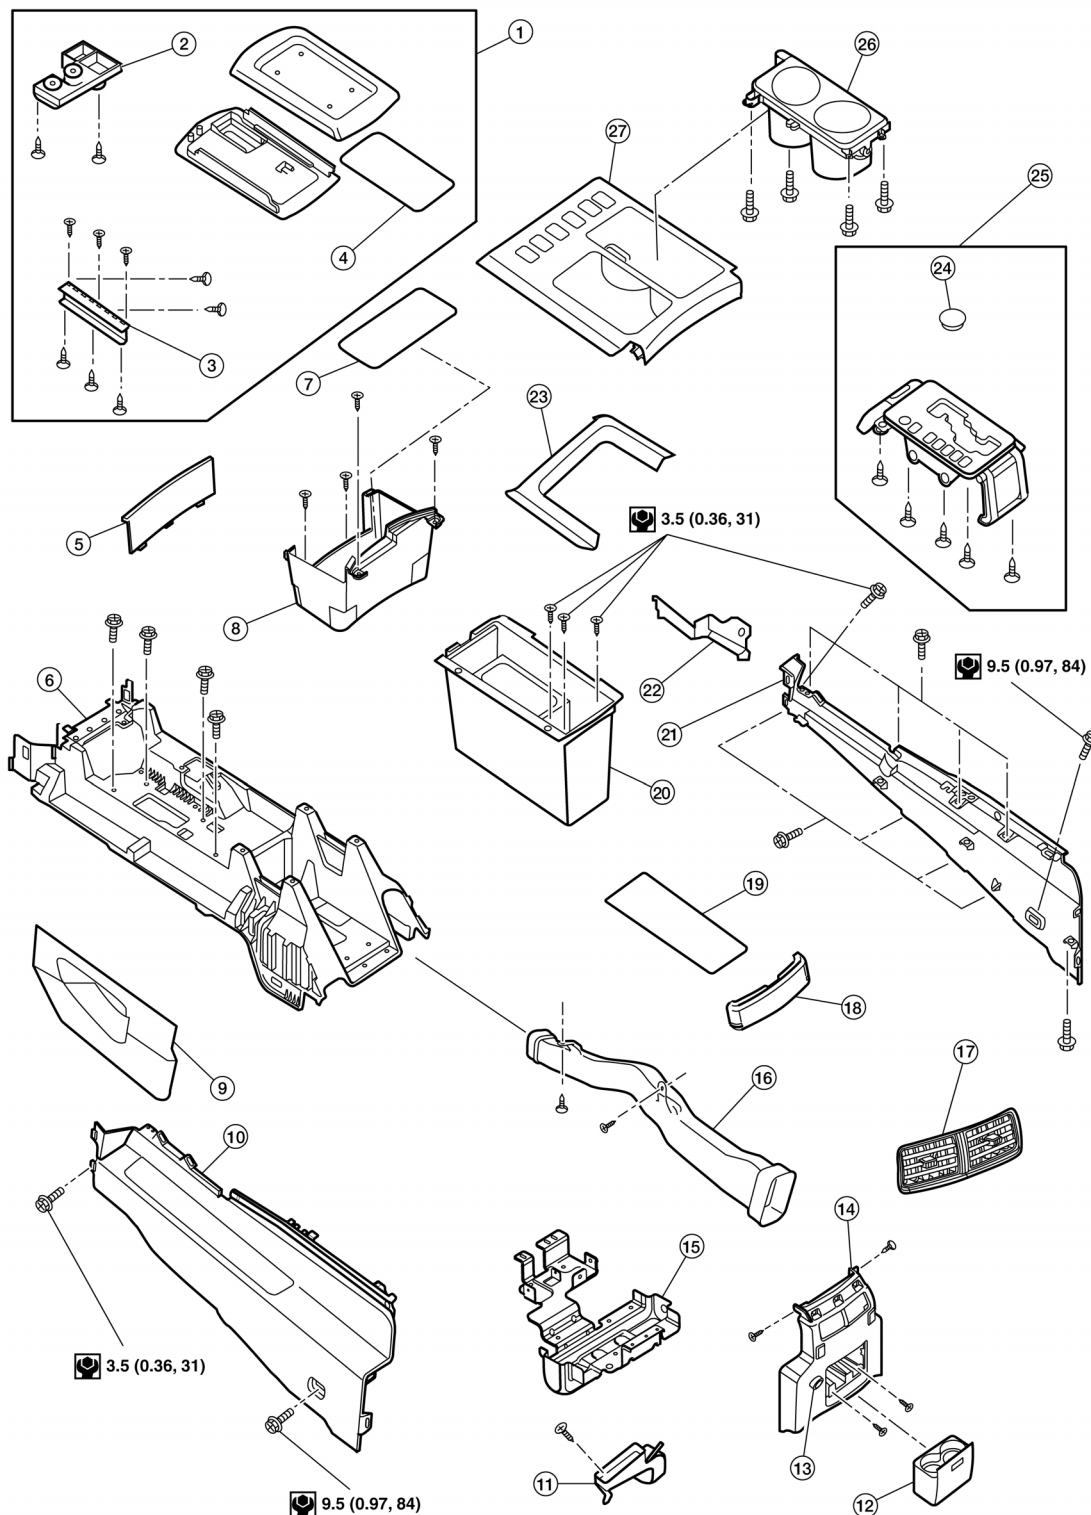
AWJIA0940ZZ

SEC.969 • 680

FRONT CENTER CONSOLE

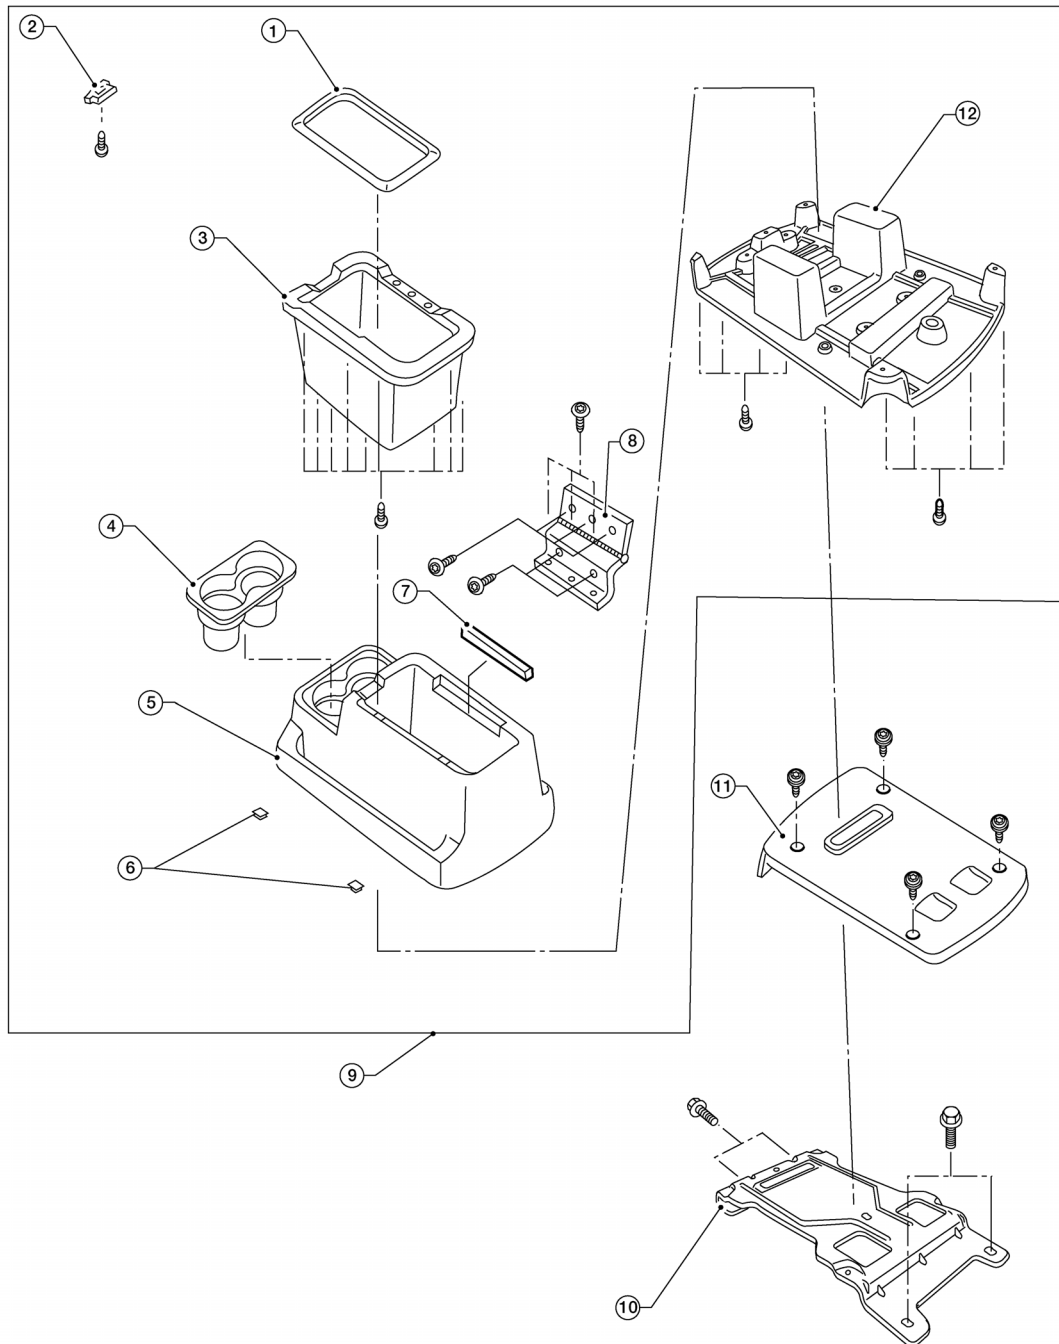
AWJIA0653ZZ

SEC. 969
