SECTION **BRM**
BODY REPAIR

Revision: March 2012

2011 Pathfinder

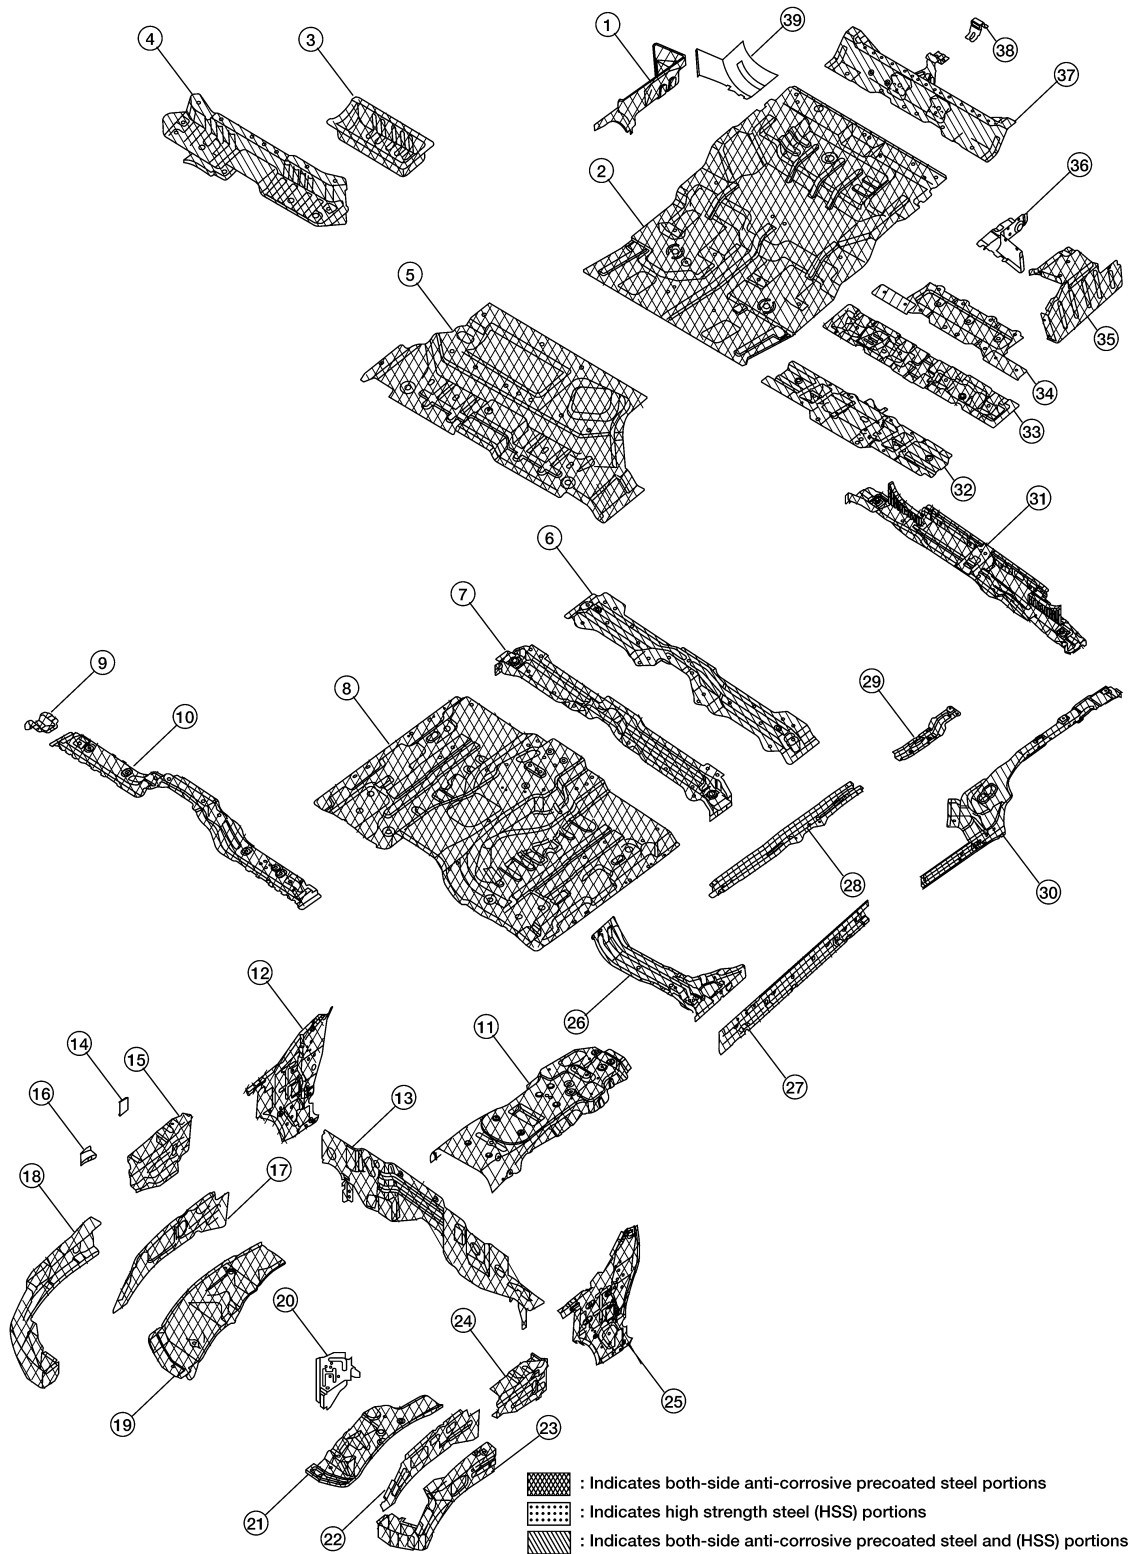
L1IA1787E

UNDERBODY COMPONENT PARTS

1. Rear floor side RH
2. Rear floor
3. Storage bin
4. Second seat mounting crossmember

5. Rear floor front
6. Center pillar crossmember assembly
7. Front seat mounting rear crossmember
8. Front floor
9. Front seat mounting crossmember
10. Second crossmember extension

11. Front floor reinforcement
12. Side dash RH
13. Lower dash
14. Wash tank bracket
15. Hoodledge reinforcement RH
16. Hoodledge plate
17. Hoodledge RH
18. Hoodledge reinforcement assembly RH

19. Rear lower hoodledge RH
20. Battery tray
21. Rear lower hoodledge LH
22. Hoodledge LH
23. Hoodledge reinforcement assembly LH
24. Hoodledge reinforcement LH

25. Side dash LH
26. Second crossmember assembly (RH/LH)
27. Inner sill (RH/LH)
28. Front side member assembly (RH/LH)
29. Center floor member assembly
30. Rear side member rear (RH/LH)

31. Rear crossmember
32. Second seat mounting crossmember
33. Third seat mounting bracket assembly
34. Rope hook bracket
35. Rear floor side LH
36. Rear floor side upper extension assembly LH

37. Third seat mounting rear crossmember assembly
38. Trim mounting bracket
39. Rear floor side upper extension assembly RH

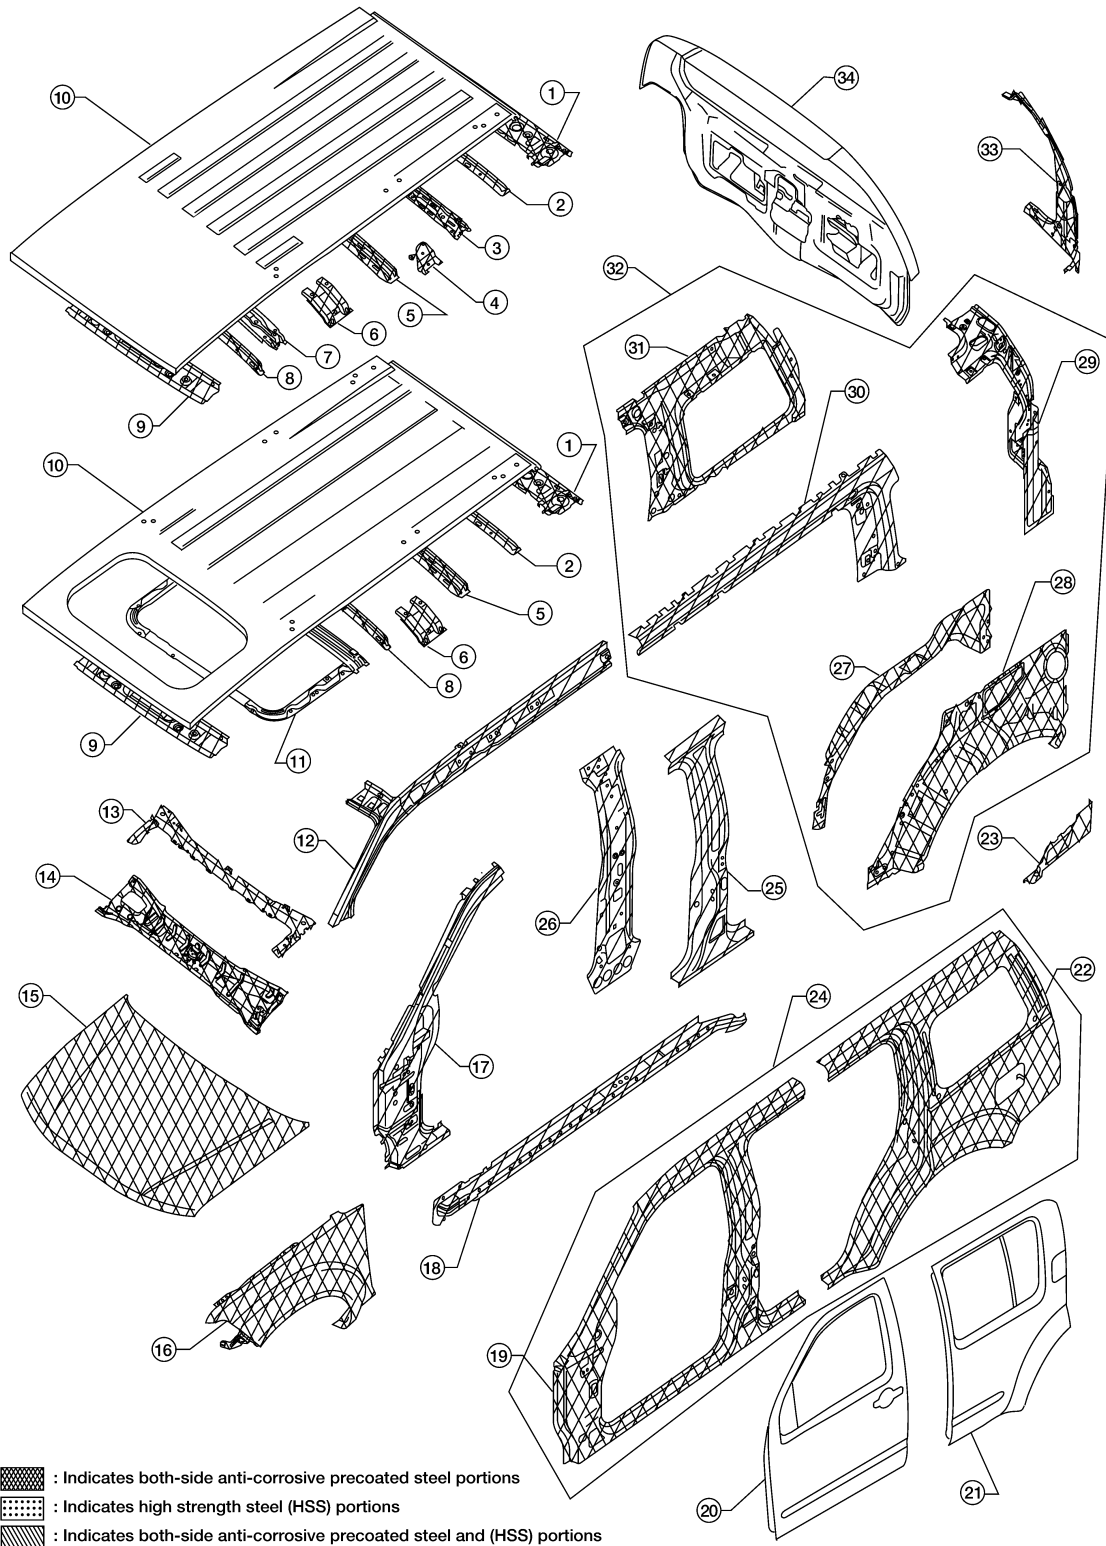
LI1A1788E

< SERVICE INFORMATION > BODY COMPONENT PARTS

1. Rear roof rail
2. Roof bow No 5
3. Roof 4th bow
4. Roof rack plate

5. Roof 3rd bow
6. Roof bow second bracket
7. Roof 2nd bow
8. Roof 1st bow
9. Front roof rail
10. Roof
11. Sunroof reinforcement
12. Front inner pillar upper (RH, LH)

13. Dash upper crossmember assembly
14. Dash upper assembly
15. Hood assembly
16. Front fender (RH, LH)
17. Front pillar hinge brace (RH, LH)
18. Outer sill reinforcement (RH, LH)

19. Front body side outer (RH, LH)
20. Front door assembly (RH, LH)
21. Rear door assembly (RH, LH)
22. Rear body side outer (RH, LH)
23. Rear fender extension RH/LH

24. Body side outer assembly
25. Center pillar hinge brace
26. Center inner pillar (RH, LH)
27. Rear wheel housing inner (RH, LH)
28. Rear wheel housing outer (RH, LH)

29. Back pillar reinforcement (RH, LH)
30. Outer roof side rail reinforcement (RH/LH)
31. Rear inner side panel (RH, LH)
32. Body side inner reinforcement assembly (RH, LH)

33. Main back pillar (RH, LH)
34. Back door assembly

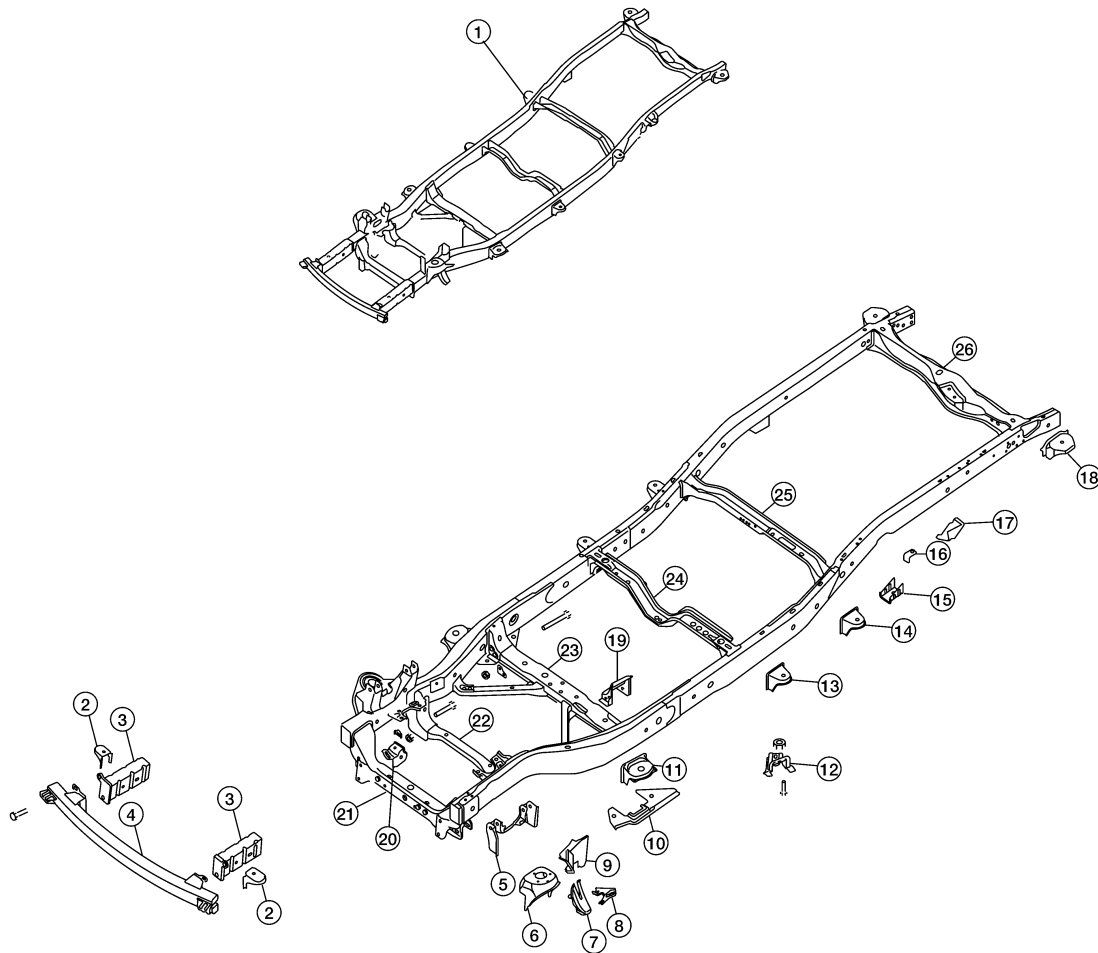
< SERVICE INFORMATION > FRAME COMPONENT PARTS

1. Frame assembly
2. 1st cab mounting bracket RH/LH
3. Front side member extension assembly RH/LH
4. 1st crossmember assembly
5. Front upper link mounting bracket RH/LH

6. Front shock absorber mounting bracket RH/LH
7. Bound bumper bracket RH/LH
8. Front brake hose bracket RH/LH
9. Panhard rod bracket reinforcement
10. 4th crossmember gusset RH/LH
11. 2nd cab mounting bracket RH/LH
12. Crossmember support RH/LH
13. 3rd cab mounting bracket RH/LH
14. 4th cab mounting bracket RH/LH
15. Rear suspension mounting bracket RH/LH
16. Rear brake hose bracket
17. Rear bound bumper bracket RH/LH
18. Cab mounting bracket assembly RH/LH
19. 4th crossmember gusset RH/LH
20. Front differential mounting bracket RH/LH
21. 2nd crossmember assembly
22. 3rd crossmember assembly
23. 4th crossmember assembly
24. 5th crossmember assembly
25. 6th crossmember assembly
26. 9th crossmember assembly

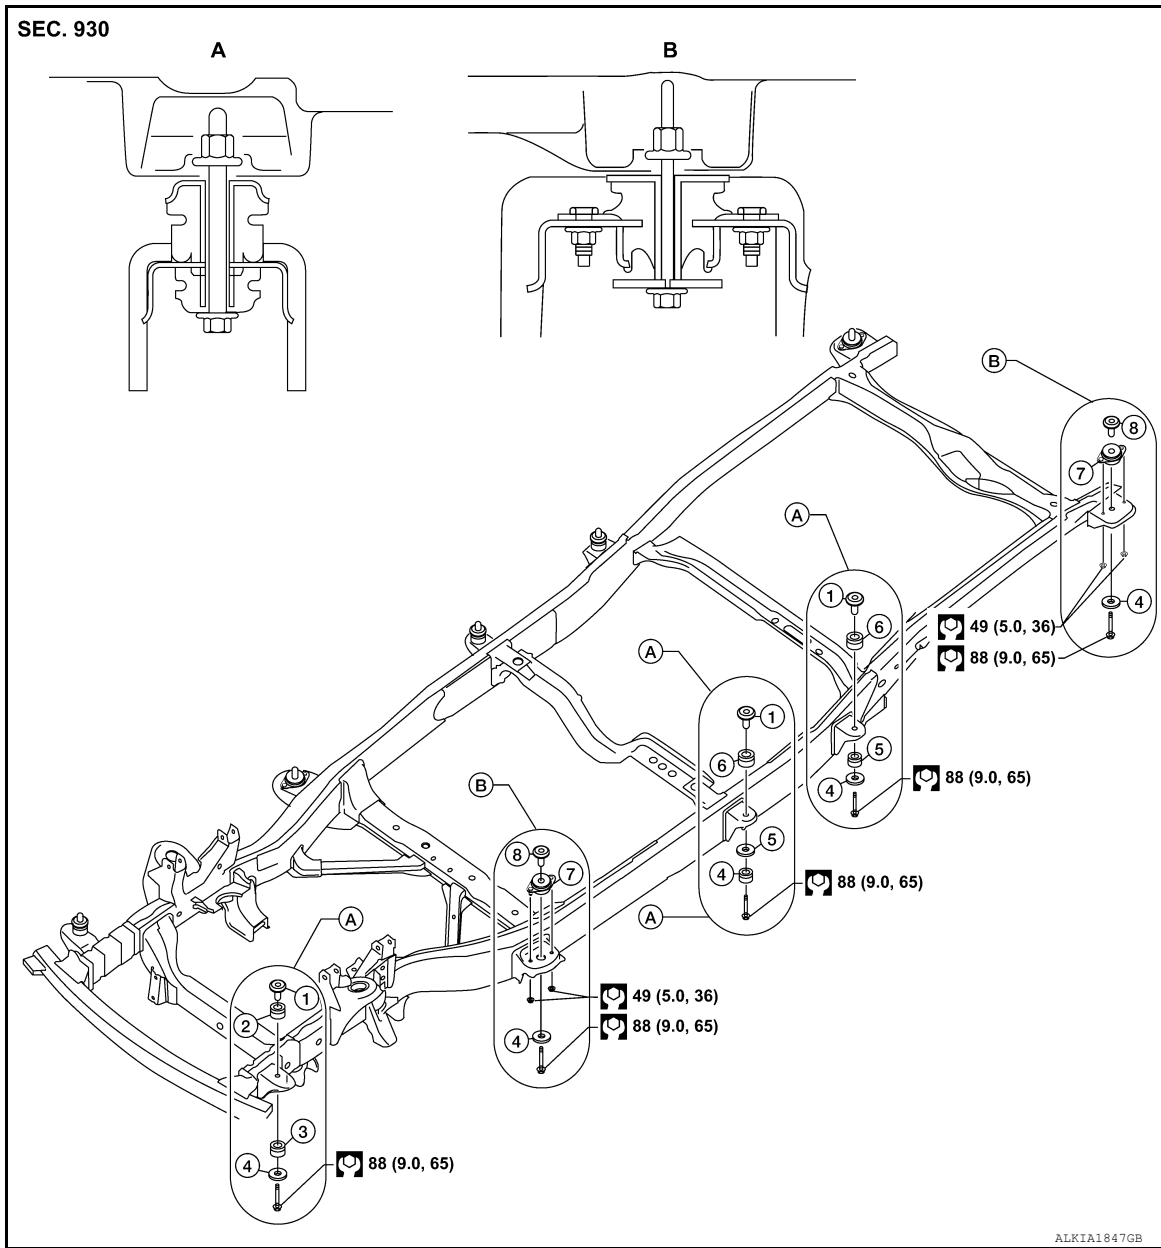
- When removing, be sure to replace bolts and nuts (sealant applied bolts or self-lock nuts are used for all mounting).
- Unless otherwise noted, the bushings and insulators have paint marks that are to be installed facing outward.

| 1. Gold washer | 2. Upper bushing | 3. Lower bushing |
| 4. Black washer | 5. Lower bushing without paint mark | 6. Upper bushing without paint mark |
| 7. Body mount insulator | 8. Body washer | |

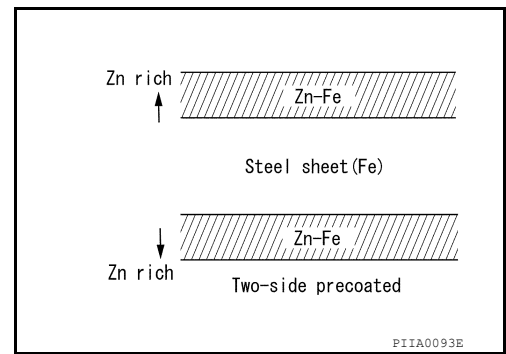
To improve repairability and corrosion resistance, a new type of anti-corrosive pre-coated steel sheet has been adopted replacing conventional zinc-coated steel sheet.

Galvannealed steel is electroplated and heated to form Zinc-iron alloy, which provides excellent and long term corrosion resistance with cationic electrode position primer.

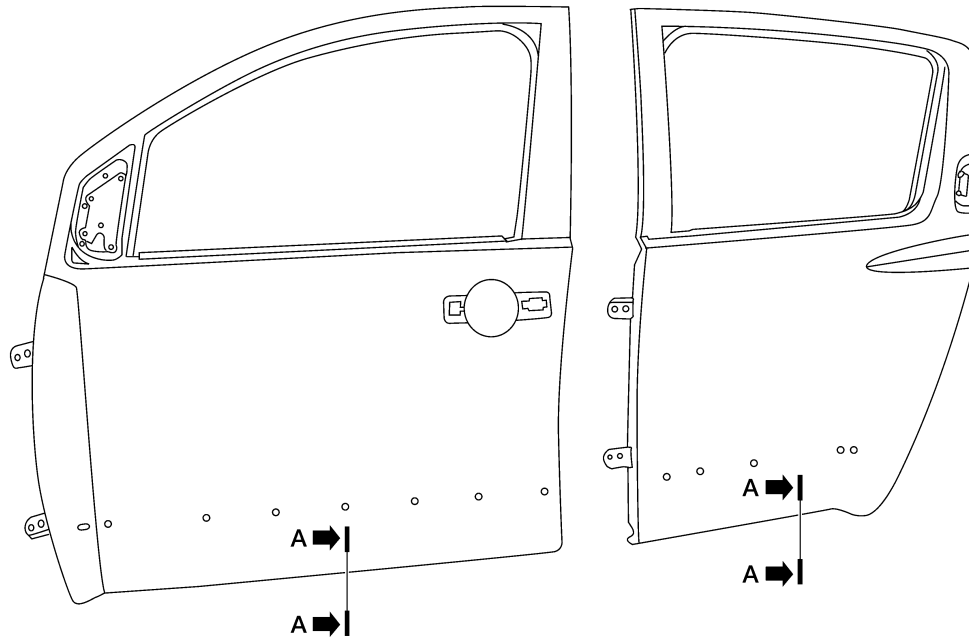
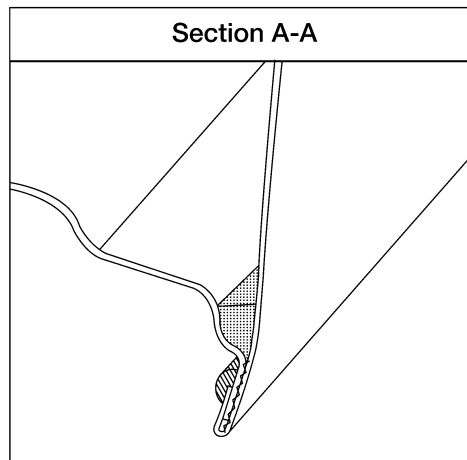
LI1A0905E

To improve corrosion resistance, anti-corrosive wax is applied inside the body sill and inside other closed sections. Accordingly, when replacing these parts, be sure to apply anti-corrosive wax to the appropriate areas of

the new parts. Select an excellent anti-corrosive wax which will penetrate after application and has a long shelf life.

: Indicates outside body sealant

: Indicates anti-corrosive wax coated portions

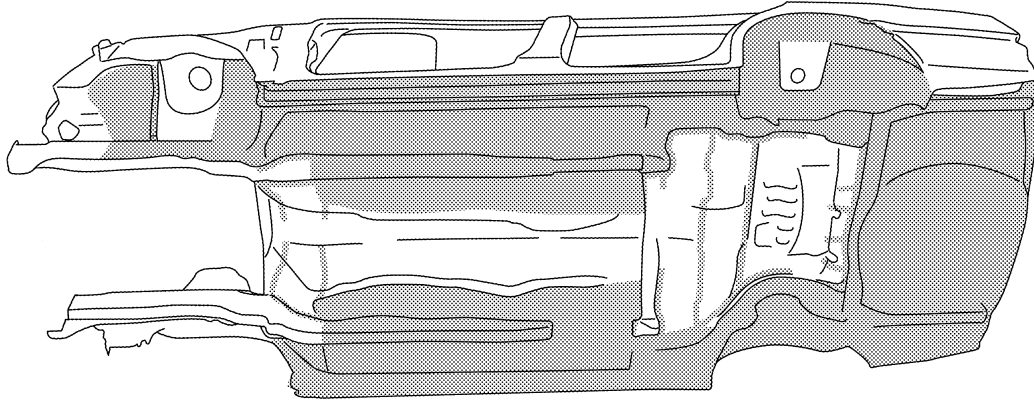
LIIA0129E

The underside of the floor and wheelhouse are undercoated to prevent rust, vibration, noise and stone chipping. Therefore, when such a panel is replaced or repaired, apply undercoating to that part. Use an undercoating which is rust preventive, soundproof, vibration-proof, shock-resistant, adhesive, and durable.

: Indicates undercoated portions.

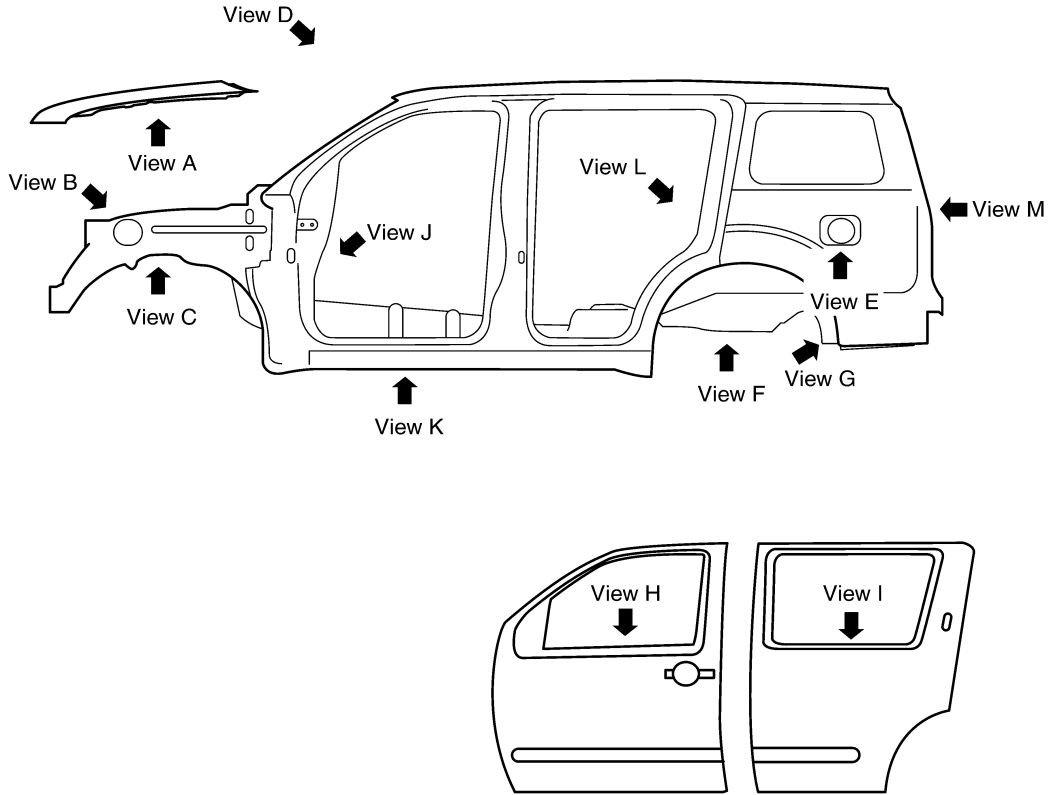
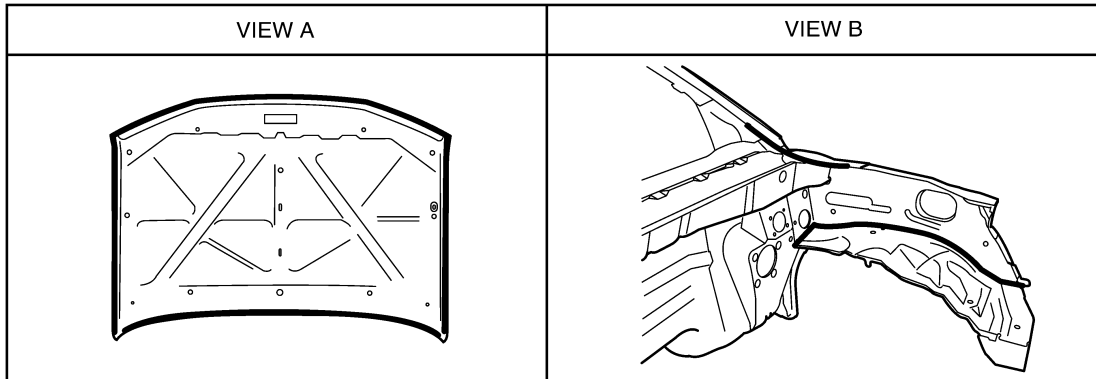
L1IA1736E

The following figure shows the areas which are sealed at the factory. Sealant which has been applied to these areas should be smooth and free from cuts or gaps. Care should be taken not to apply an excess amount of sealant and not to allow other unaffected parts to come into contact with the sealant.

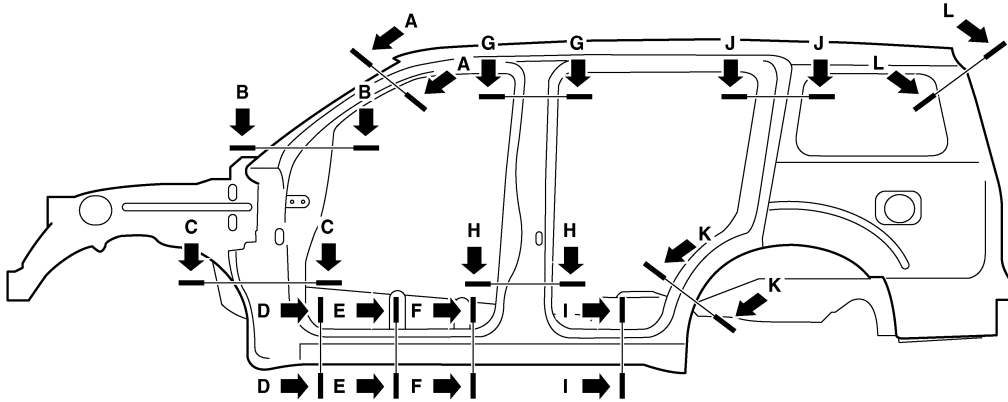
LIIA1739E

BODY CONSTRUCTION

Section A-A	Section B-B	Section C-C	Section D-D

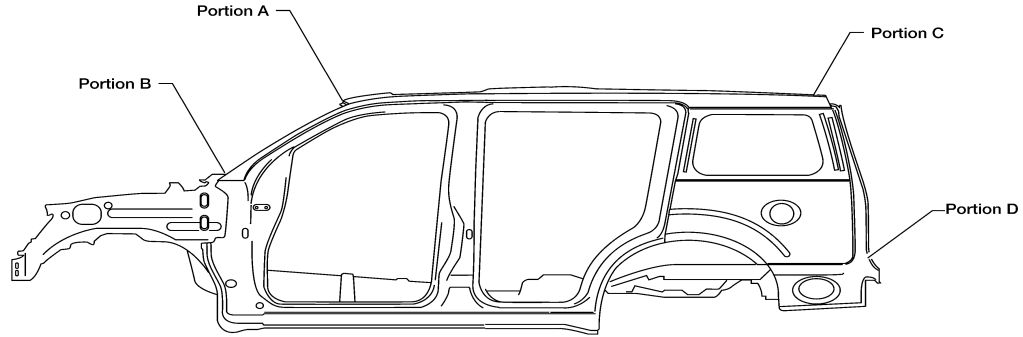
L1IA1790E

A mark has been placed on each part of the body to indicate the vehicle center. When repairing parts damaged by an accident which might affect the vehicle frame (members, pillars, etc.), more accurate and effective repair will be possible by using these marks together with body alignment specifications.

Portion A	Portion B	Portion C

<p>Embossment</p>

<p>Flange end</p>

<p>Notch</p>

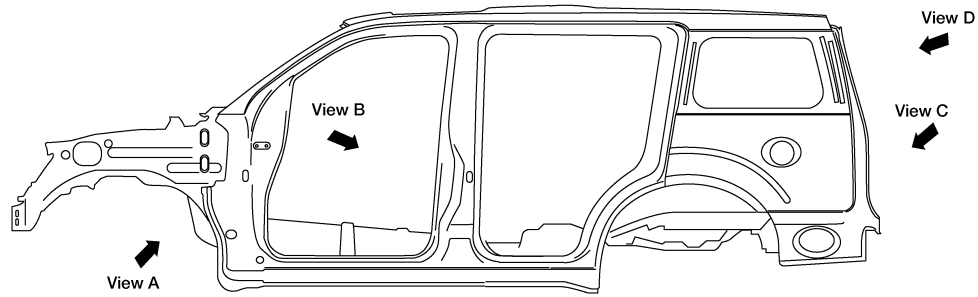
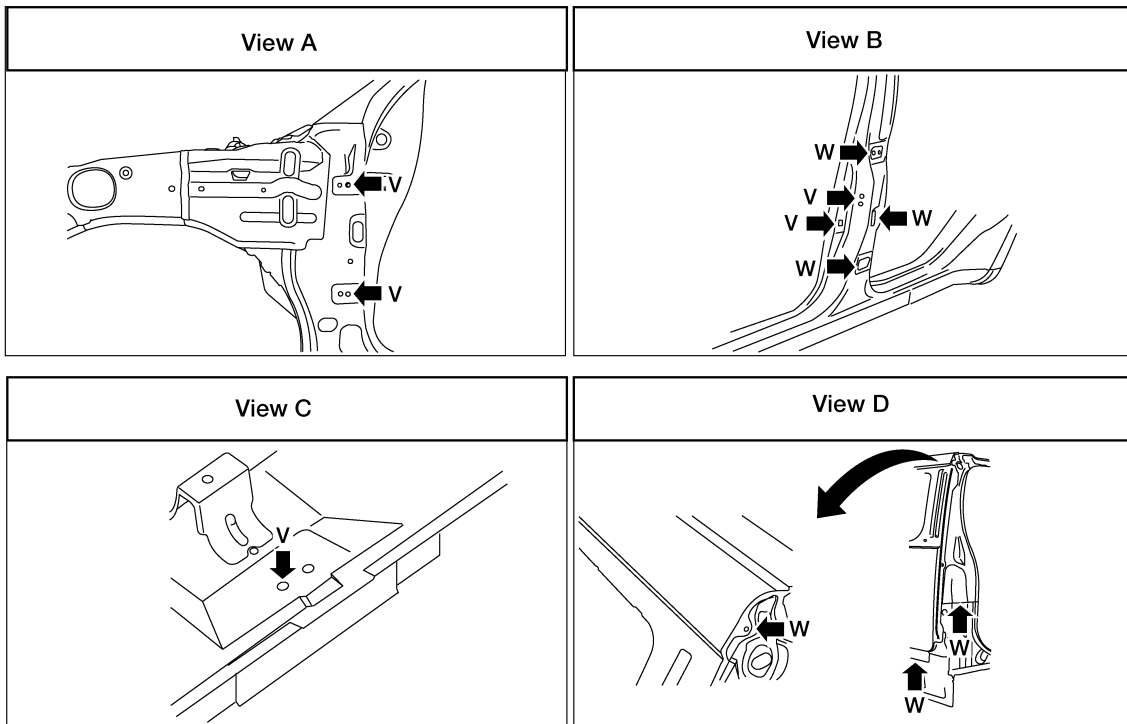
L1IA1791E

A mark has been placed on each body panel to indicate the parts matching positions. When repairing parts damaged by an accident which might affect the vehicle structure (members, pillars, etc.), more accurate and effective repair will be possible by using these marks together with body alignment specifications.

Type V:

Type W:

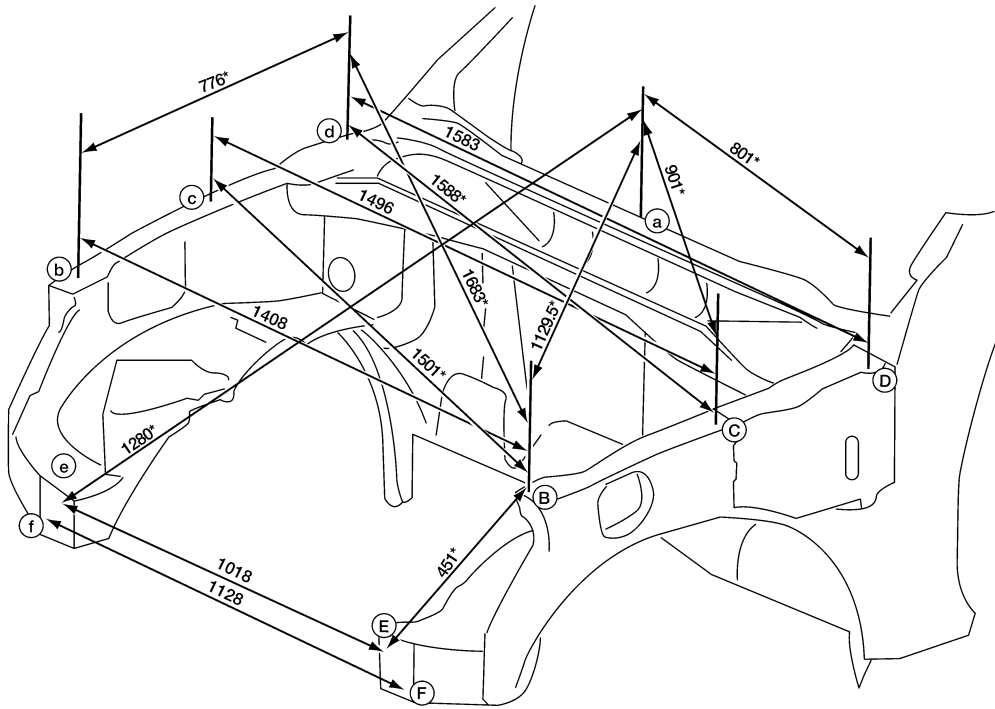
WIIA0729E

All dimensions indicated in this figure are actual.

Figures marked with an (*) indicate symmetrically identical dimensions on both right and left hand sides of the vehicle.

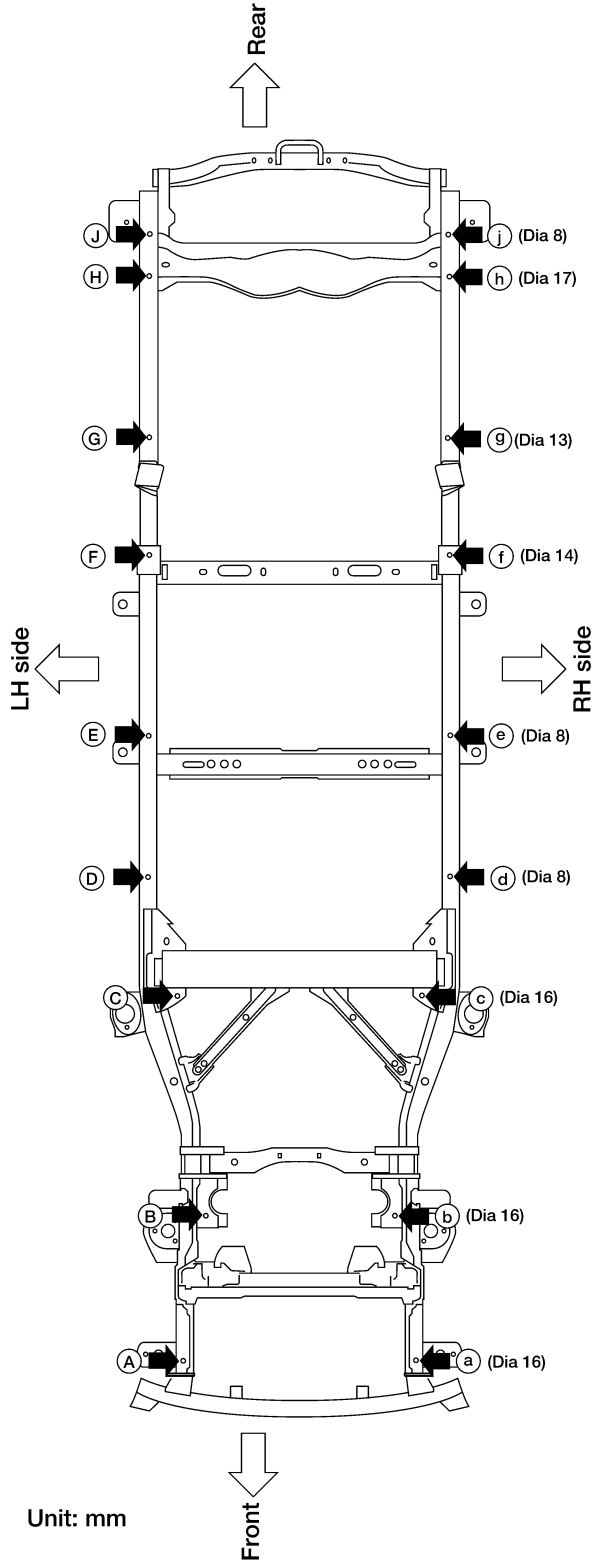
LIIA1795E

- (A), (a)
X : ± 425
Y : -531
Z : 275
- (B), (b)
X : ± 353
Y : 35
Z : 304
- (C), (c)
X : ± 460
Y : 807
Z : 100
- (D), (d)
X : ± 568
Y : 1356
Z : 109
- (E), (e)
X : ± 570
Y : 1710
Z : 99
- (F), (f)
X : ± 555
Y : 2420
Z : 205
- (G), (g)
X : ± 559
Y : 3066
Z : 400
- (H), (h)
X : ± 559
Y : 3471
Z : 400
- (J), (j)
X : ± 560
Y : 3652
Z : 368

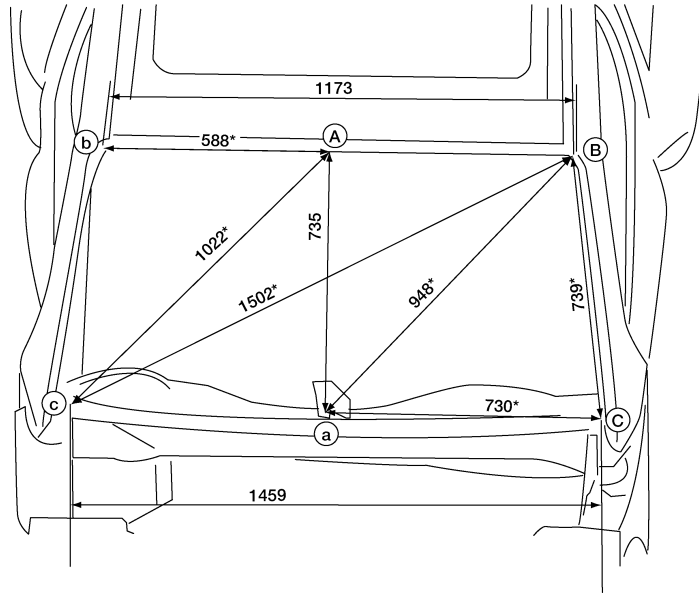
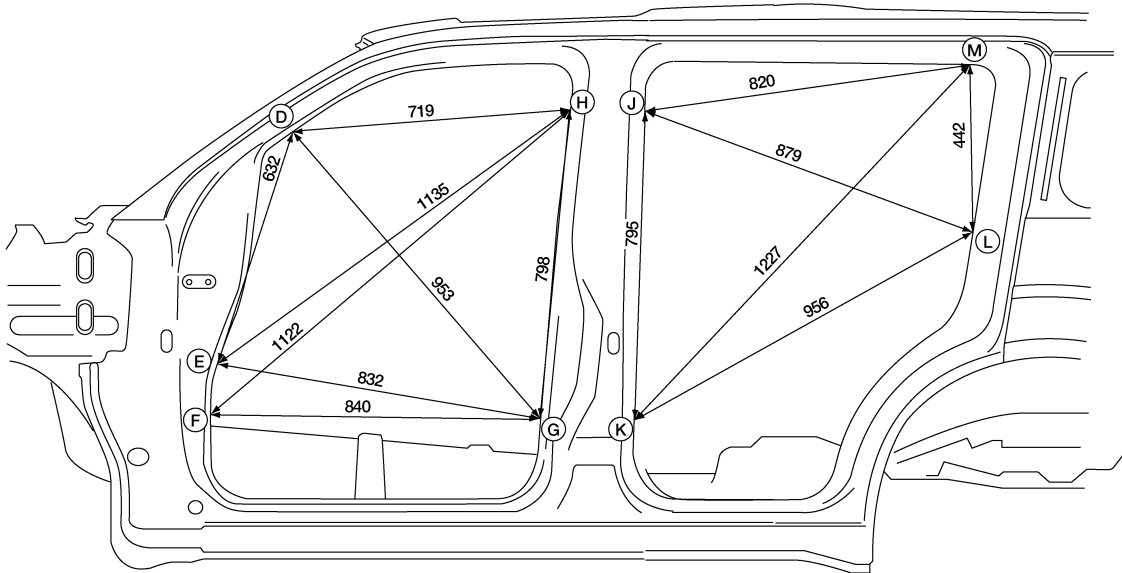
L1IA1798E

Figures marked with a (*) indicate symmetrically identical dimensions on both right and left hand sides of the vehicle.

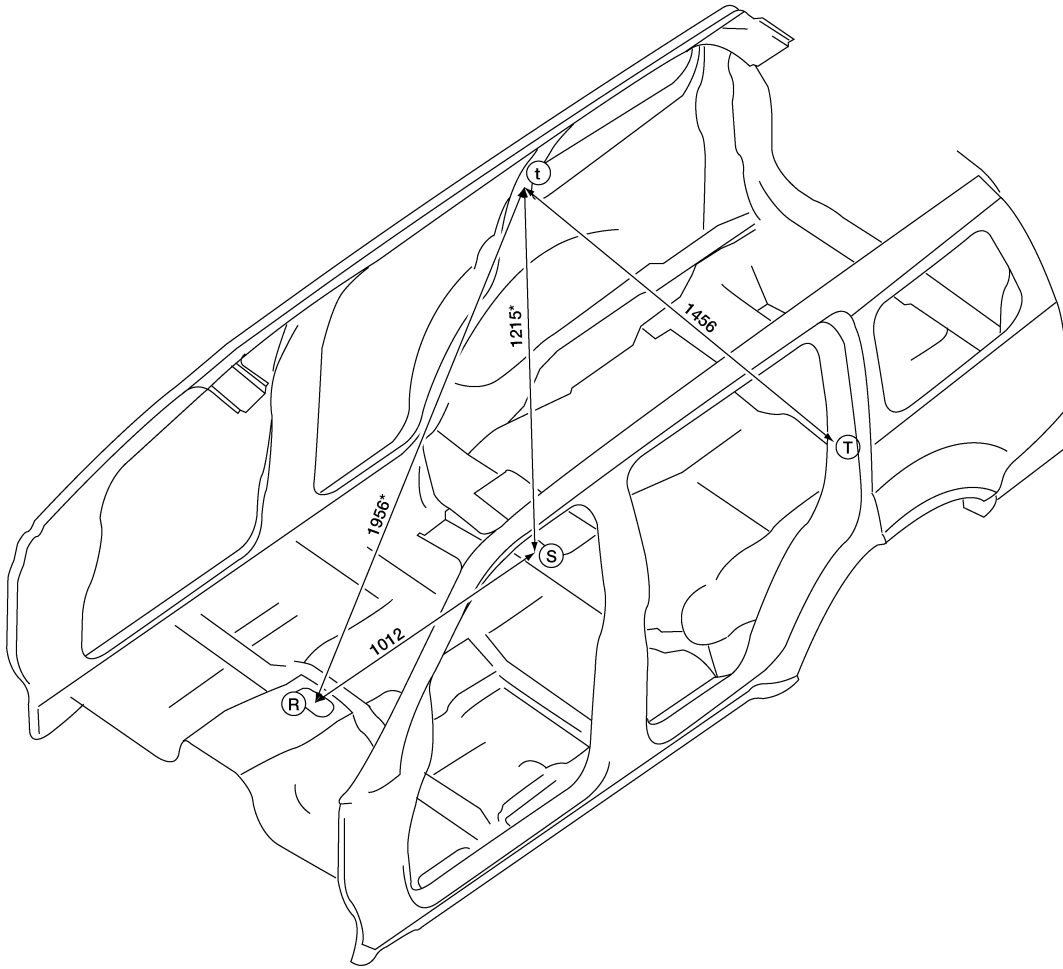
LI1A1799E

Figures marked with a (*) indicate symmetrically identical dimensions on both right and left hand sides of the vehicle.

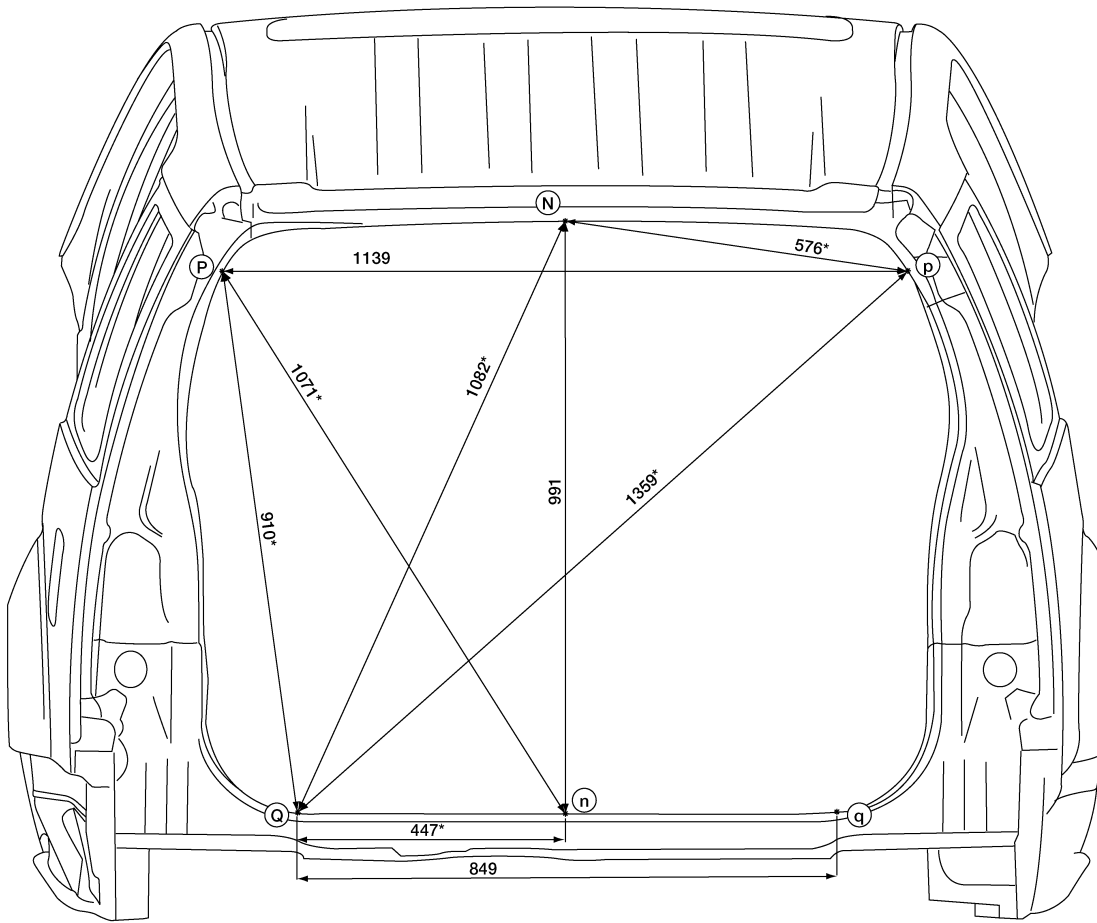
LIIA1803E

Figures marked with a (*) indicate symmetrically identical dimensions on both right and left sides of vehicle.

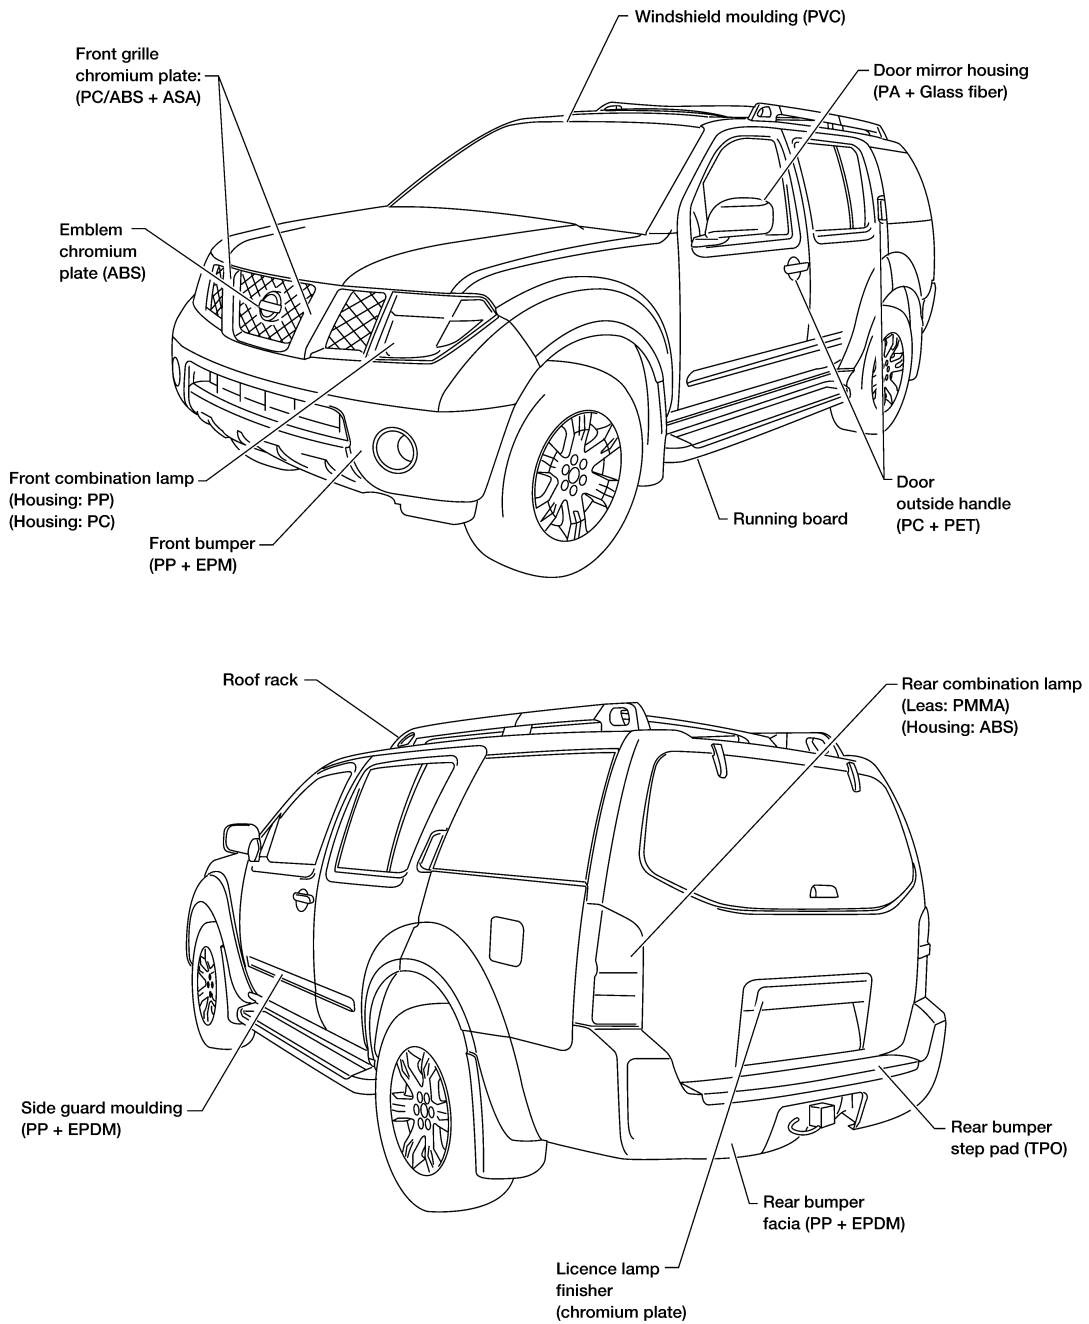
LI1A1805E

LOCATION OF PLASTIC PARTS

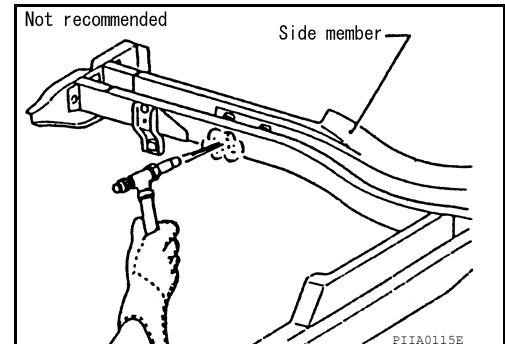
- The repair of reinforcements (such as side members) by heating is not recommended since it may weaken the component. When heating is unavoidable, do not heat HSS parts above 550°C (1,022°F). Verify heating temperature with a thermometer. (Crayon-type and other similar type thermometer are appropriate.)

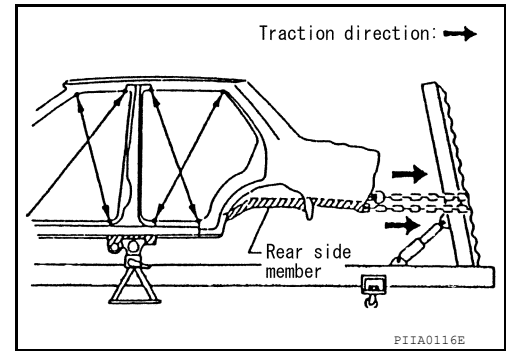
- When straightening body panels, use caution in pulling any HSS panel. Because HSS is very strong, pulling may cause deformation in adjacent portions of the body. In this case, increase the number of measuring points, and carefully pull the HSS panel.

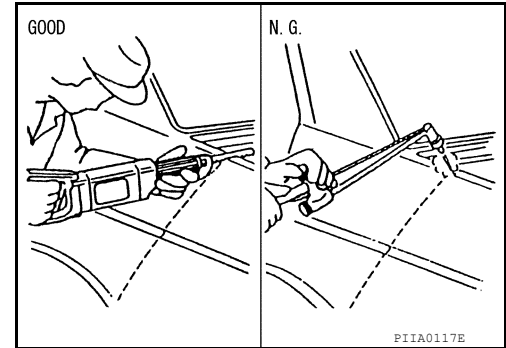
- When cutting HSS panels, avoid gas (torch) cutting if possible. Instead, use a saw to avoid weakening surrounding areas due to heat. If gas (torch) cutting is unavoidable, allow a minimum margin of 50 mm (1.97in).

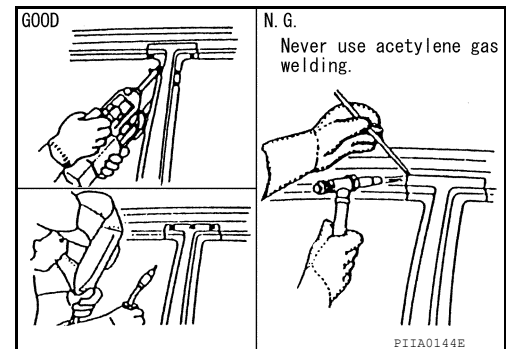
- When welding HSS panels, use spot welding whenever possible in order to minimize weakening surrounding areas due to heat. If spot welding is impossible, use M.I.G. welding. Do not use gas (torch) welding because it is inferior in welding strength.

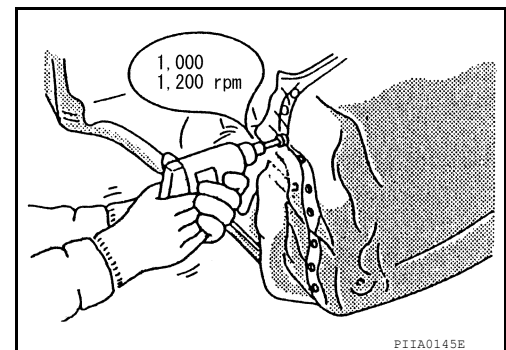
- The spot weld on HSS panels is harder than that of an ordinary steel panel. Therefore, when cutting spot welds on a HSS panel, use a low speed high torque drill (1,000 to 1,200 rpm) to increase drill bit durability and facilitate the operation.
- SP150 HSS panels with a tensile strength of 785 to 981 N/mm² (80 to 100 kg/mm², 114 to 142 klb/sq in), used as reinforcement in the door guard beams, is too strong to repair. When these HSS parts are damaged, the outer panels also sustain substantial damage; therefore, the assembly parts must be replaced.

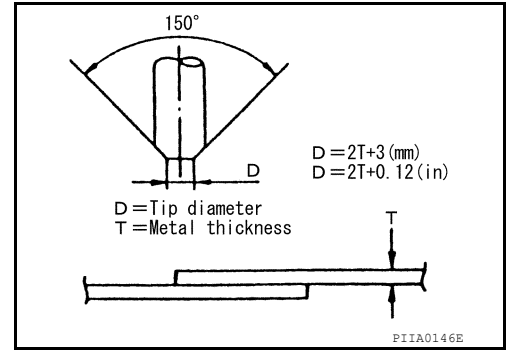
- The electrode tip diameter must be sized properly according to the metal thickness.

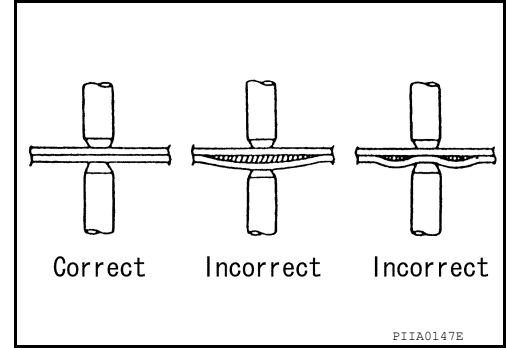
- The panel surfaces must fit flush to each other, leaving no gaps.

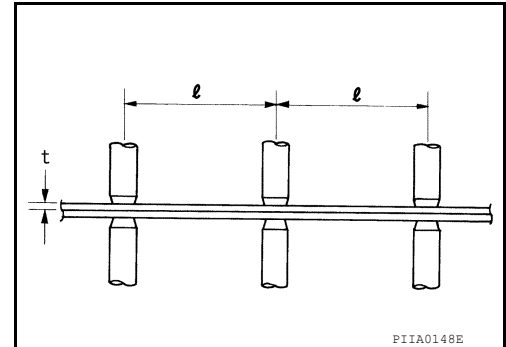
- Follow the specifications for the proper welding pitch.

Thickness (t)	Minimum pitch (ℓ)
0.6 (0.024)	10 (0.39) or over
0.8 (0.031)	12 (0.47) or over
1.0 (0.039)	18 (0.71) or over
1.2 (0.047)	20 (0.79) or over
1.6 (0.063)	27 (1.06) or over
1.8 (0.071)	31 (1.22) or over

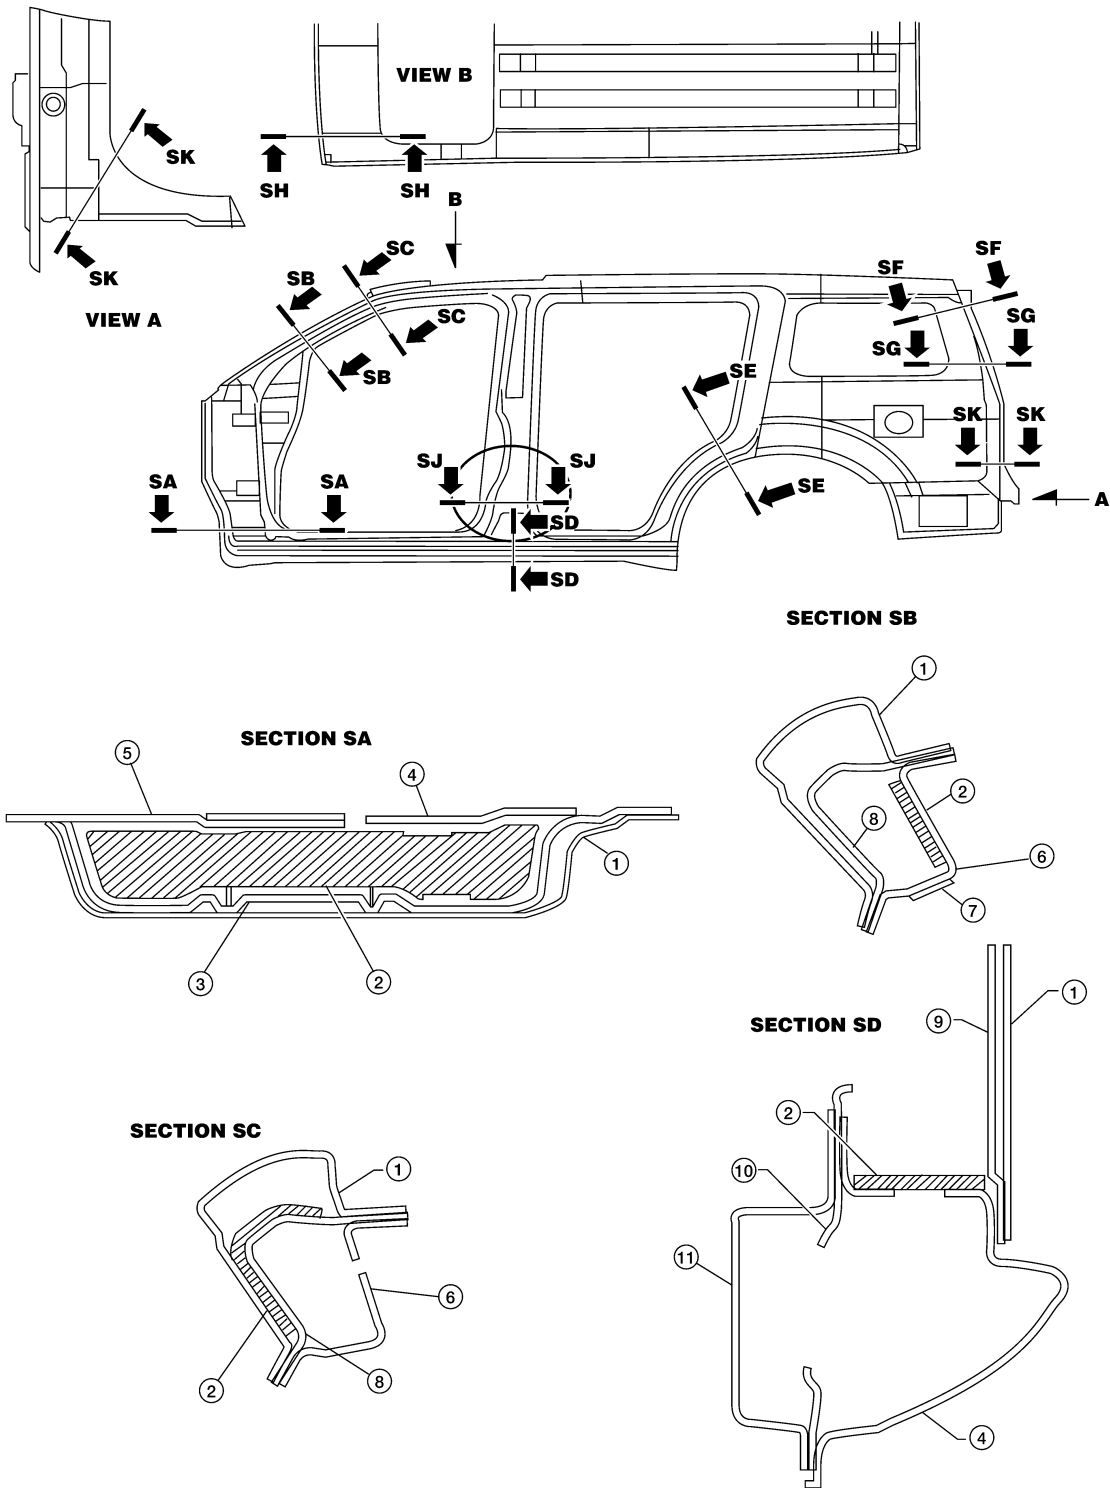
| 1. Body side outer | 2. Body side insulation (foam) | 3. A-pillar lower hinge brace |

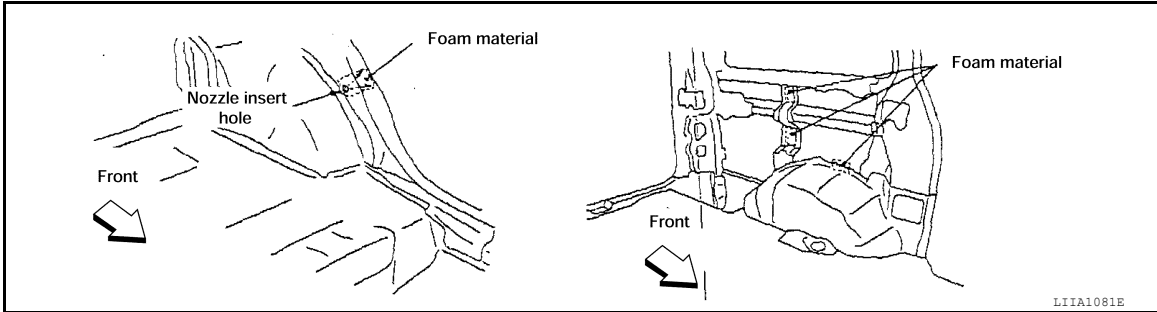
- Remove foam material remaining on vehicle side.
- Clean area in which foam was removed.
- Install service part.
- Insert nozzle into hole near fill area and fill foam material or fill in enough to close gap with the service part.

2. Fill procedures before installation of service part.
 - Remove foam material remaining on vehicle side.
 - Clean area in which foam was removed.
 - Fill foam material on wheelhouse outer side.

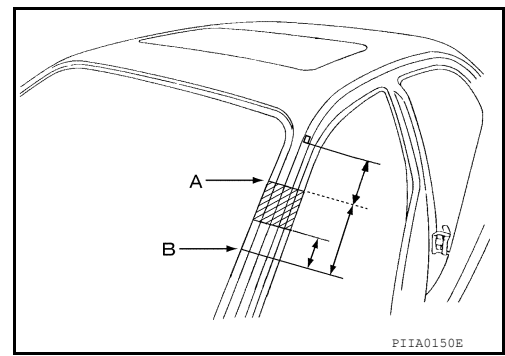
- Front pillar butt joint can be determined anywhere within shaded area as shown in the figure. The best location for the butt joint is at position A due to the construction of the vehicle. Refer to the front pillar section.
