SECTION **BRM**
BODY REPAIR

Revision: March 2012

2011 Pathfinder

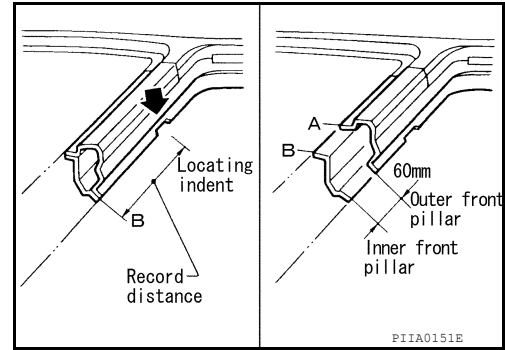
- Determine cutting position and record distance from the locating indent. Use this distance when cutting the service part. Cut outer front pillar over 60 mm above inner front pillar cut position.

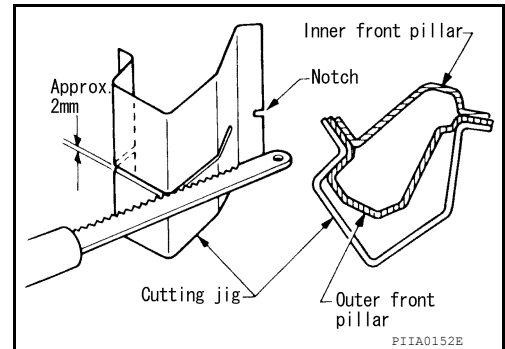
- Prepare a cutting jig to make outer pillar easier to cut. Also, this will permit service part to be accurately cut at joint position.

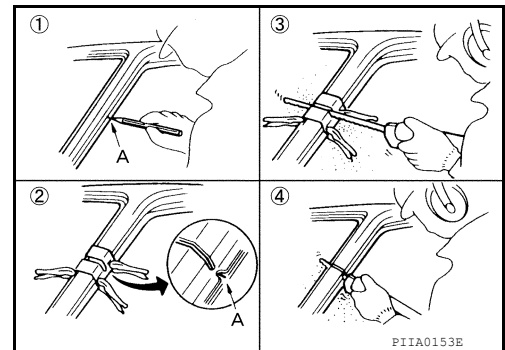
- An example of cutting operation using a cutting jig is as follows.

1. Mark cutting lines.
A: Cut position of outer pillar
B: Cut position of inner pillar
2. Align cutting line with notch on jig. Clamp jig to pillar.
3. Cut outer pillar along groove of jig. (At position A)
4. Remove jig and cut remaining portions.
5. Cut inner pillar at position B in same manner.

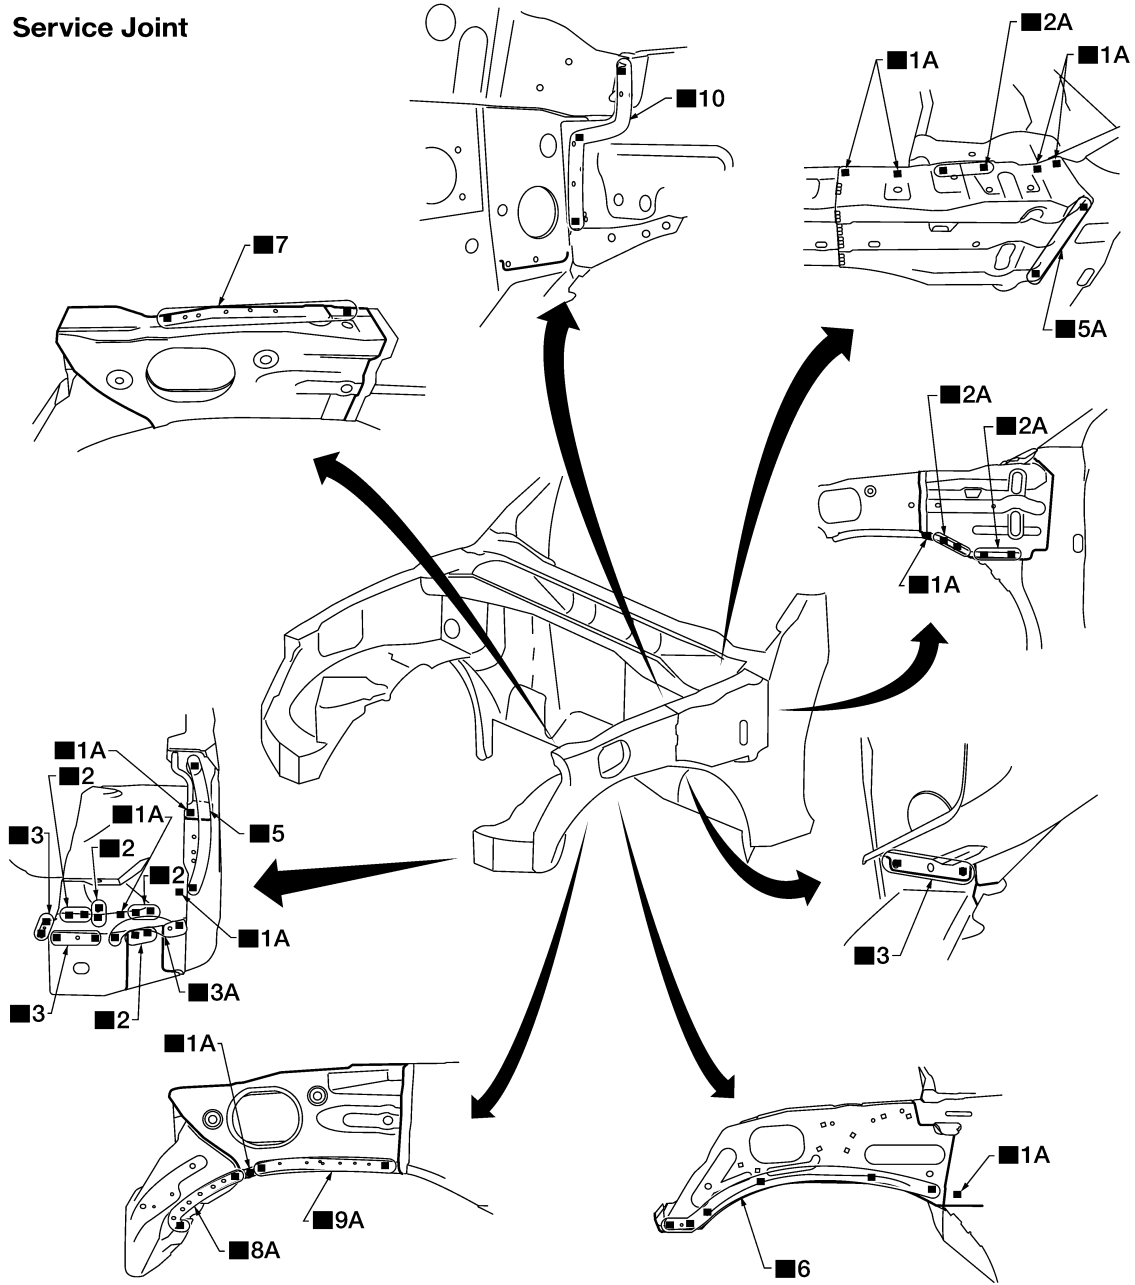
Service Joint

- Work after radiator core support has been removed.

2-spot welds

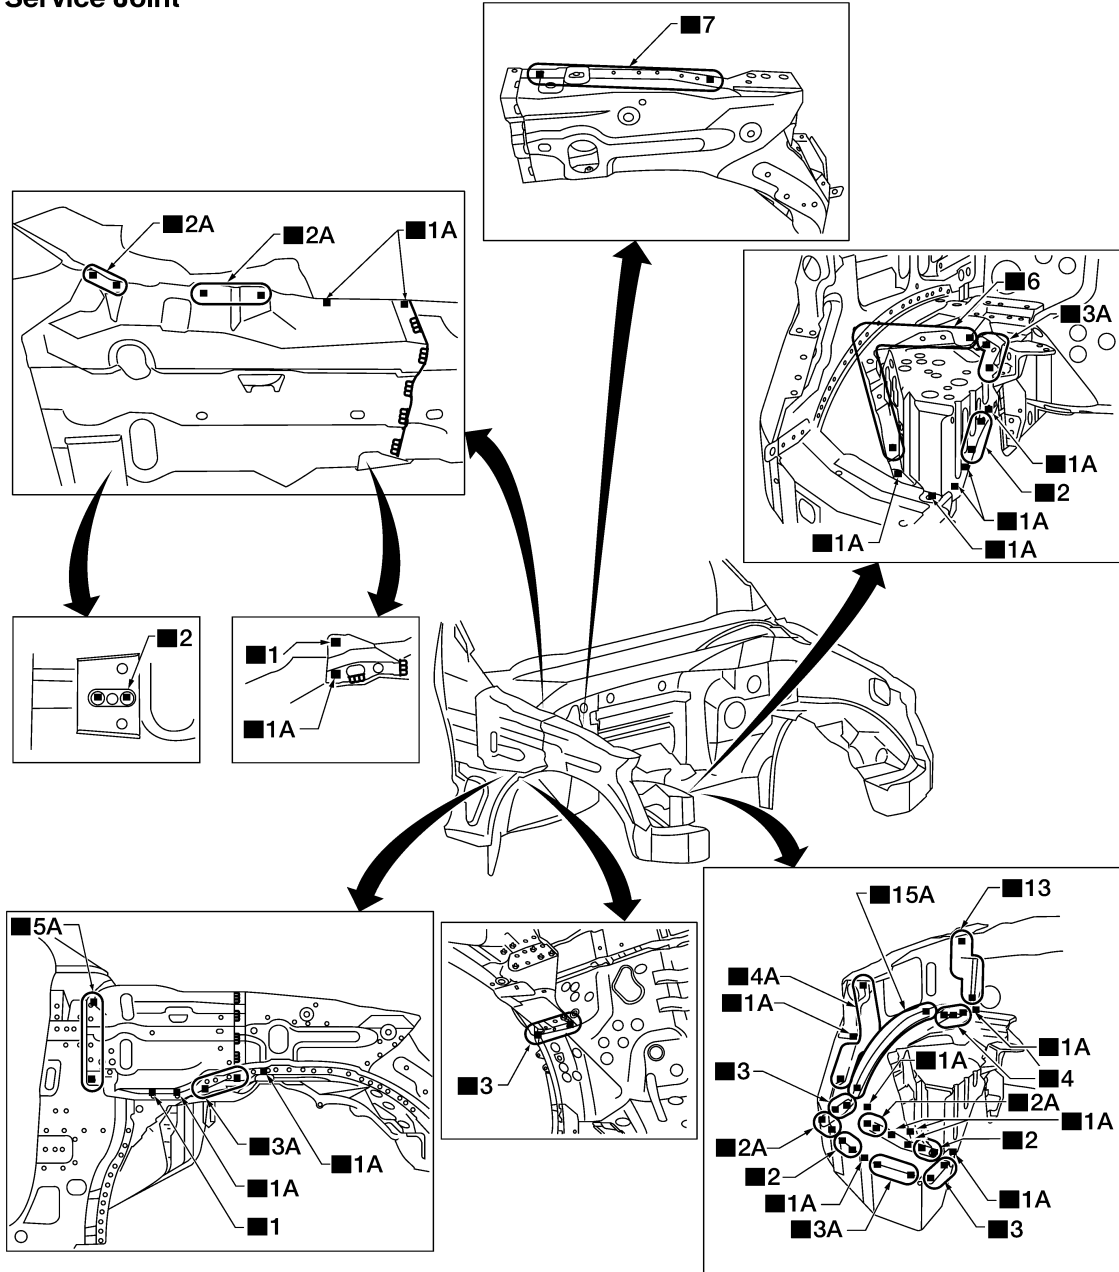
L11A1809E

- Work after radiator core support has been removed.

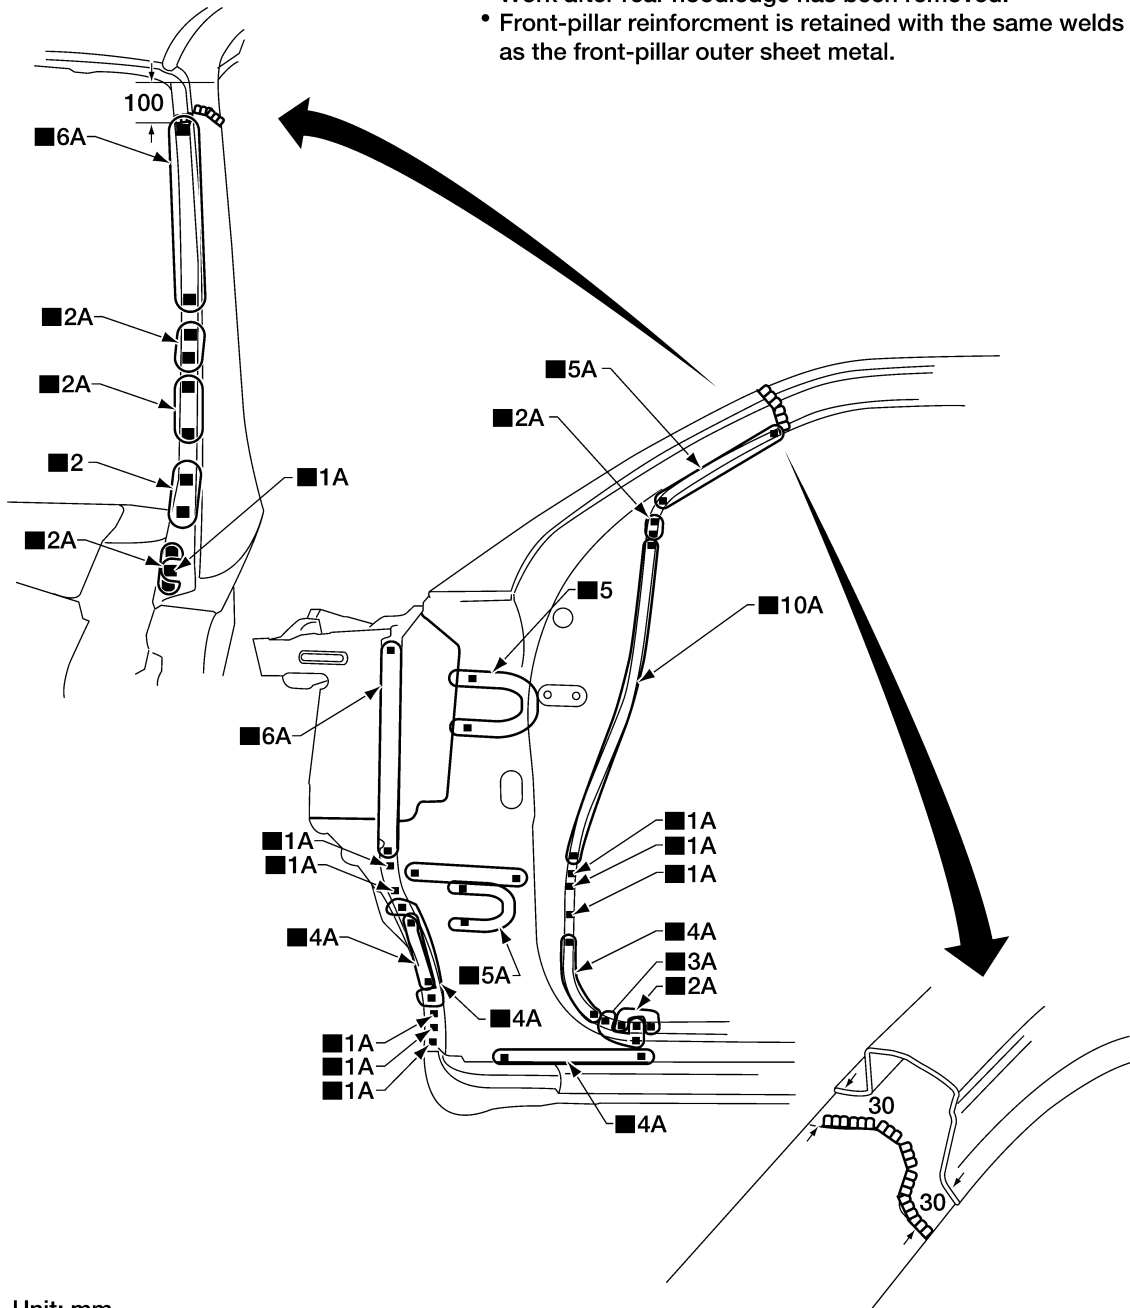
Service Joint

- Work after rear hoodledge reinforcement has been removed.

- Work after rear hoodledge has been removed.
- Front-pillar reinforcement is retained with the same welds as the front-pillar outer sheet metal.

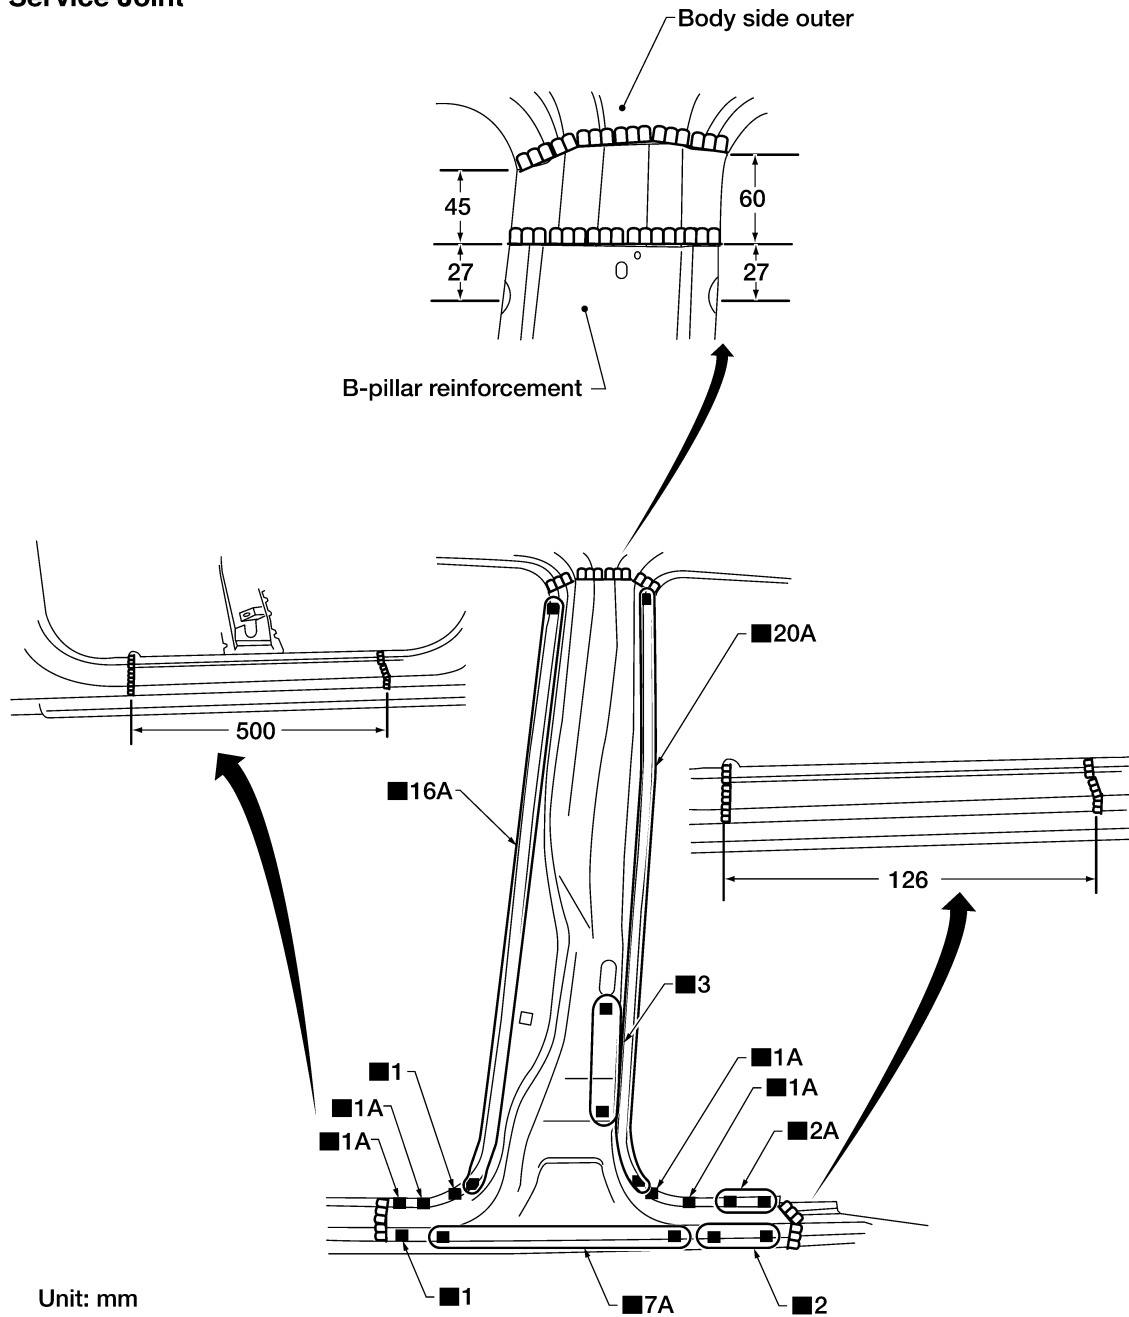
Service Joint

CENTER PILLAR

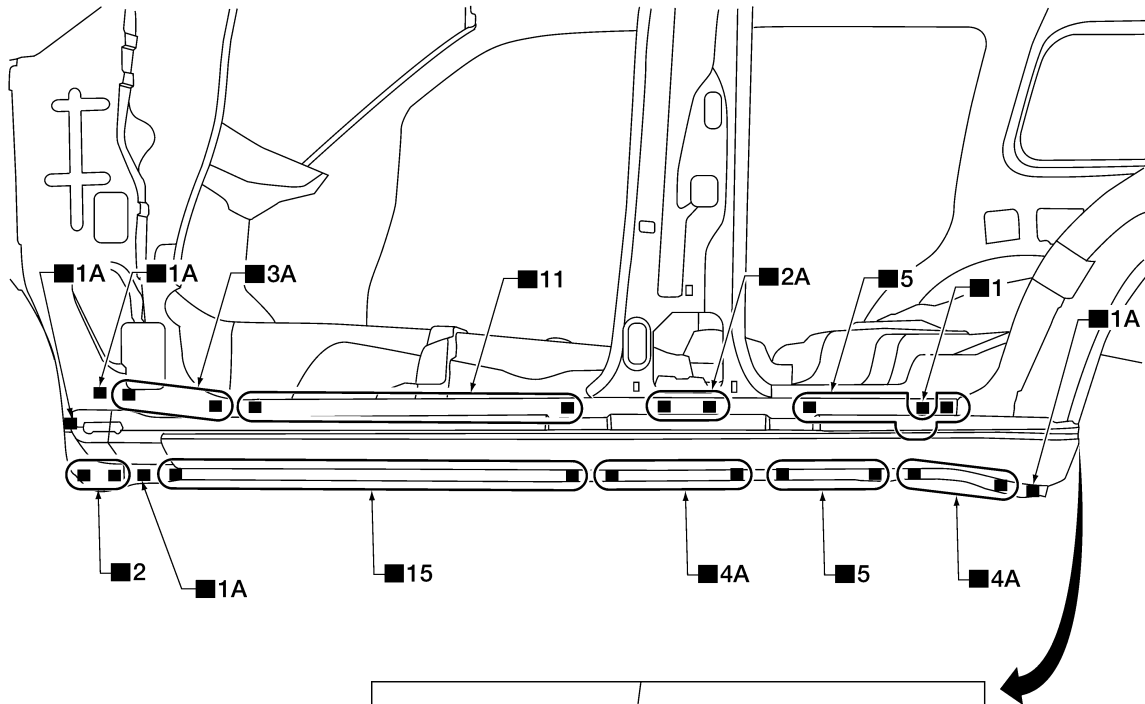
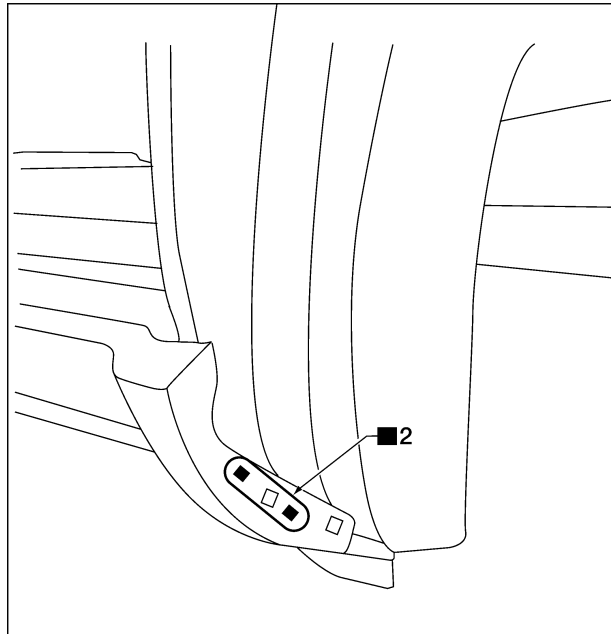
LIIA1813E

OUTER SILL

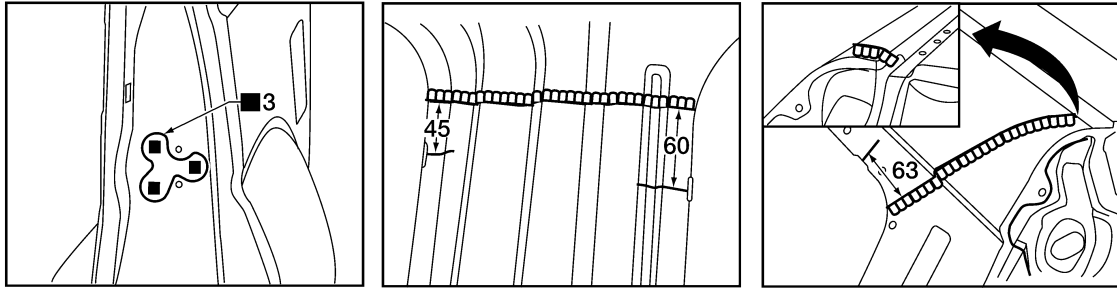
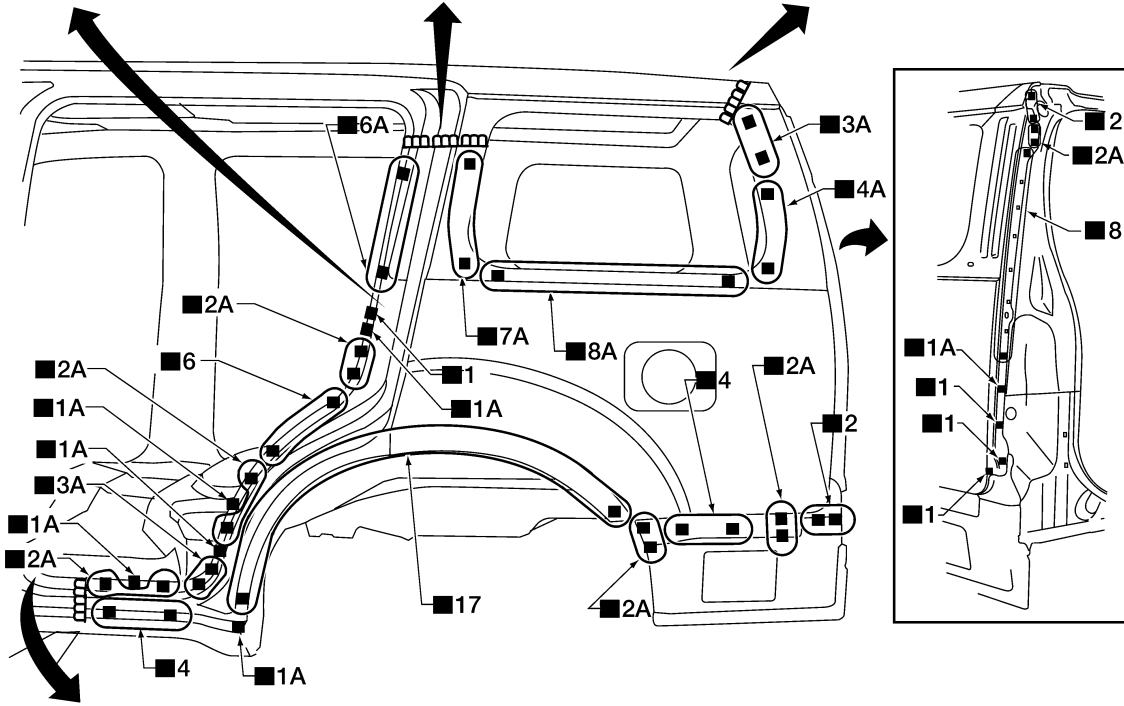
Service Joint

REAR FENDER

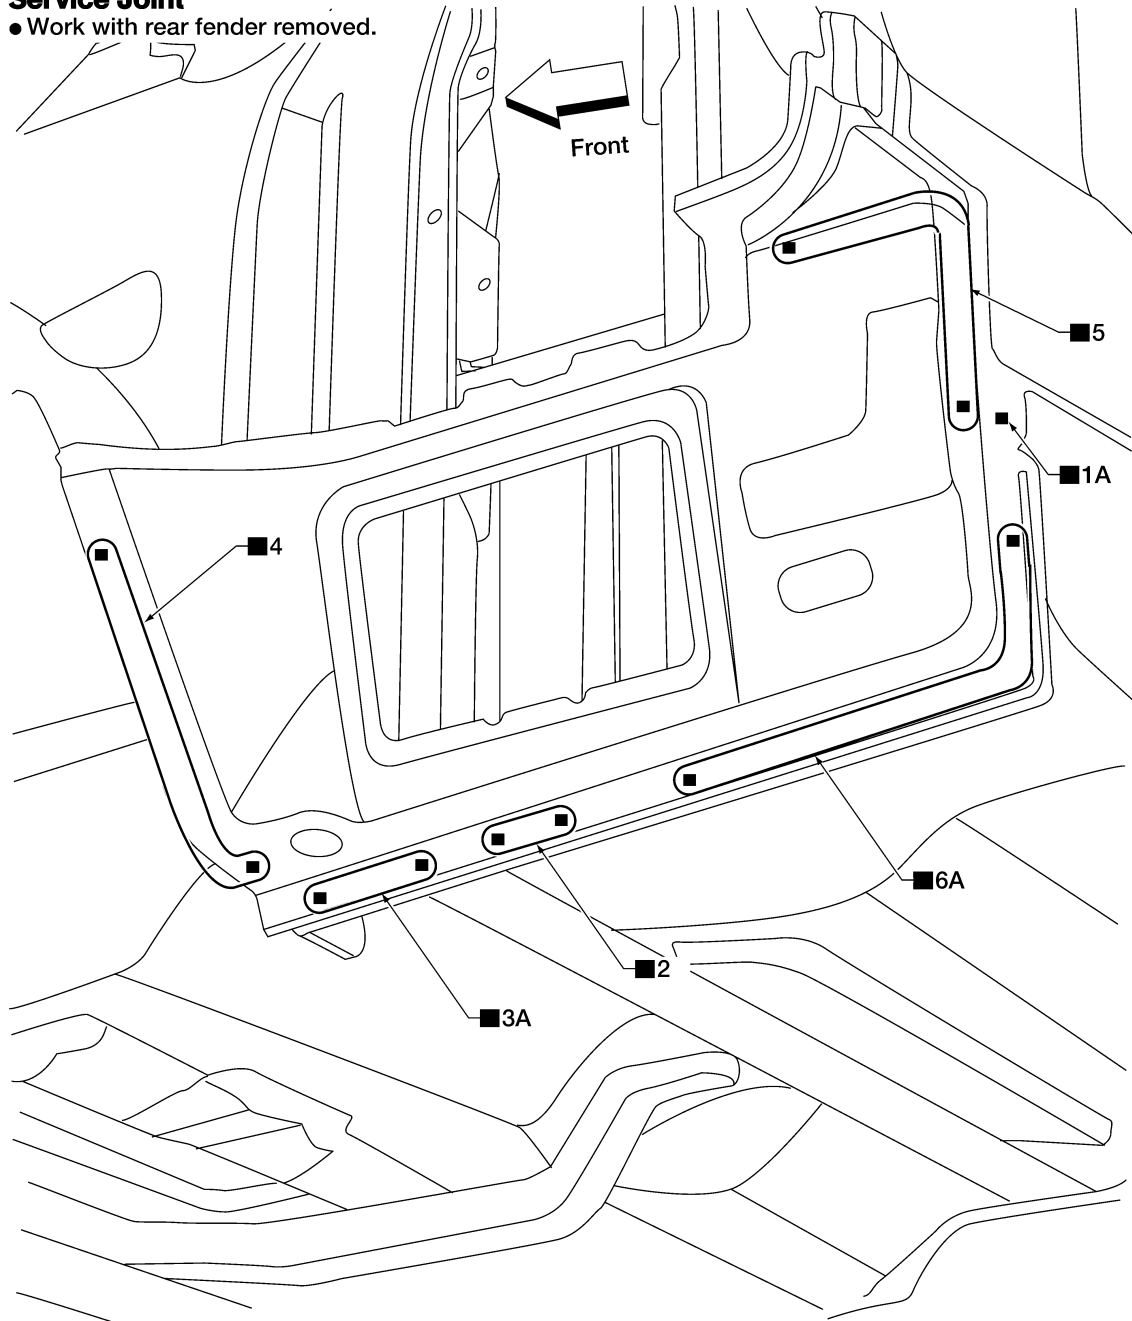
Service Joint

● Work with rear fender removed.

2-spot welds

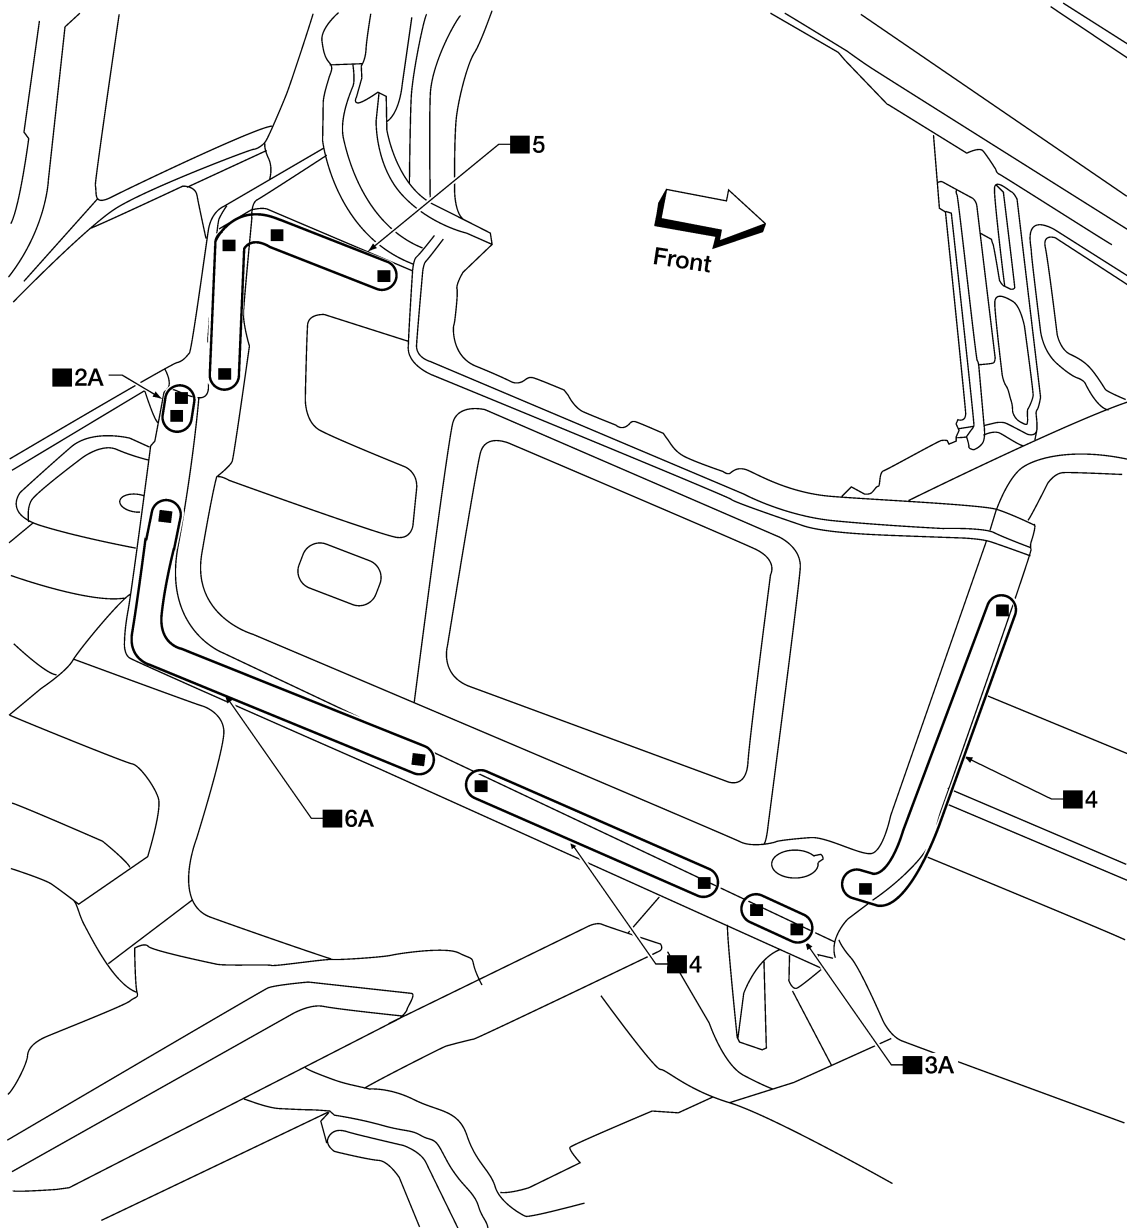
Service Joint

- Work with rear fender removed.

2-spot welds

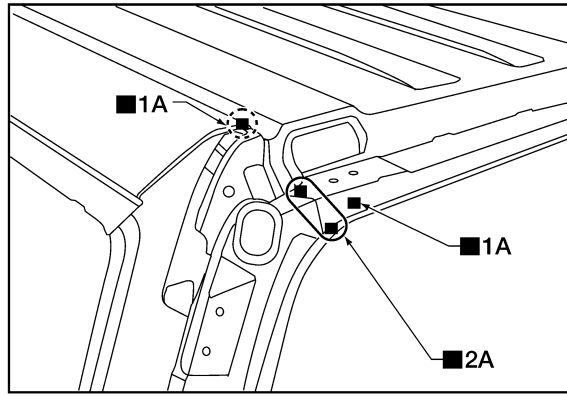
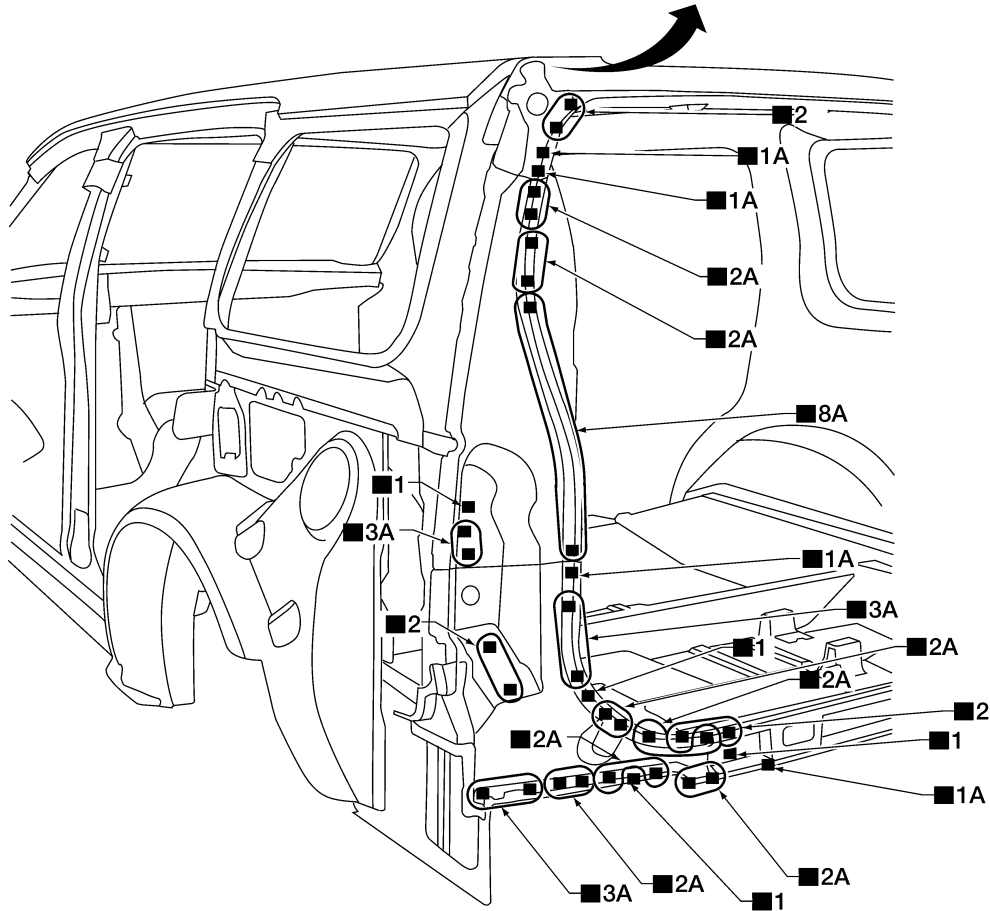
L11A1820E

- Work with rear fender and extension removed.

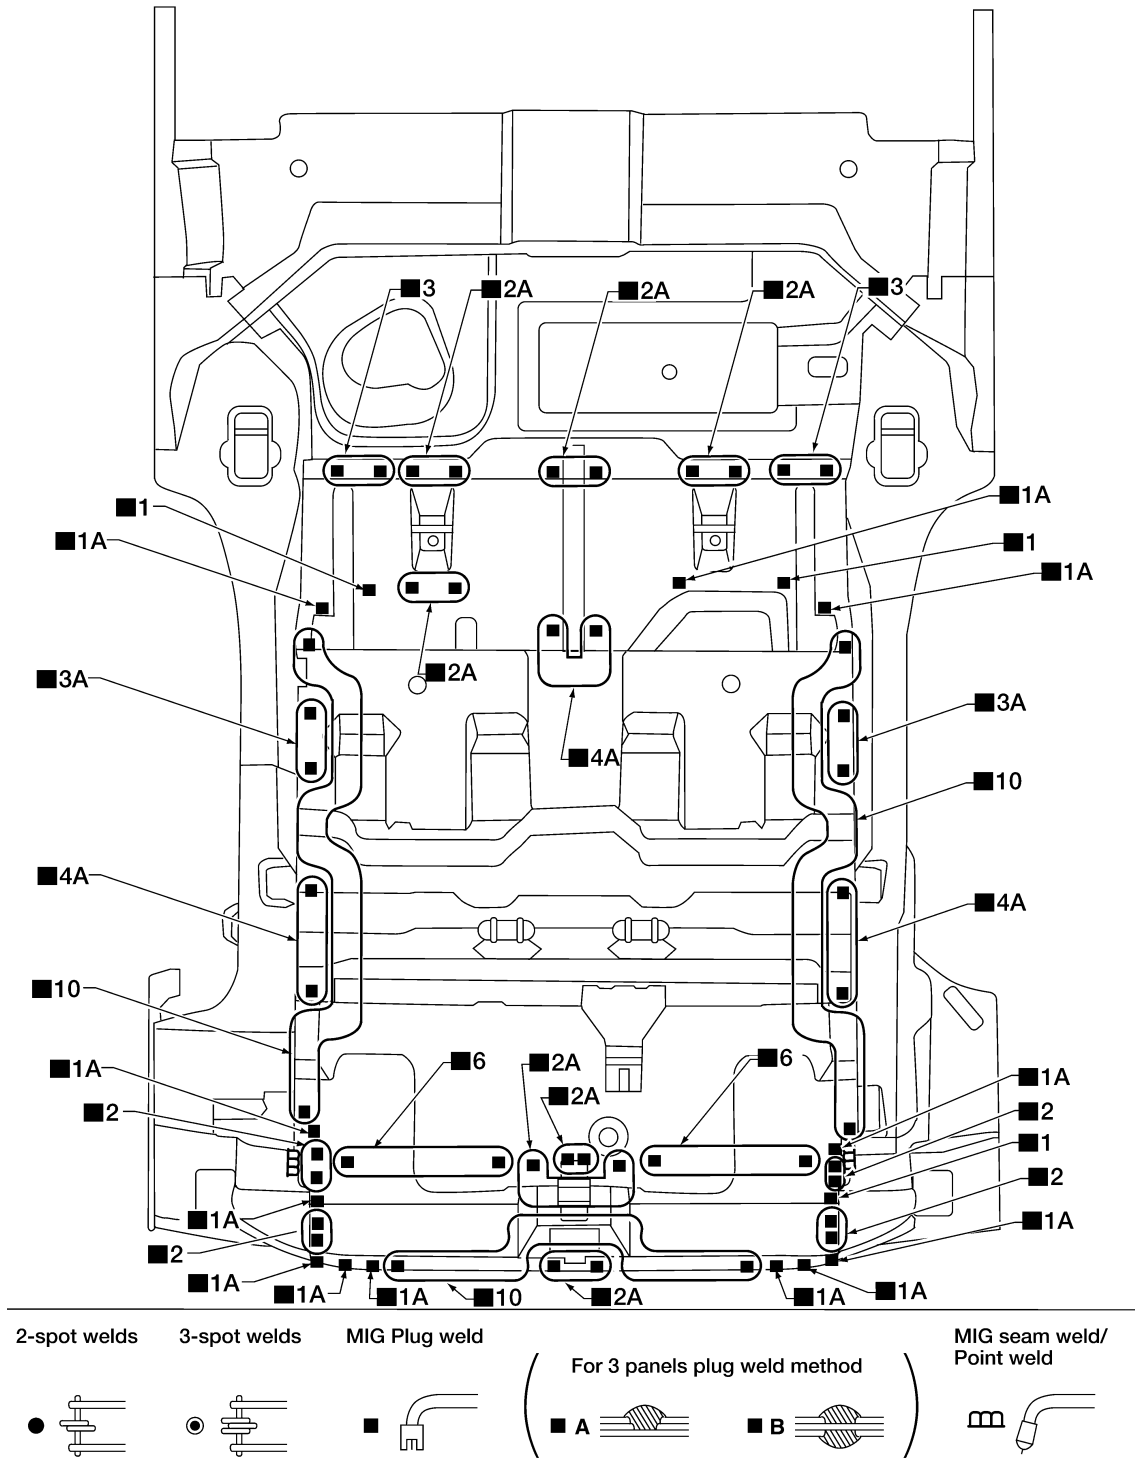
L1IA1815E

REAR FLOOR REAR

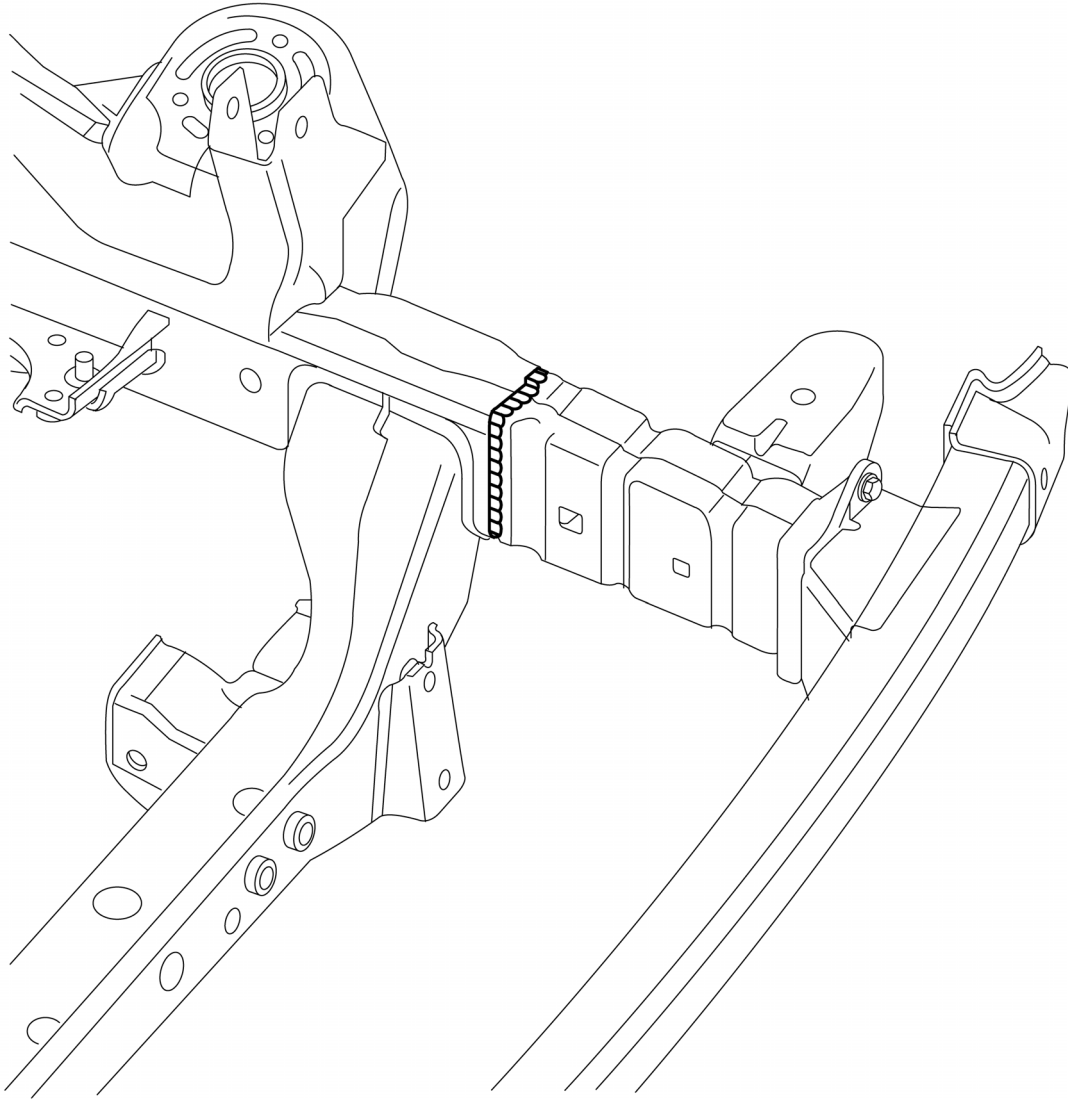
Service Joint

When replacing a damaged crush horn on N50 model, do not choose partial replacement method, such as cutting and butt-joint welding the crush horn.

Be sure to replace the entire crush horn when the crush horn has damage at the back of the body mounting bracket.

2-spot welds
