CONTENTS

IP-9 Revision: October 2012 2013 Pathfinder NAM

INSTRUMENT PANEL ASSEMBLY

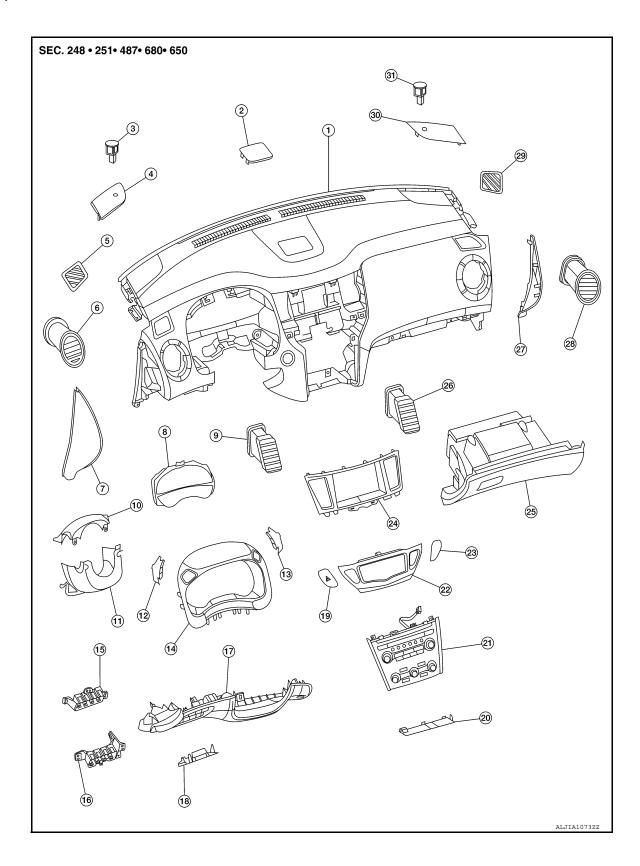
Exploded View

1.	Instrument panel assembly	2.	Center speaker grille	3.	Sunload sensor	
4.	Instrument panel tweeter grille (LH)	5.	Side defroster grille (LH)	6.	Side ventilator grille (LH)	
7.	Instrument side finisher (LH)	8.	Combination meter	9.	Center ventilator grille (LH)	
10.	Steering column upper cover	11.	Steering column lower cover	12.	Illumination control switch	[
13.	Trip computer switch	14.	Cluster lid A	15.	Upper switch carrier	
16.	Lower switch carrier	17.	Instrument lower panel LH	18.	Fuse block cover	
19.	Hazard switch	20.	Cluster lid C lower	21.	A/C and AV switch assembly	(
22.	Cluster lid C	23.	Passenger airbag illumination lamp	24.	Cluster lid D	
25.	Glove box assembly	26.	Center ventilator grille (RH)	27.	Instrument side finisher (RH)	
28.	Side ventilator grille (RH)	29.	Side defroster grille (RH)	30.	Instrument panel tweeter grille (RH)	[
31.	Optical sensor

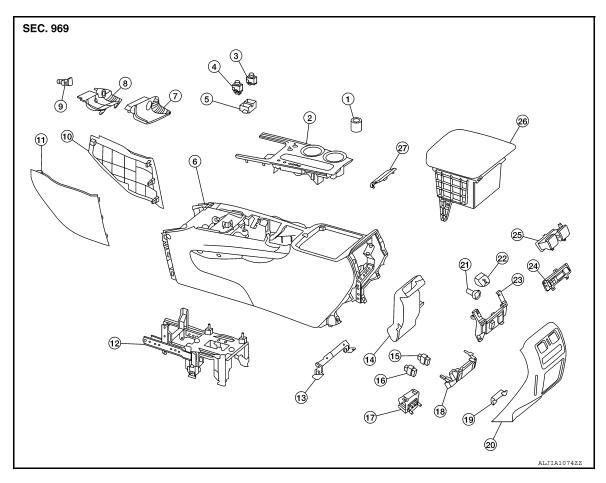
Exploded View INFOID:0000000008508966

- 1. Drive mode selector switch
- Front seat climate control switch (LH) 5.
- Front console mat 7.
- 10. Center console side finisher (RH)
- 13. Center console lower brace
- 16. 2nd row heated seat switch (LH)
- 19. Intelligent Key antenna
- 22. AC 120V outlet

- 2. CVT shift selector finisher
- Center console switch bracket
- Front console tray
- 11. Center console side finisher (LH) 12. Center console brace
- 14. Rear center ventilator duct
- 17. Rear auxiliary input jack
- 20. Center console rear finisher
- 23. Center console rear finisher upper 24. Rear blower control bracket
- 25. Rear center ventilator grille assembly 26. Center console bin

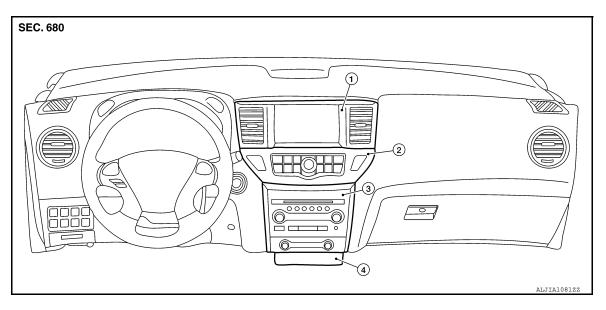
Exploded View

1. Cluster lid D

- 2. Cluster lid C
- 3. AV and A/C switch assembly

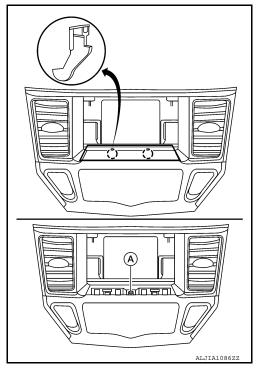
- 3. Release the cluster lid C finisher pawls using a suitable tool and remove.
 - (_): Pawl
- 4. Remove cluster lid C screw (A).

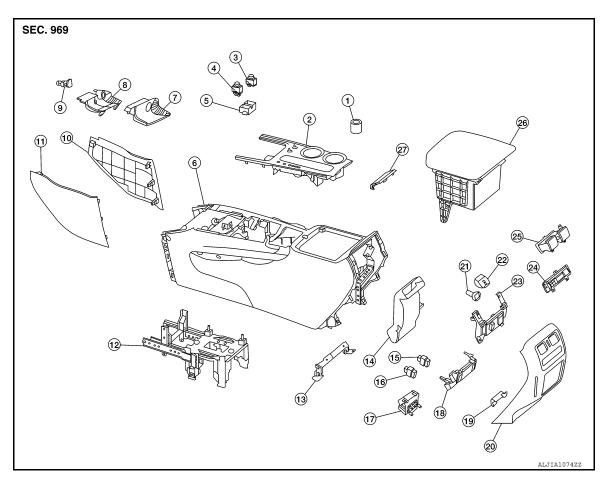
Exploded View INFOID:0000000008508975

- Drive mode selector switch
- Front seat climate control switch (LH) 5.
- 7. Front console mat
- 10. Center console side finisher (RH)
- Center console lower brace
- 16. 2nd row heated seat switch (LH)
- 19. Intelligent Key antenna
- 22. AC 120V outlet

- 2. CVT shift selector finisher
- Center console switch bracket
- Front console tray
- 11. Center console side finisher (LH)
- 14. Rear center ventilator duct
- 17. Rear auxiliary input jack
- 20. Center console rear finisher
- 23. Center console rear finisher upper 24. bracket
- 25. Rear center ventilator grille assembly 26. Center console bin

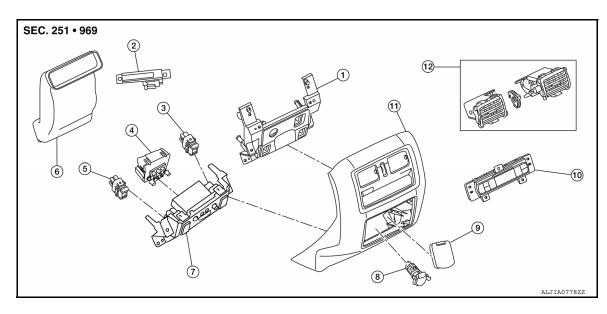
Disassembly and Assembly

- Center console rear finisher upper bracket
- Rear auxiliary input jack
- Center console rear finisher lower bracket 7.
- 10. Rear blower control

- 2. Intelligent Key antenna
- 5. 2nd row heated seat switch (LH) 6.
- 8. Power socket
- 11. Center console rear finisher
- 3. 2nd row heated seat switch (RH)
- Rear center ventilator duct
- AC 120V outlet (if equipped)
- 12. Rear center ventilator grille assembly
