Revision: July 2009 IP-2 2010 Pathfinder

INSTRUMENT PANEL ASSEMBLY

Exploded View

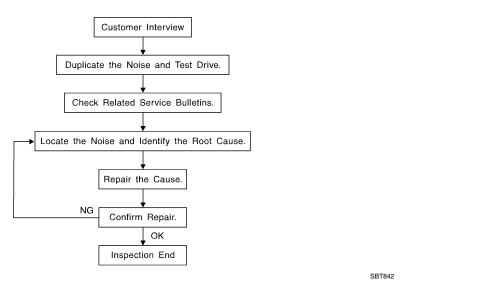
Work Flow INFOID:0000000005259197

CUSTOMER INTERVIEW

Interview the customer if possible, to determine the conditions that exist when the noise occurs. Use the Diagnostic Worksheet during the interview to document the facts and conditions when the noise occurs and any customer's comments; refer to IP-9, "Diagnostic Worksheet". This information is necessary to duplicate the conditions that exist when the noise occurs.

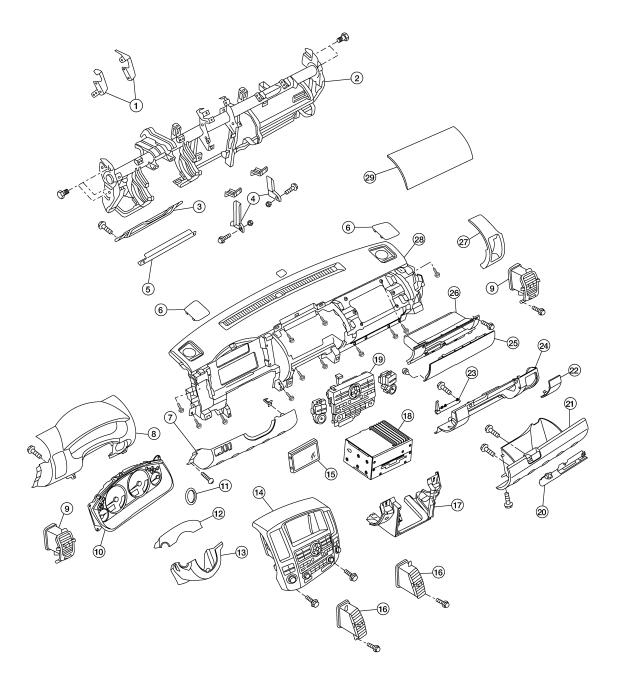
AWJIA0462ZZ

- 1. Display unit bracket RH/LH
- 4. Instrument stay RH/LH
- 7. Lower instrument panel LH
- 10. Combination meter
- 13. Column cover lower
- 2. Steering member assembly
- 5. Knee protector brace
- 8. Cluster lid A
- 11. Steering lock escutcheon
- 14. Cluster lid C

- 3. Knee protector
- 6. Speaker grille RH/LH
- 9. Side ventilator grille RH/LH
- 12. Column cover upper
- 15. Display unit

16.	Center ventilator grill RH/LH	17.	Cluster lid D	18.	AV control unit
19.	A/C and AV switch assembly	20.	Lower glove box latch assembly	21.	Lower glove box
22.	Fuse block cover	23.	Lower glove box damper assembly	24.	Lower instrument panel RH
25.	Upper glove box door	26.	Upper glove box	27.	Instrument side finisher
28.	Instrument panel and pad assembly	29.	Passenger air bag module

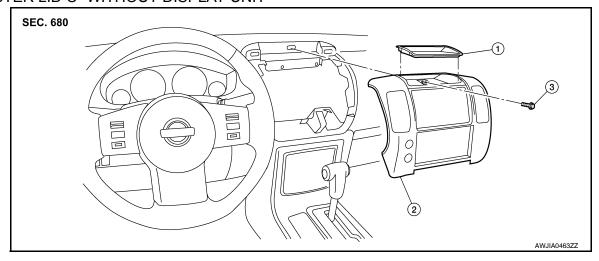
CLUSTER LID C -WITHOUT DISPLAY UNIT

1. Storage tray

2. Cluster lid C

Cluster lid C screw

- 1. Remove A/T finisher. Follow the A/T FINISHER removal procedure.
- 2. Remove storage tray, then remove cluster lid C screw.
- 3. Pull cluster lid C rearward to release clips.
- 4. Disconnect harness connectors, then remove cluster lid C.

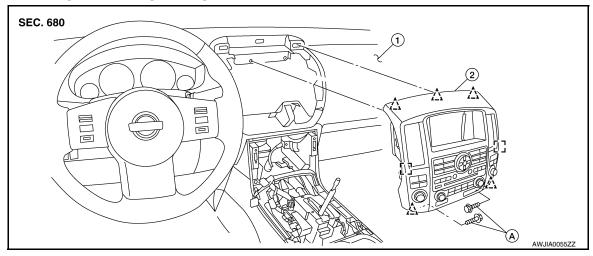
CLUSTER LID C - WITH DISPLAY UNIT

1. Instrument panel

Clip C103

2. Cluster lid C

Metal clip

A. Cluster lid C bolt

- 1. Select neutral, then remove shift lever handle.
- 2. Remove A/T finisher.
- 3. Remove the center console bin screws and center console bin.
- 4. Remove cluster lid C bolts, then release the clips and remove cluster lid C.
- 5. Disconnect electrical connectors and remove cluster lid C.

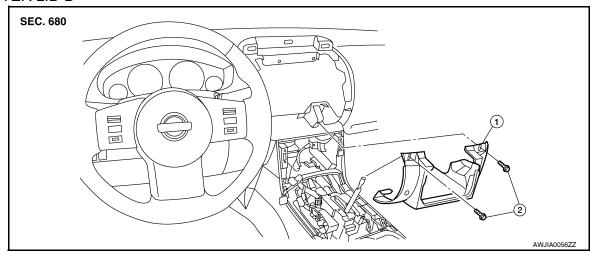
CLUSTER LID D

1. Cluster lid D

A. Cluster lid D screw

- 1. Remove A/T finisher.
- 2. Remove lower instrument panel LH.
- 3. Remove lower instrument panel RH.
- 4. Remove cluster lid C.
- 5. Disconnect the electrical connectors and remove cluster lid D.

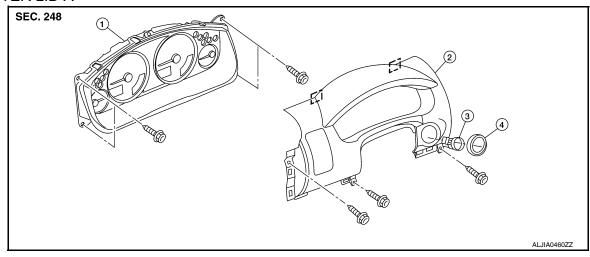
CLUSTER LID A

- Combination meter 1
- Cluster lid A

3. Ignition key lamp assembly

- Steering lock escutcheon
- Metal clip

- 1. Remove front pillar upper finisher. Refer to XX-XX, "*****".
- Remove lower instrument panel LH. Refer to LOWER INSTRUMENT PANEL LH in this section.
- Remove steering lock escutcheon.
- Remove the screws and clips, then lift cluster lid A rearward in vehicle away from the instrument panel.

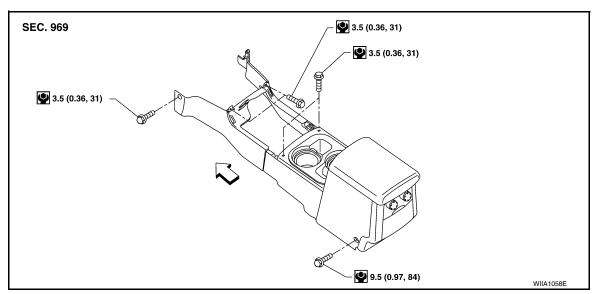
⟨□: Vehicle front

Disconnect harness connectors, then remove center console front base.

- Remove lower instrument panel RH and glove box. Refer to LOWER INSTRUMENT PANEL RH AND GLOVE BOX in this section.
- 2. Remove cup holder finisher.
- 3. Remove A/T finisher. Refer to AT FINISHER in this section.
- 4. Remove center console screws, then lift center console rear base away from center console front base and disconnect harness connectors.

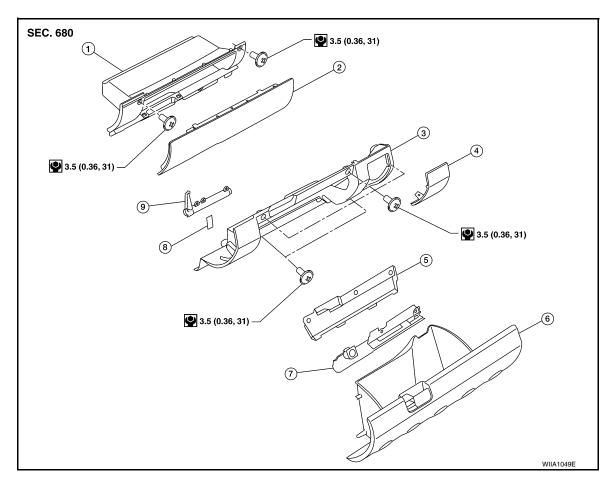
Exploded View INFOID:0000000005259202

- Upper glove box
- Fuse block cover
- Lower glove box latch assembly
- 2. Upper glove box door
- Lower glove box latch assembly cover 6.
- Damper hook

- Lower instrument panel RH
- Lower glove box

- 1. Remove fuse block cover.
- Remove damper hook.
- Remove lower glove box latch cover.
- Remove lower glove box latch assembly.

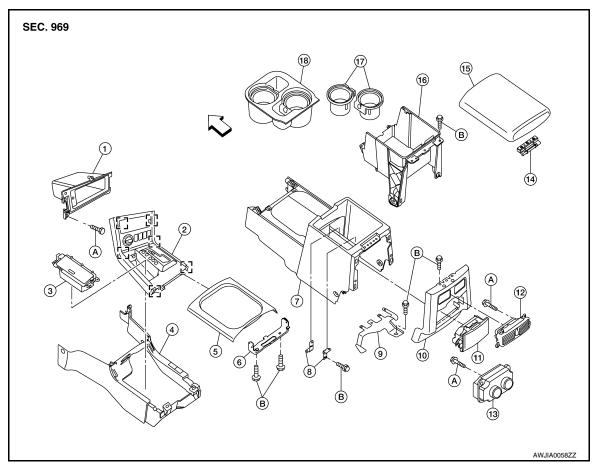
Center Console

- Console bin 1.
- Center console front base 4.
- 7. Center console rear base
- 10. Rear finisher assembly
- 13. Rear air control (rear) (if equipped) 14.
- Center console bin 16.
- Screw Α.

- 2. A/T finisher
- 5. Cup holder finisher
- **Bracket DVD**
- 11. Rear cup holder assembly
- Hinge
- 17. Cup holder insert
- B. Bolt
