SECTION IP
INSTRUMENT PANEL

SQUEAK AND RATTLE TROUBLE DIAGNOSES

INSTRUMENT PANEL ASSEMBLY

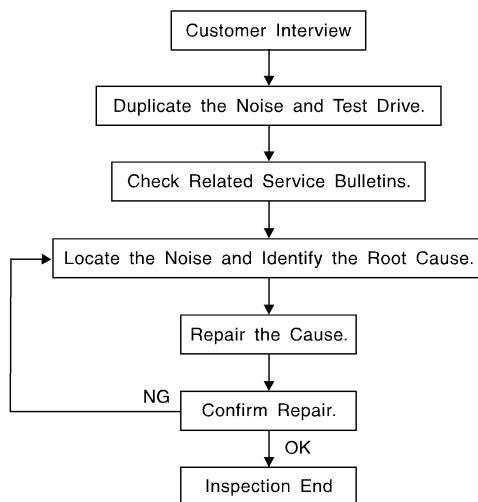
SBT842

Work Flow

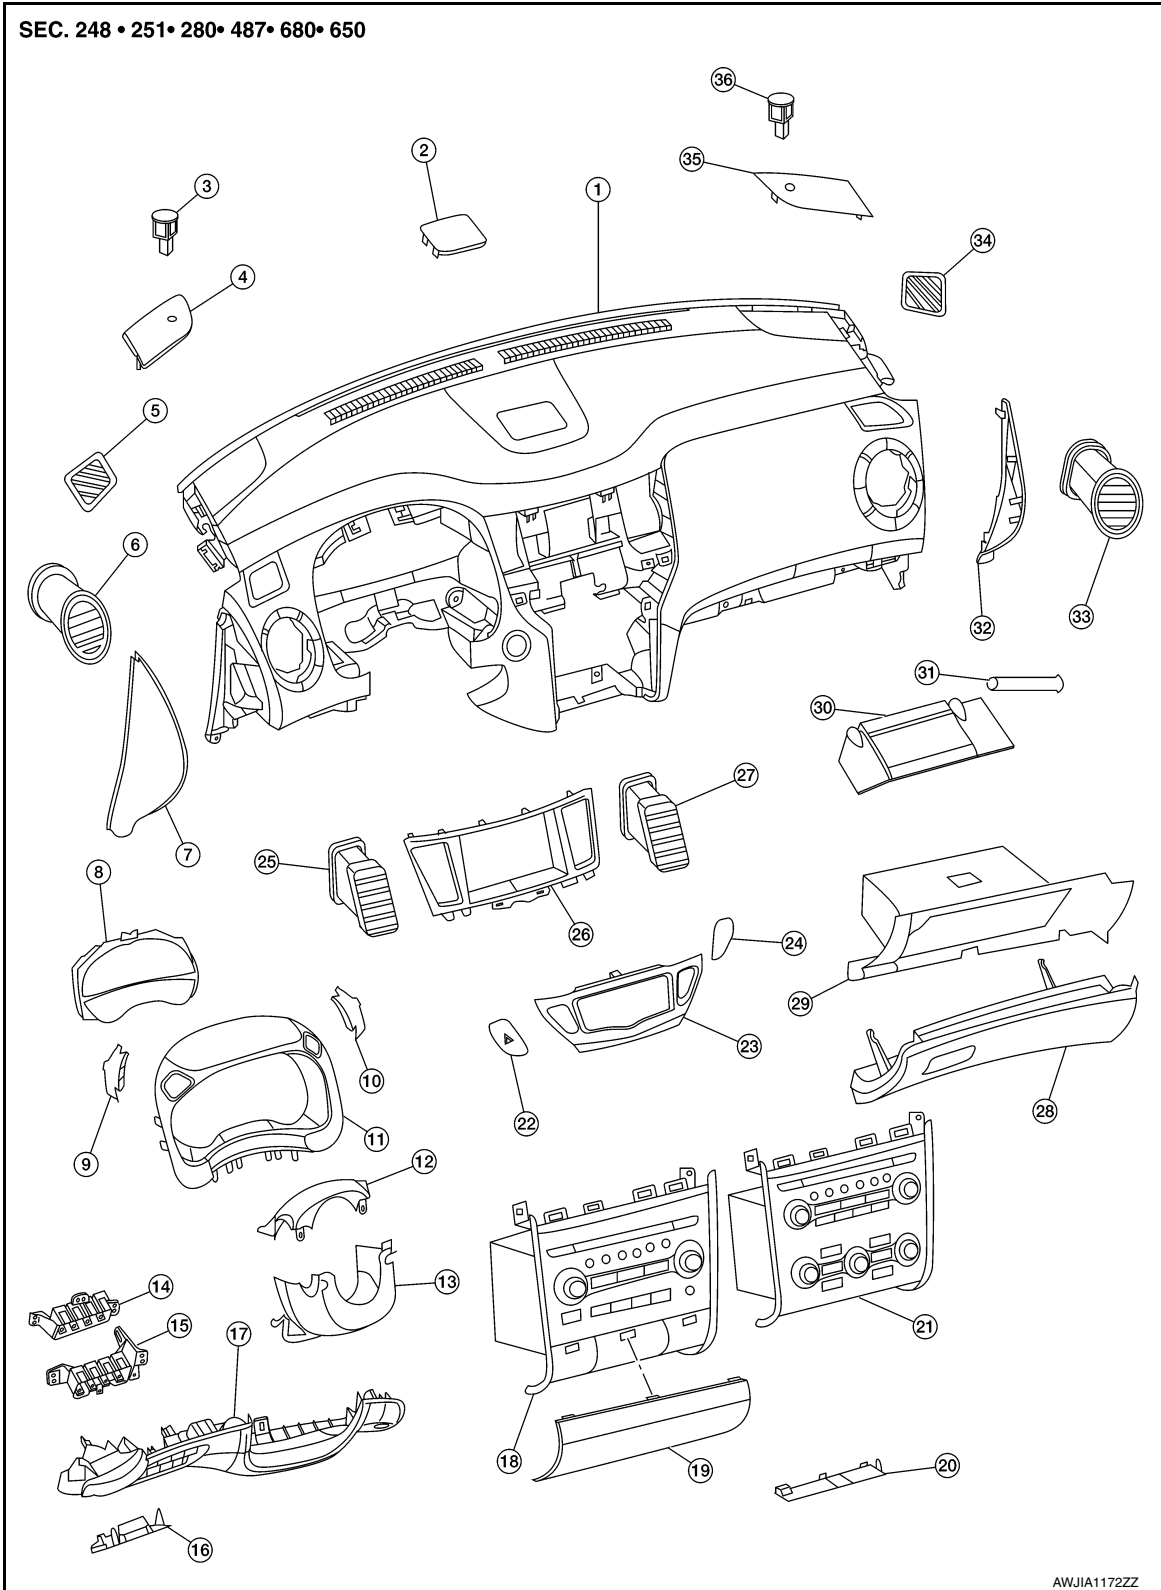
Exploded View

| 4. Instrument panel tweeter grille (LH) | 5. Side defroster grille (LH) | 6. Side ventilator grille (LH) |
| 22. Hazard switch | 23. Cluster lid C | 24. Front passenger air bag off indicator |
| 34. Side defroster grille (RH) | 35. Instrument panel tweeter grille (RH) | 36. Optical sensor |

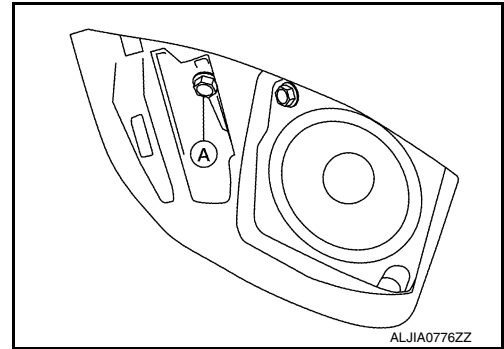
13. Remove instrument panel bolt (A) from the instrument panel tweeter grille (RH) area.

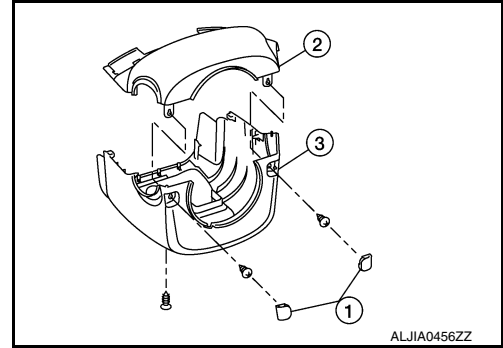
1. Remove instrument lower panel LH. Refer to [IP-25, "Removal and Installation"](#).
2. Remove steering column cover screw finishers (1) using a suitable tool, then remove screws.
- NOTE:**
Rotate steering wheel to access steering column cover screw finishers (1) and screws (if necessary).
3. Remove steering column upper cover (2).
4. Remove steering column lower cover screw, then remove steering column lower cover (3).

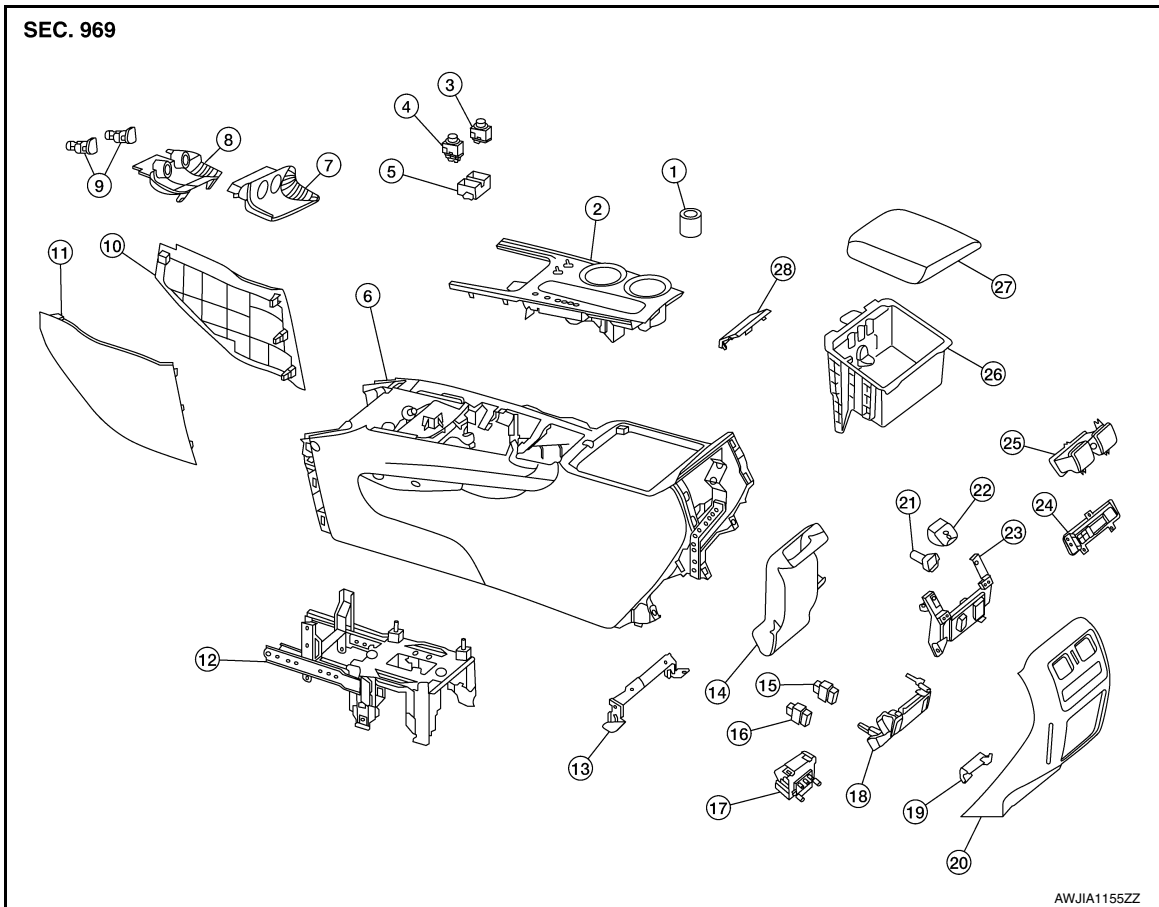
Exploded View

| 1. Drive mode selector switch | 2. Shift selector finisher | 3. Front seat climate control switch (RH) (if equipped) |

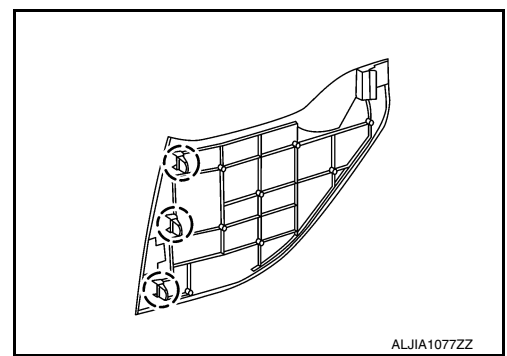
1. Release center console side finisher (LH/RH) pawls using a suitable tool and remove.

○: Pawl

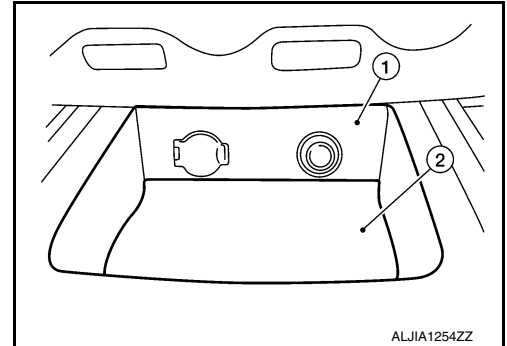
2. Remove front console mat (2) from front console tray (1).

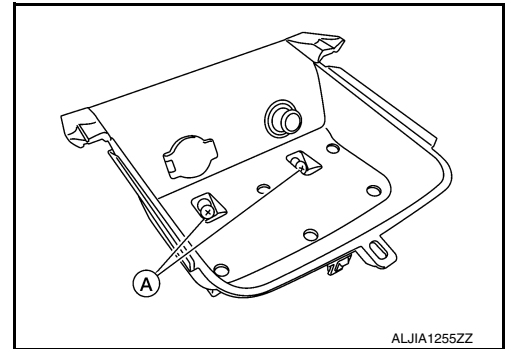
3. Remove front console tray screws (A).

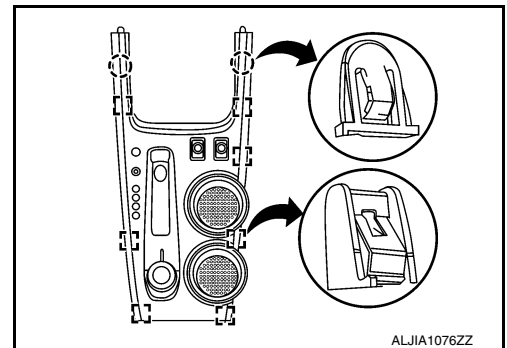
4. Release front console tray clips using a suitable tool, disconnect the harness connectors and remove.
5. Remove shift selector handle. Refer to [TM-192. "Exploded View"](#).
6. Release shift selector finisher clips and pawls using a suitable tool, disconnect the harness connectors and remove.

□: Metal clip

○: Pawl

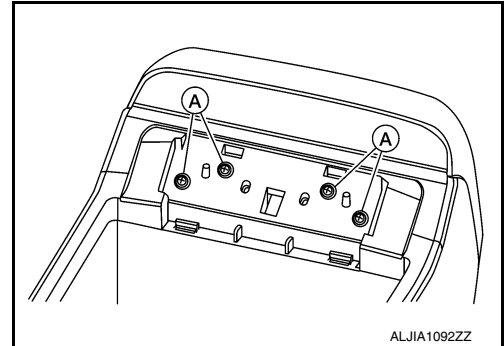
8. Remove center console rear finisher screws (A).

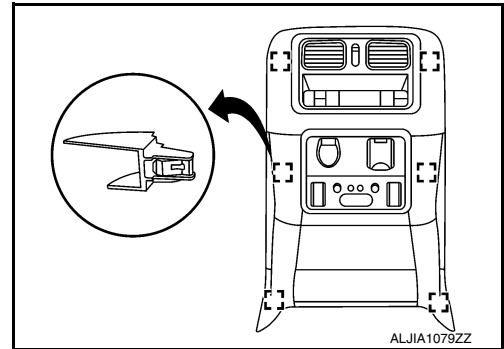
9. Release center console rear finisher clips using a suitable tool, disconnect the harness connectors and remove.

□: Metal clip

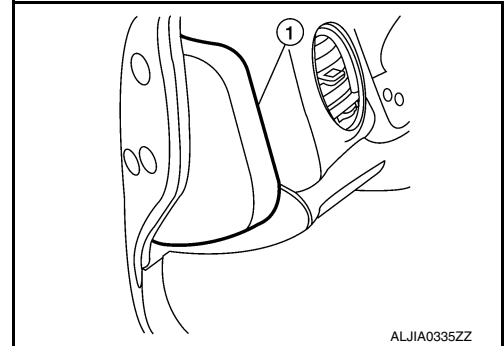
1. Remove instrument side finisher (LH) (1) using a suitable tool.

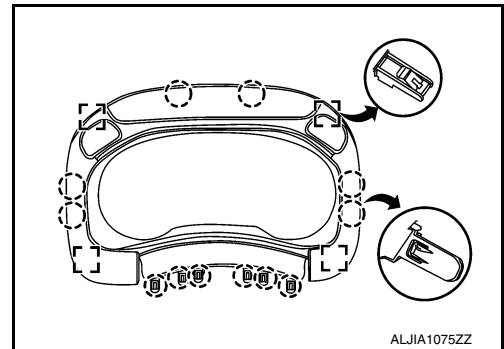
2. Remove instrument lower panel LH. Refer to [IP-25, "Removal and Installation"](#).
3. Release cluster lid A pawls and clips using a suitable tool, disconnect the harness connector and remove.

- Metal clip
- Pawl

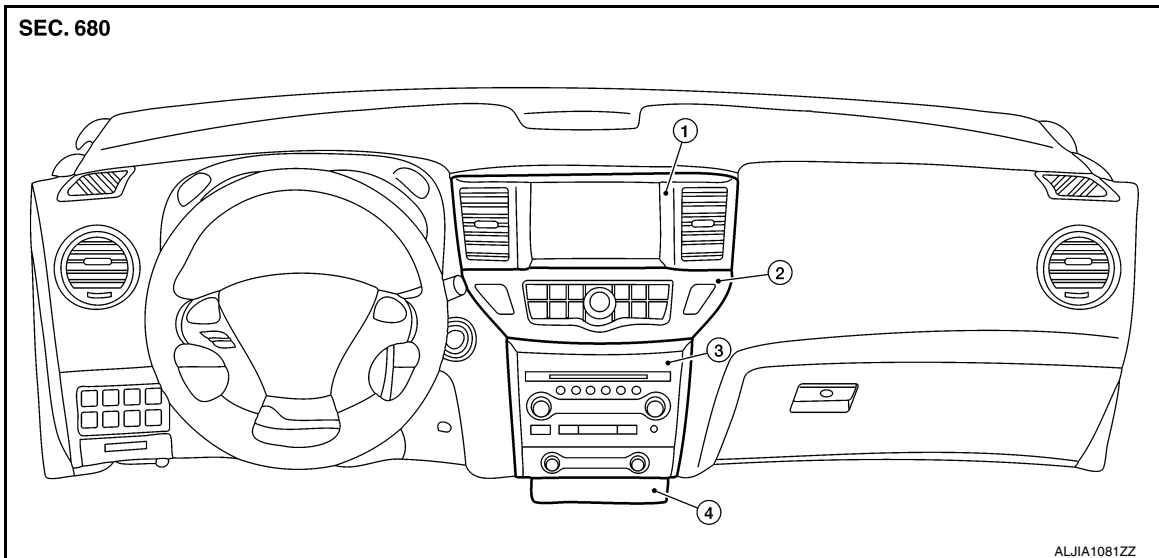
Exploded View

- 1. Cluster lid D
- 2. Cluster lid C
- 3. A/C and AV switch assembly
- 4. Cluster lid C lower

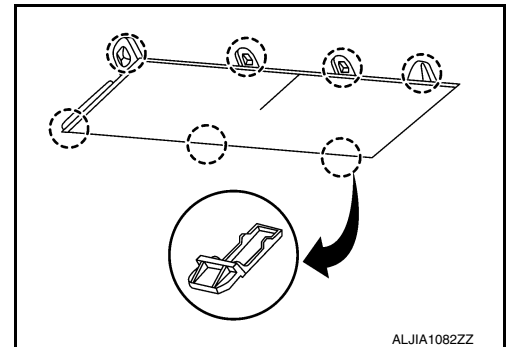
1. Release cluster lid C lower pawls using a suitable tool and remove.

○: Pawl

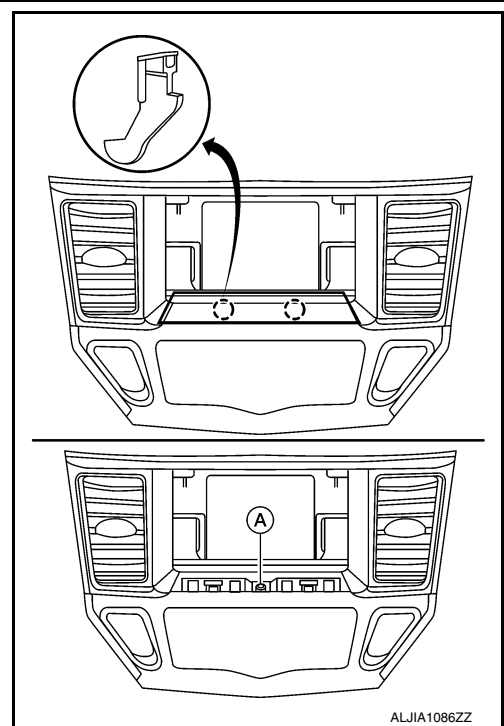
1. Release cluster lid C finisher pawls using a suitable tool and remove.
○: Pawl
2. Remove cluster lid C screw (A).

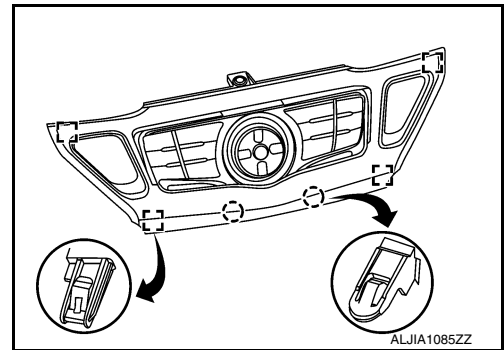
3. Release cluster lid C clips and pawls using a suitable tool.
□: Metal clip
○: Pawl

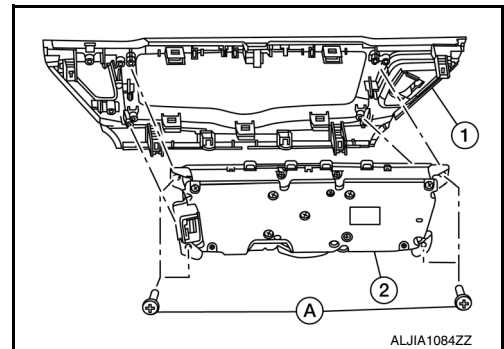
4. Disconnect the harness connectors from cluster lid C and remove.
5. Remove screws (A) and separate cluster lid C (1) from multi-function switch assembly (2) (if necessary).

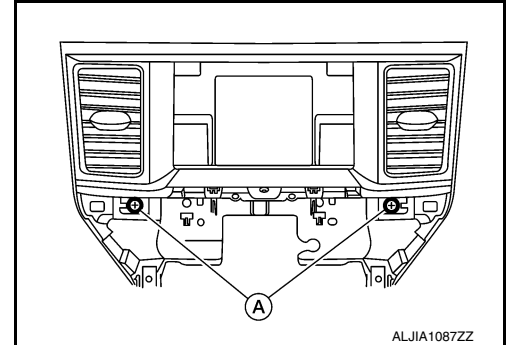
1. Remove cluster lid C. Refer to [IP-22. "CLUSTER LID C : Removal and Installation"](#).
2. Remove cluster lid D screws (A).

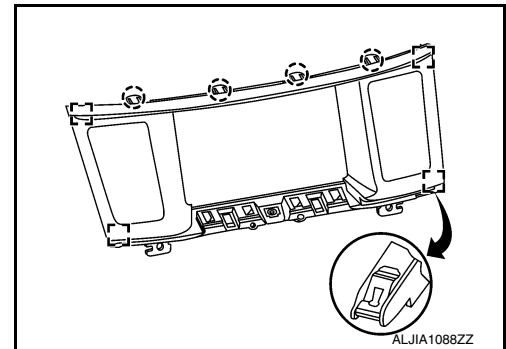
3. Release cluster lid D clips and pawls using a suitable tool and remove.

- : Metal clip
- : Pawl

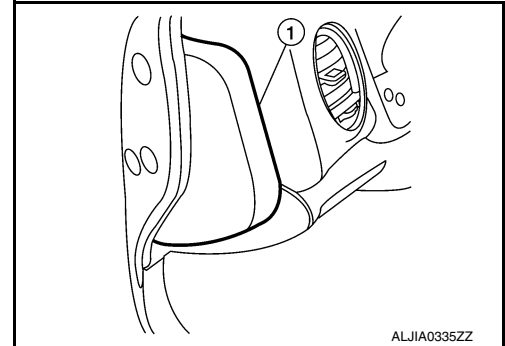
1. Remove instrument side finisher (LH) (1) using a suitable tool.

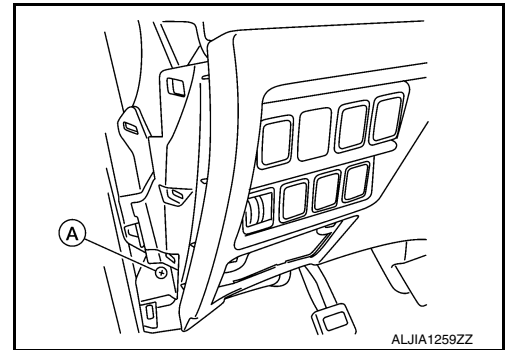
2. Remove instrument lower panel LH screw (A).

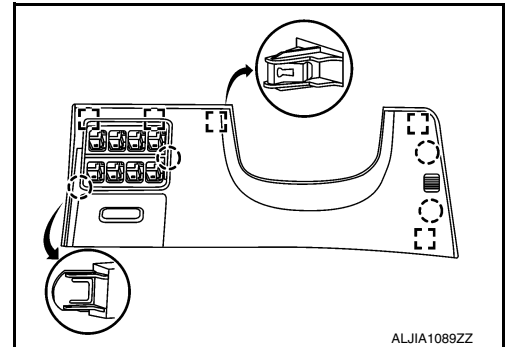
3. Remove hood lock release handle from instrument lower panel LH. Refer to [DLK-300. "Exploded View"](#).
4. Remove data link connector from instrument lower panel LH.
5. Release instrument lower panel LH clips and pawls using a suitable tool.

- : Metal clip
- : Pawl

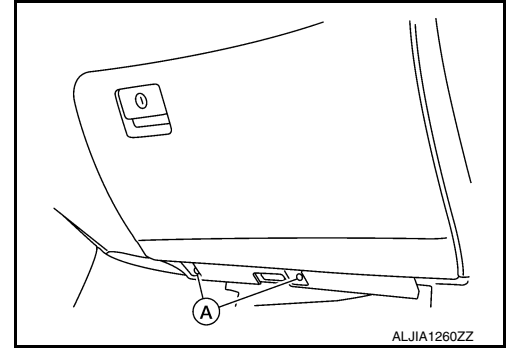
1. Remove instrument side finisher (RH) using a suitable tool.
2. Remove glove box assembly lower screws (A).

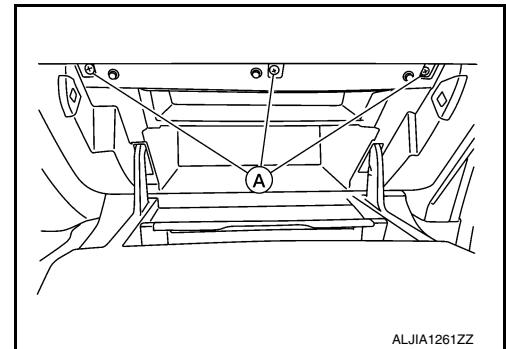
3. Open glove box lid, then remove the glove box assembly upper screws (A).

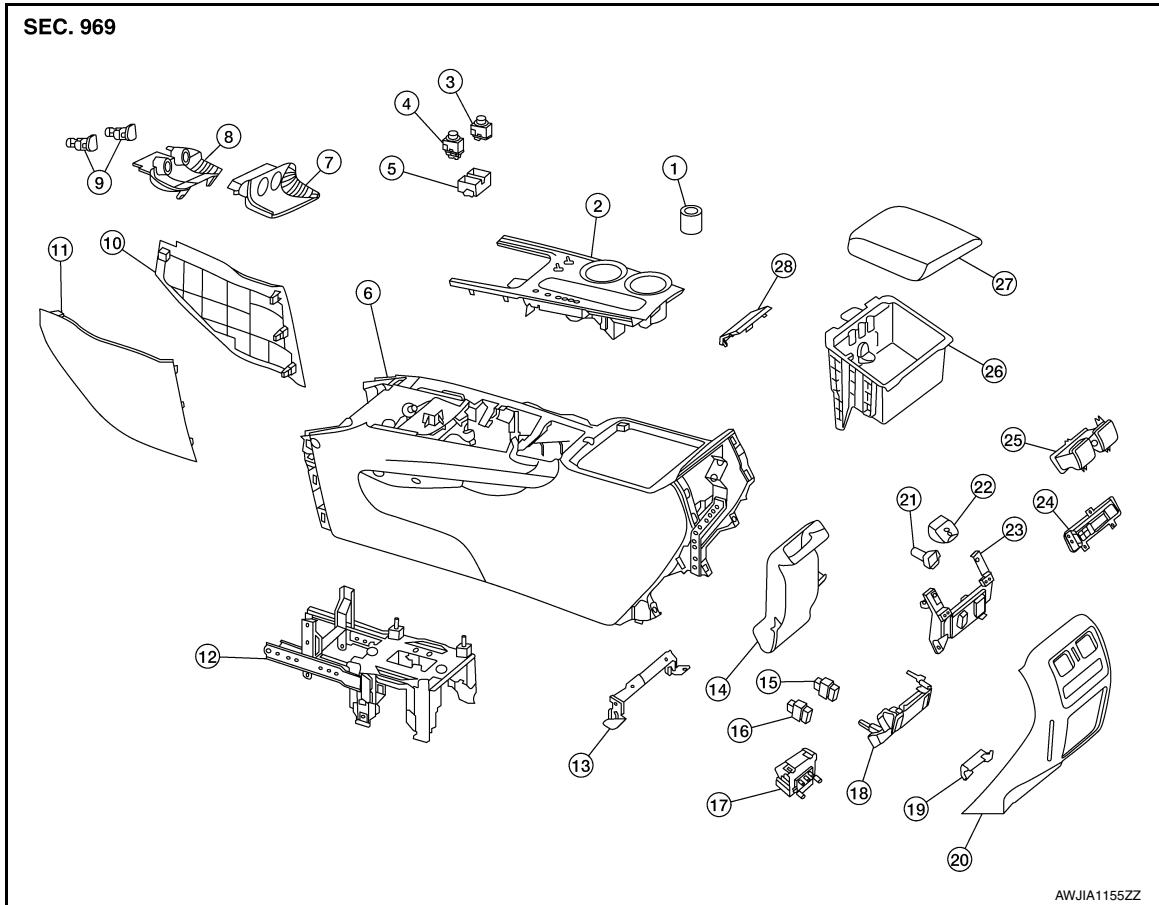
Exploded View

| 1. Drive mode selector switch | 2. Shift selector finisher | 3. Front seat climate control switch (RH) (if equipped) |

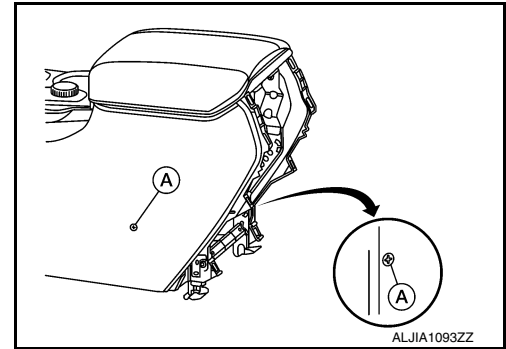
3. Remove center console bin screws (A)

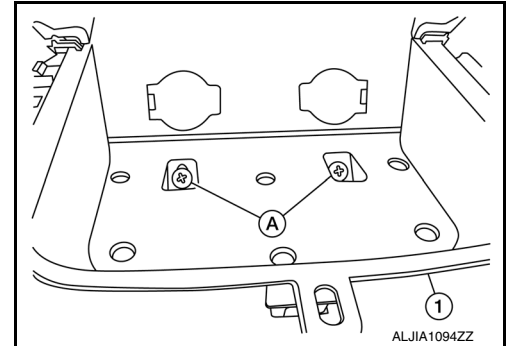
4. Remove remaining center console bin screws (A), disconnect the harness connectors, then remove the center console bin (1).

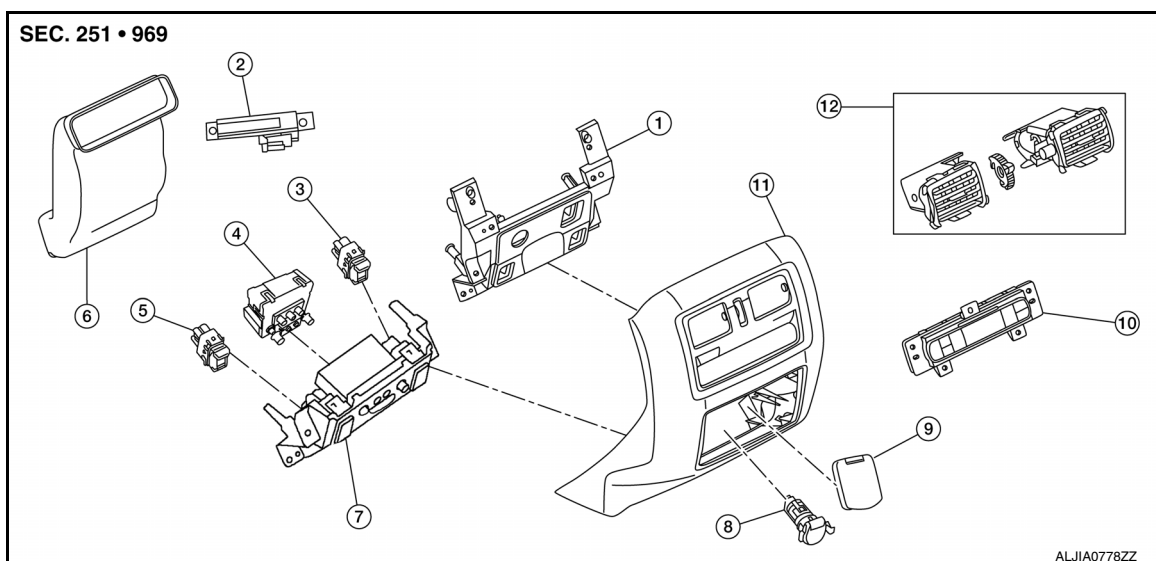
Exploded View

| 1. Center console rear finisher upper bracket | 2. Intelligent Key antenna | 3. 2nd row heated seat switch (RH) (if equipped) |

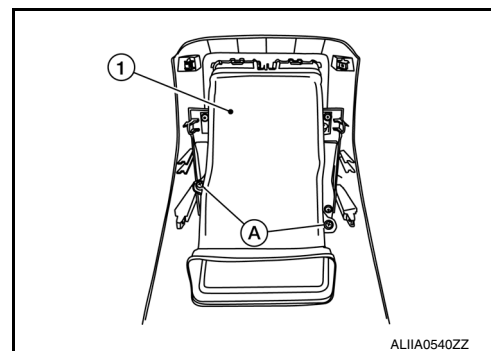
1. Remove center console rear finisher by releasing clips and pawls using a suitable tool.
2. Remove rear center ventilator duct screws (A) and rear center ventilator duct (1).
