SECTION **BRM**
 BODY REPAIR

CONTENTS

VEHICLE INFORMATION

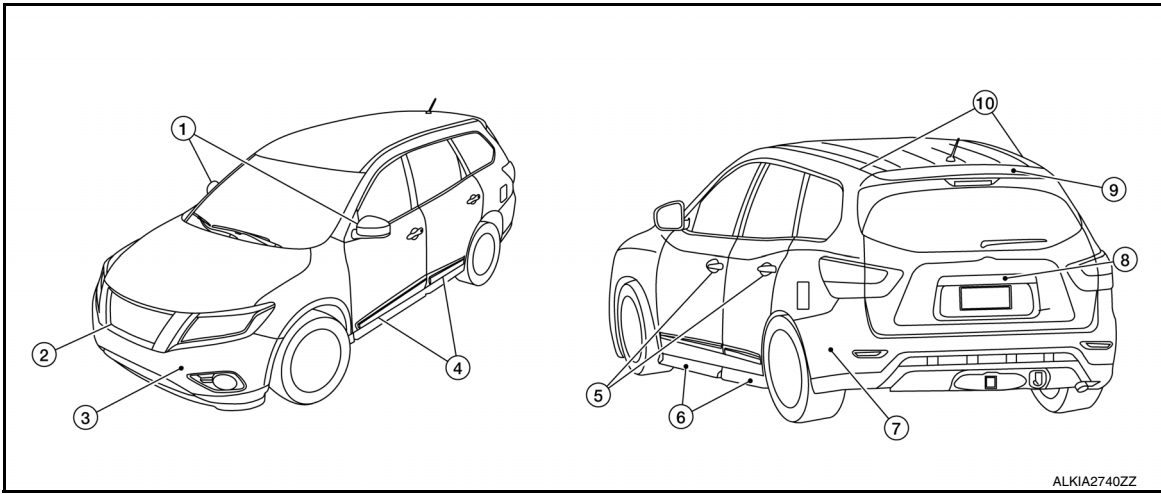
ALKIA2740ZZ

Body Exterior Paint Color

Component	Color code	CAJ	EAN	K23	KAD	G41	NAH	RBG	QAB	QAK	
	Description	Brown	Olive	Silver	Gray	Black	Red	Blue	White	White	
	Paint type	M	M	M	M	M	M	M	P	S	
	Hard clear coat	t	t	t	t	t	t	t	t	t	
1	Door mirror	Body color	CAJ	EAN	K23	KAD	G41	NAH	RBG	QAB	QAK
2	Front grille	Chromium Plate	Cr2P	Cr2P	Cr2P	Cr2P	Cr2P	Cr2P	Cr2P	Cr2P	Cr2P
3	Front bumper fascia	Body color	CAJ	EAN	K23	KAD	G41	NAH	RBG	QAB	QAK
4	Side guard molding	Chromium Plate	Cr2P	Cr2P	Cr2P	Cr2P	Cr2P	Cr2P	Cr2P	Cr2P	Cr2P
5	Door outside handle	Chromium Plate	Cr2P	Cr2P	Cr2P	Cr2P	Cr2P	Cr2P	Cr2P	Cr2P	Cr2P
6	Sill molding	Black	G41	G41	G41	G41	G41	G41	G41	G41	G41
7	Rear bumper fascia	Body color	CAJ	EAN	K23	KAD	G41	NAH	RBG	QAB	QAK
8	Back door outer finisher	Chromium Plate	Cr2P	Cr2P	Cr2P	Cr2P	Cr2P	Cr2P	Cr2P	Cr2P	Cr2P
9	Rear spoiler	Body color	CAJ	EAN	K23	KAD	G41	NAH	RBG	QAB	QAK
10	Roof side molding	Black	G41	G41	G41	G41	G41	G41	G41	G41	G41

M = Metallic, S = Solid, 2S = Solid and Clear, 2 P = 2-coat Pearl, 3P = 3-coat pearl, P = Pearl, Black is solvent based, all others are water based, t = TMAC clear coat

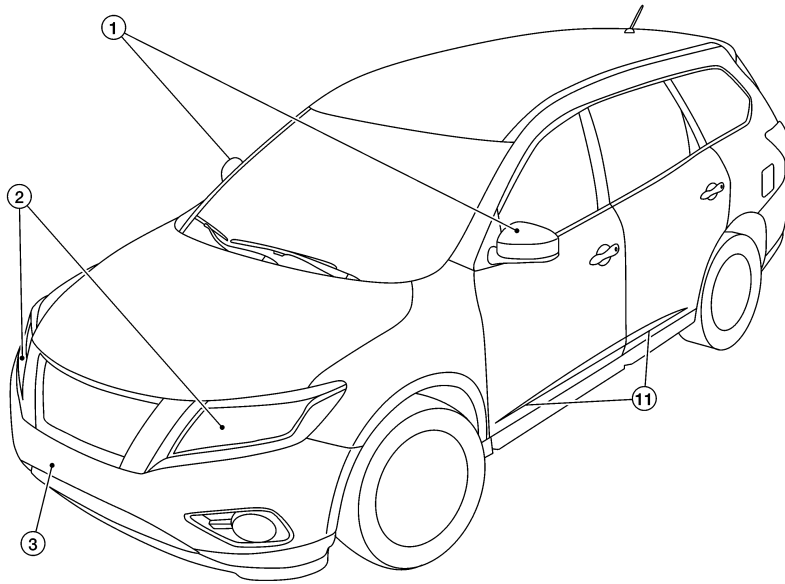
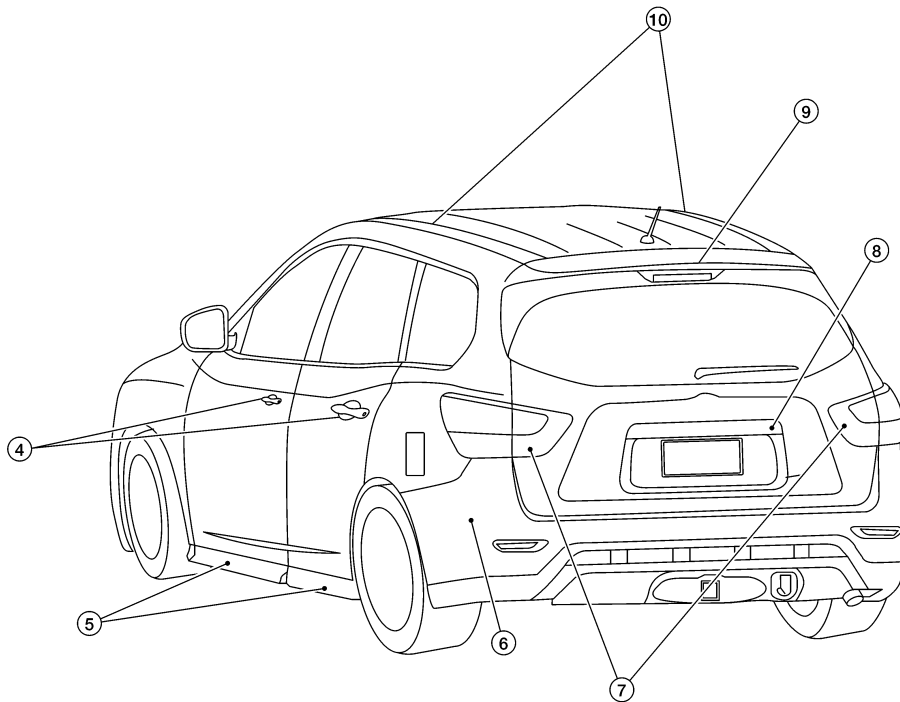
ALKIA2823ZZ

LOCATION OF PLASTIC PARTS

Item	Component	Abbreviation	Material
1.	Door mirror	Base	PA Polyamide (Nylon)
		Housing	ABS Acrylonitrile Butadiene Styrene
2.	Front combination lamp	Lens	PC Polycarbonate
		Housing	PP Polypropylene
3.	Front bumper fascia	PP	Polypropylene

Item	Component	Abbreviation	Material
4.	Outside door handle	Grip	PC Polycarbonate
		Escutcheon	PA Polyamide (Nylon)
5.	Sill molding	TPO	Thermoplastic Olefine
6.	Rear bumper fascia	PP	Polypropylene
7.	Rear combination lamp	Lens	PMMA Poly Methyl Methacrylate
		Housing	ASA Acrylonitrile Styrene Acrylate
8.	Back door outer finisher (upper/lower)	ABS + PC	Acrylonitrile Butadiene Styrene + Polycarbonate
9.	Rear spoiler	ABS + PC	Acrylonitrile Butadiene Styrene + Polycarbonate
10.	Roof side molding	ABS + PC	Acrylonitrile Butadiene Styrene + Polycarbonate
11.	Body side molding	PC	Polycarbonate

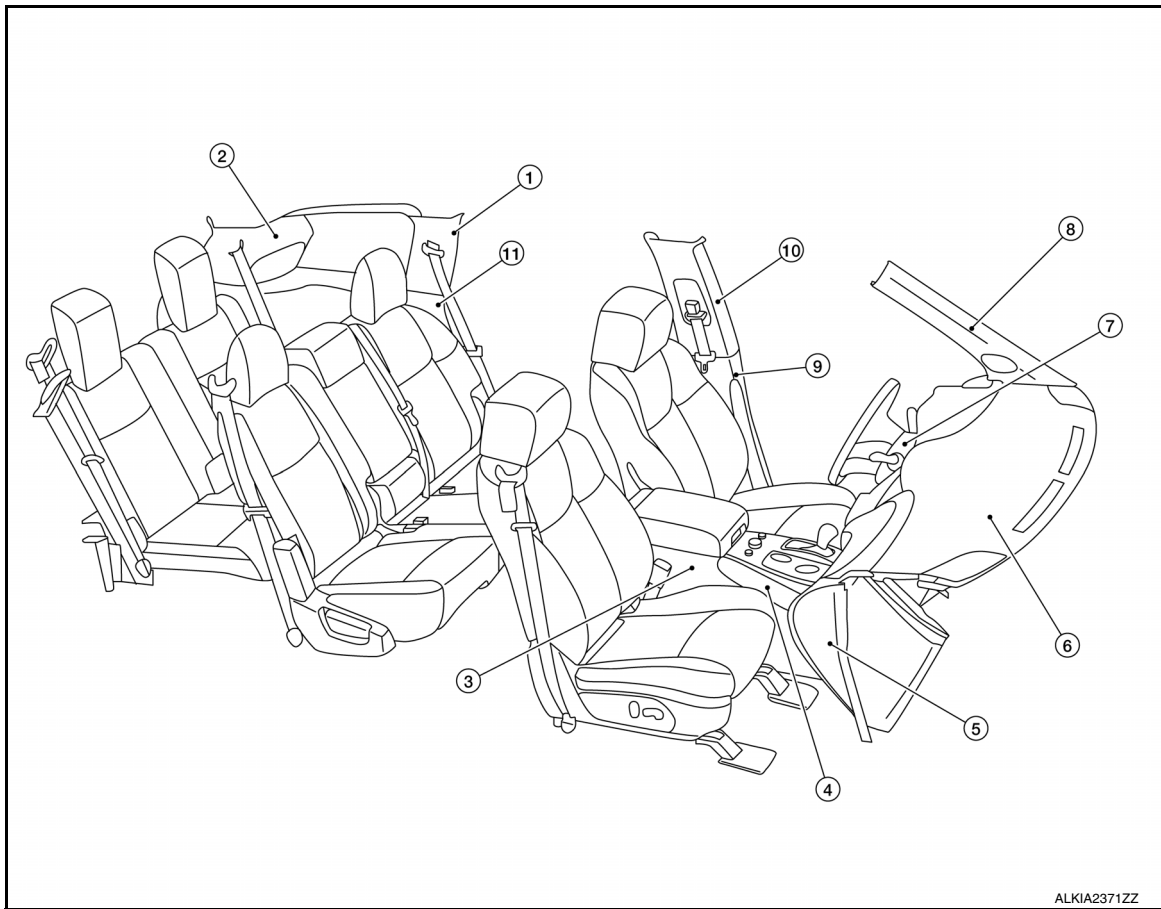
ALKIA2371ZZ

Item	Component	Abbreviation	Material
1.	Rear pillar finisher	PP	Polypropylene
2.	Back pillar finisher	PP	Polypropylene
3.	Center console assembly	Base	PP + EPDM Polypropylene + Ethylene Propylene (Diene) copolymer
		Box	ABS + PC Acrylonitrile Butadiene Styrene + Polycarbonate
4.	Shift selector finisher	ABS + PC	Acrylonitrile Butadiene Styrene + Polycarbonate
5.	Instrument panel side finisher	PP + EPDM	Polypropylene + Ethylene Propylene (Diene) copolymer
6.	Instrument panel	Base	PPC Polypropylene Composite
		Skin	PET Polyester

Item	Component	Abbreviation	Material
7.	Steering column covers	PP	Polypropylene
8.	Front pillar finisher	Core	Polypropylene
		Skin	Polyester
9.	Center pillar lower finisher	PP	Polypropylene
10.	Center pillar upper finisher	Core	Polypropylene
11.	Luggage side finisher	PP	Polypropylene

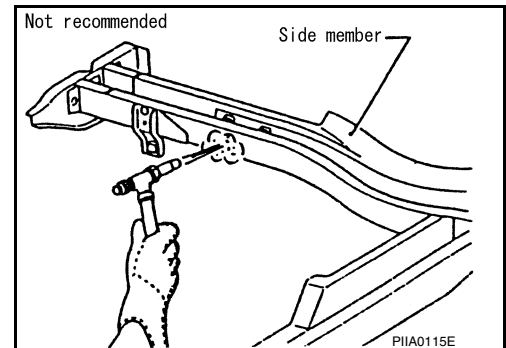
- The repair of reinforcements (such as side members) by heating is not recommended since it may weaken the component. When heating is unavoidable, do not heat HSS parts above 550°C (1,022°F).

Verify heating temperature with a thermometer.

(Crayon-type and other similar type thermometers are appropriate.)

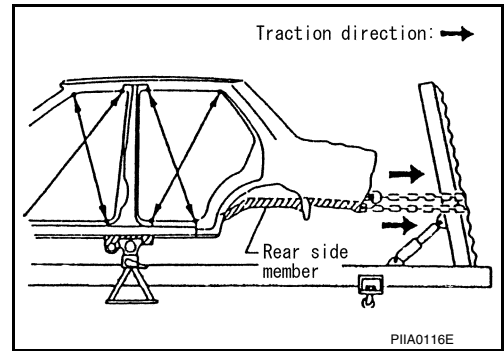
- When straightening body panels, use caution in pulling any HSS panel. Because HSS is very strong, pulling may cause deformation in adjacent portions of the body. In this case, increase the number of measuring points and carefully pull the HSS panel.

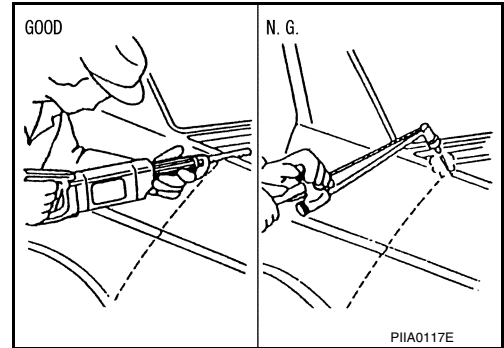
- When cutting HSS panels, avoid gas (torch) cutting if possible. Instead, use a saw to avoid weakening surrounding areas due to heat. If gas (torch) cutting is unavoidable, allow a minimum margin of 50 mm (1.97 in).

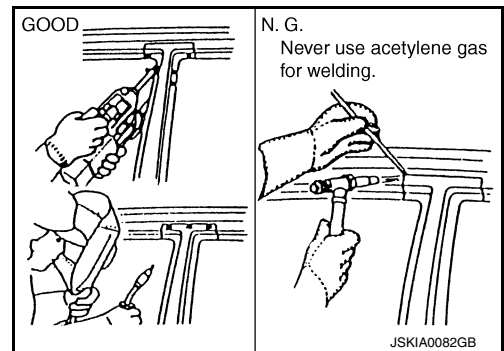
- When welding HSS panels, use spot welding whenever possible in order to minimize weakening surrounding areas due to heat. If spot welding is impossible, use MIG. welding. Do not use gas (torch) for welding because it is inferior in welding strength.

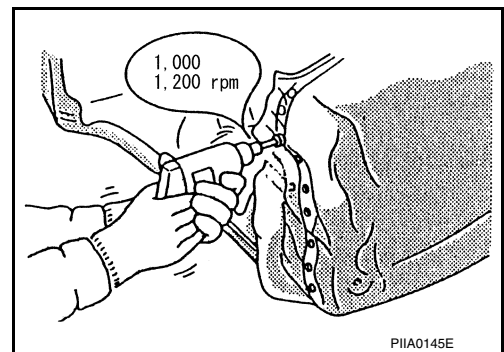
- The spot weld on HSS panels is harder than that of an ordinary steel panel. Therefore, when cutting spot welds on a HSS panel, use a low speed high torque drill (1,000 to 1,200 rpm) to increase drill bit durability and facilitate the operation.

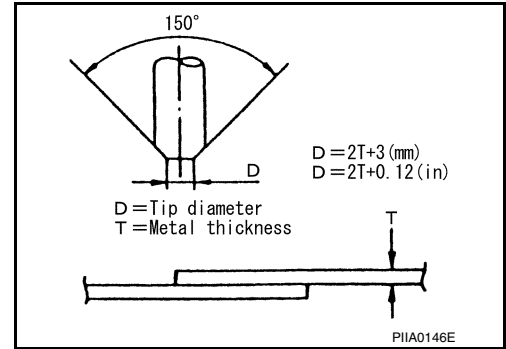
- The electrode tip diameter must be sized properly according to the metal thickness.

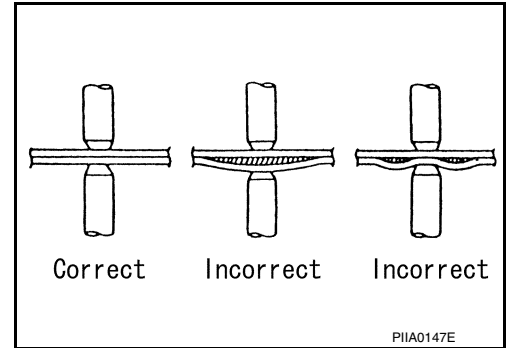
- The panel surfaces must fit flush to each other, leaving no gaps.

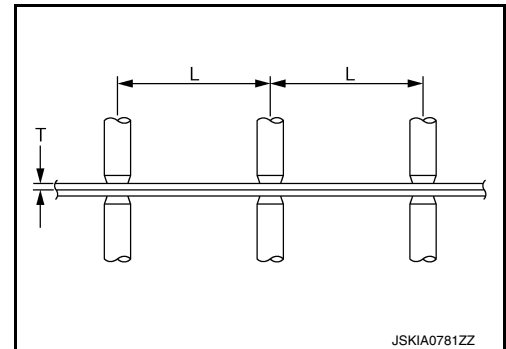
- Follow the specifications for the proper welding pitch.

Thickness (T)	Minimum pitch (L)
0.6 (0.024)	10 (0.39) or over
0.8 (0.031)	12 (0.47) or over
1.0 (0.039)	18 (0.71) or over
1.2 (0.047)	20 (0.79) or over
1.6 (0.063)	27 (1.06) or over
1.8 (0.071)	31 (1.22) or over

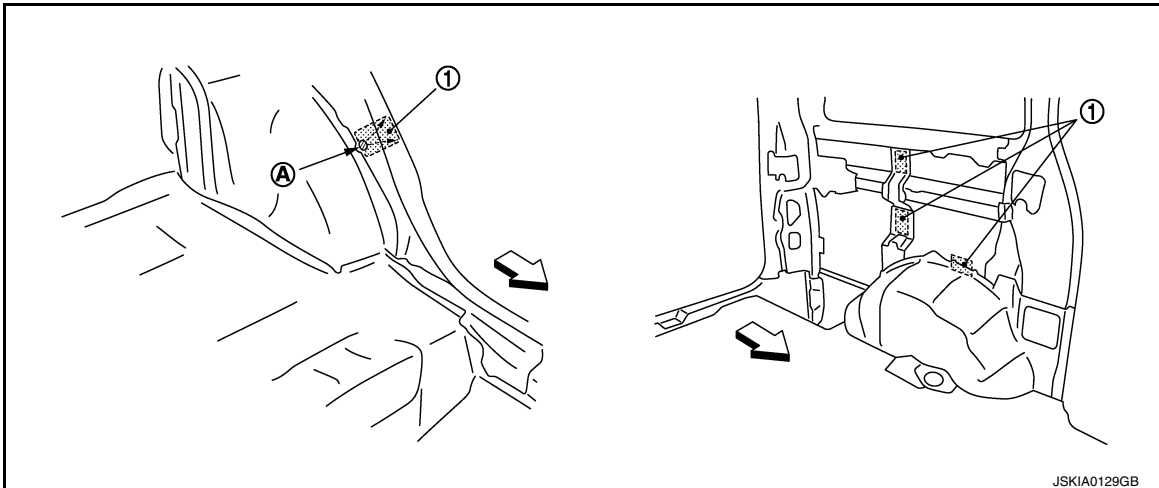
1. Fill procedures after installation of service part.
 - a. Eliminate foam material remaining on vehicle side.
 - b. Clean area after eliminating form insulator and foam material.
 - c. Install service part.
 - d. Insert nozzle into hole near fill area and fill foam material or fill enough to close gap with the service part.

1. Urethane foam

A. Nozzle insert hole

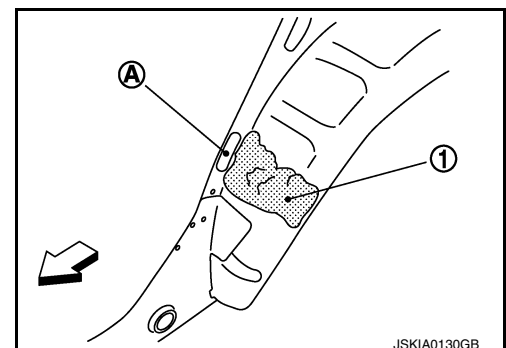
2. Fill procedures before installation of service part:
 - a. Eliminate foam material remaining on vehicle side.
 - b. Clean area after eliminating foam insulator and foam material.
 - c. Fill with enough foam material on the wheelhouse outer side to close the gap with the service part while avoiding the flange area.

1. Urethane foam

A. Fill while avoiding flange area

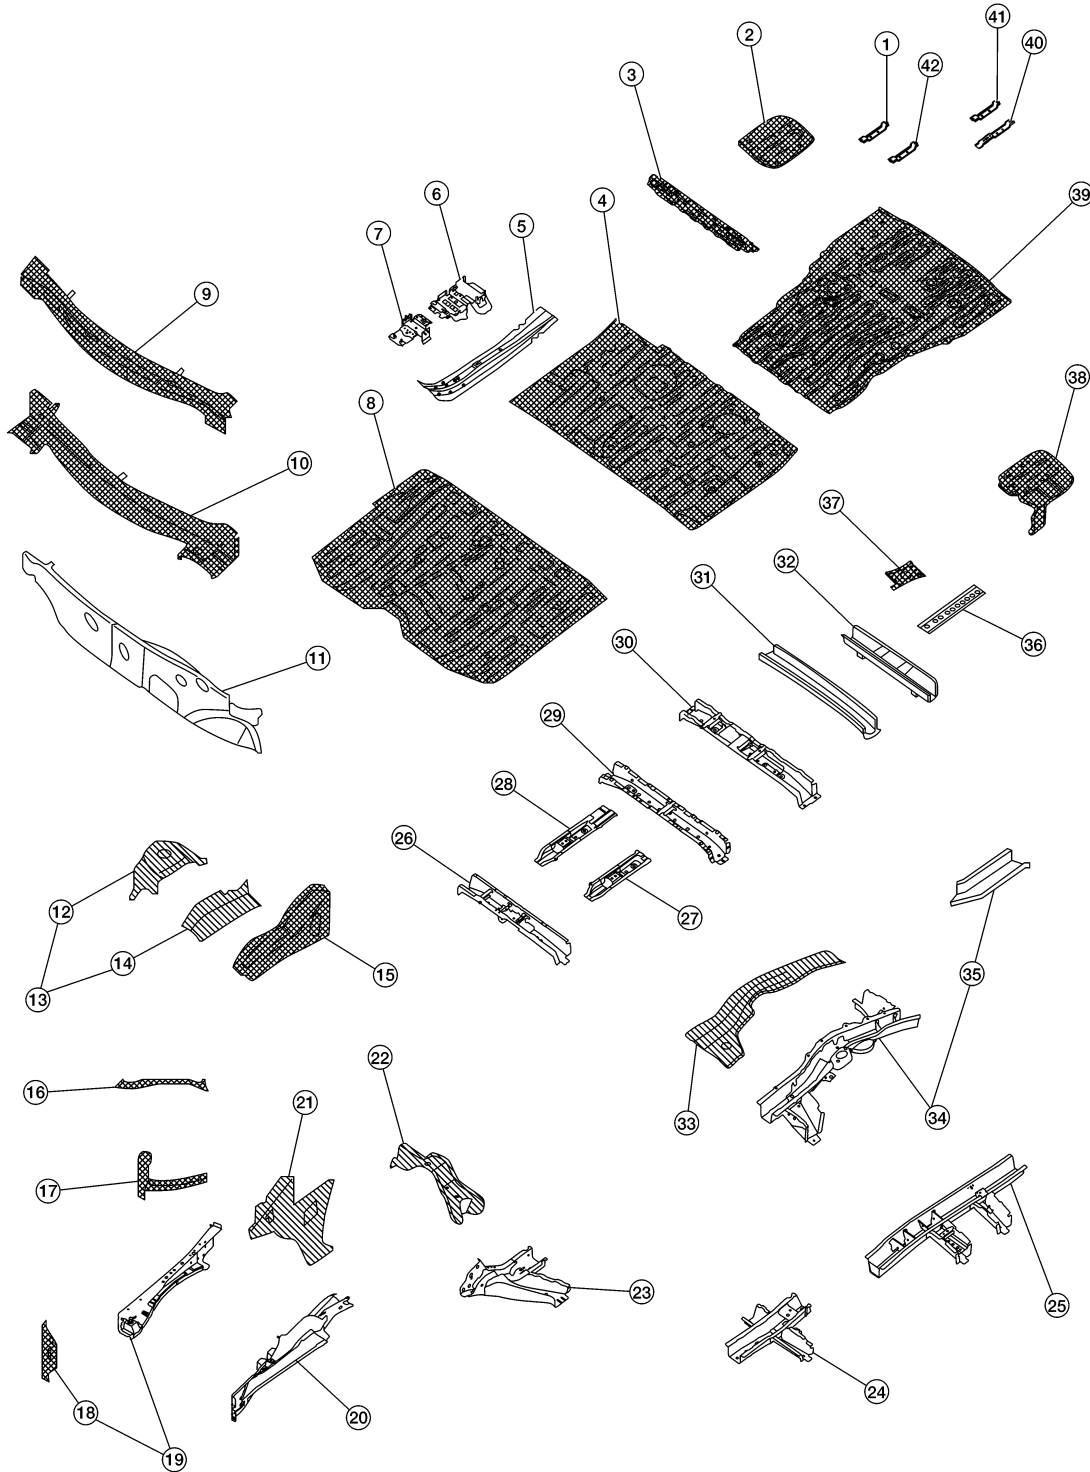
AWKIA324ZZ

Underbody Component Parts

: Both sided anti-corrosive pre-coated steel portions

: High strength steel (HSS) portions

: Both sided anti-corrosive steel and HSS portions

Item	Part name	Material	
1.	Front woofer bracket (LH)	—	A
2.	Rear floor side assembly (RH)	SP781B	B
3.	Lower seatback support assembly	SP123B	C
4.	Rear floor front	—

5.	Front side member stiffener (RH)	SP151-1350Hv	D
6.	Trim mounting bracket assembly	SP121B	
7.	Instrument stay bracket assembly	—	
8.	Front floor front	SP781B	E

9.	Cowl assembly	—	
10.	Upper dash assembly	SP781B	
11.	Lower dash assembly	—	F
12.	Hoodledge lower assembly (LH)	—	
13.	Hoodledge assembly (LH)	—	
14.	Upper hoodledge (LH)	SP781-390B	G

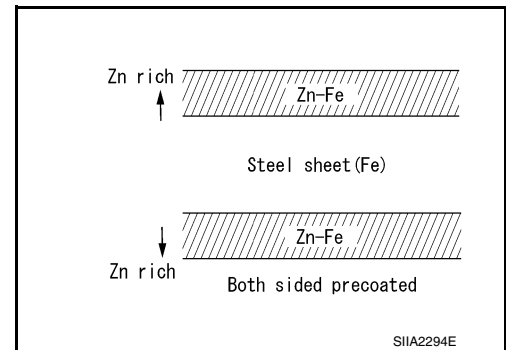
Galvannealed steel is electroplated and heated to form zinc-iron alloy, which provides excellent and long term corrosion resistance with cationic electrodeposition primer.

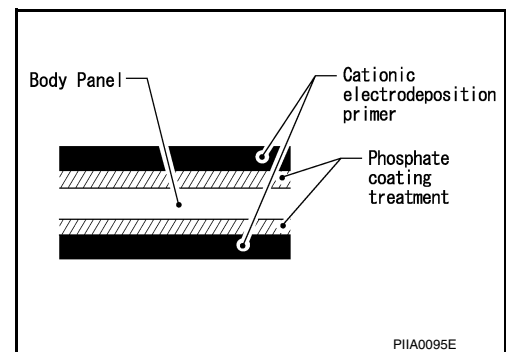
A phosphate coating treatment and a cationic electrodeposition primer, which provide excellent corrosion protection, are employed on all body components.

Confine paint removal during welding operations to an absolute minimum.

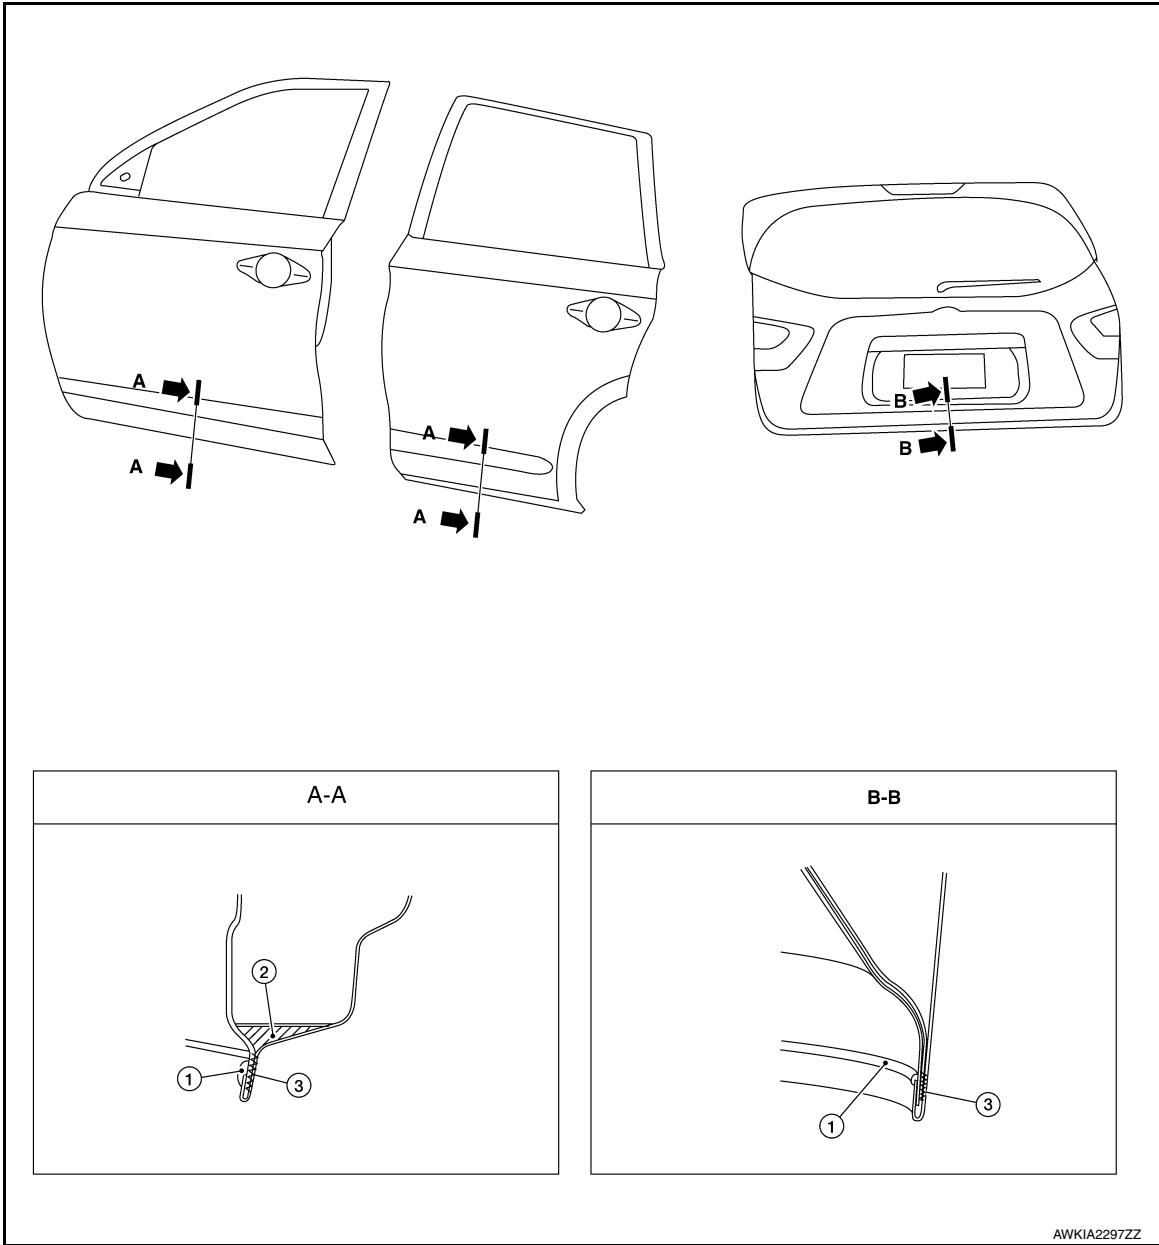
To improve corrosion resistance, anti-corrosive wax is applied inside the body sill and inside other closed sections. Accordingly, when replacing these parts, be sure to apply anti-corrosive wax to the appropriate areas of the new parts. Select an excellent anti-corrosive wax which will penetrate after application and has a long shelf life.

1. Body caulk

2. Anti-corrosive wax

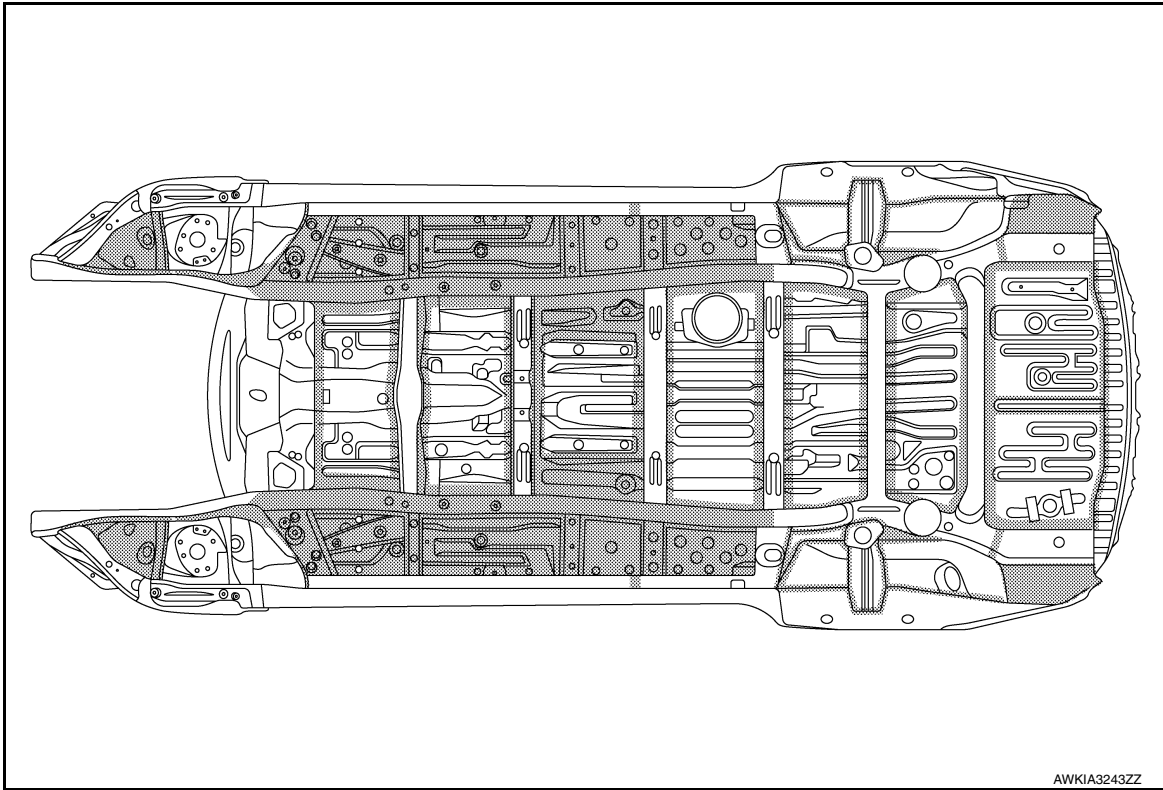
The underside of the floor and wheelhouse are undercoated to prevent rust, vibration, noise and stone chipping. Therefore, when such a panel is replaced or repaired, apply undercoating to that part. Use an undercoating which is rust preventive, soundproof, vibration-proof, shock-resistant, adhesive, and durable.

Undercoated areas are shaded.

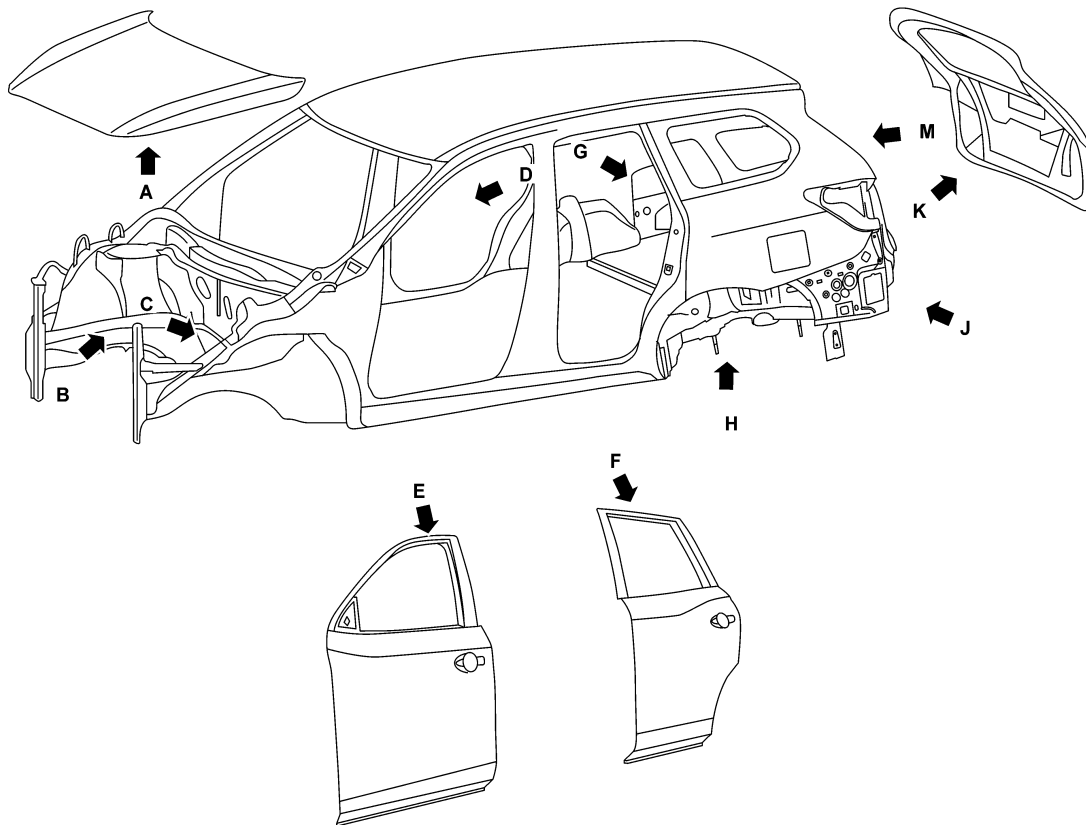
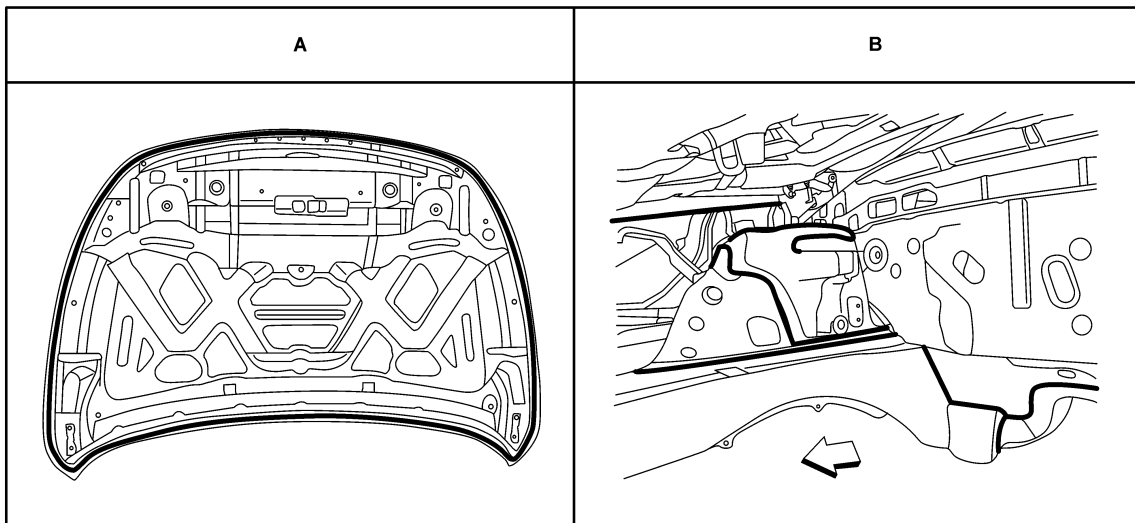
ALKIA2749ZZ

The following figure shows the areas which are sealed at the factory. Sealant which has been applied to these areas should be smooth and free from cuts or gaps. Care should be taken not to apply an excess amount of sealant and not to allow other unaffected parts to come into contact with the sealant.

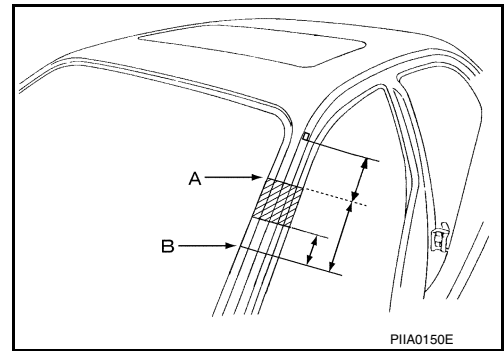
- Front pillar butt joint can be determined anywhere within shaded area as shown in the figure. The best location for the butt joint is at position A due to the construction of the vehicle. Refer to the front pillar section.

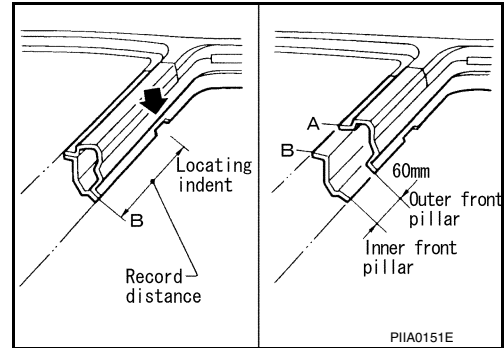
- Determine cutting position and record distance from the locating indent. Use this distance when cutting the service part. Cut outer front pillar over 60 mm (2.4 in) above inner front pillar cut position.

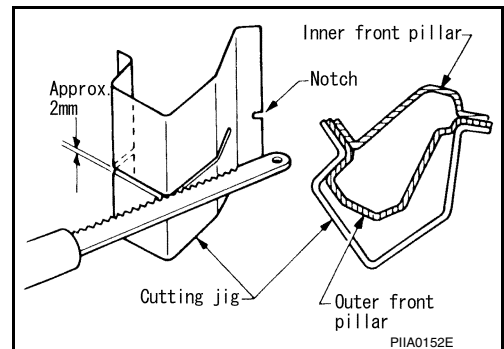
- Prepare a cutting jig to make the outer pillar easier to cut. Also, this will permit the service part to be accurately cut at the joint position.

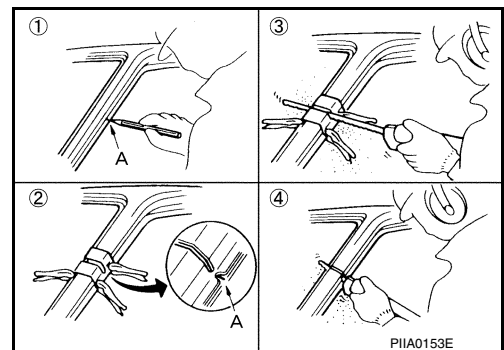
- An example of cutting operation using a cutting jig is as follows:

1. Mark cutting lines.
A: Cut position of outer pillar
2. Align cutting line with notch on jig. Clamp jig to pillar.
3. Cut outer pillar along groove of jig. (At position A)
4. Remove jig and cut remaining portions.

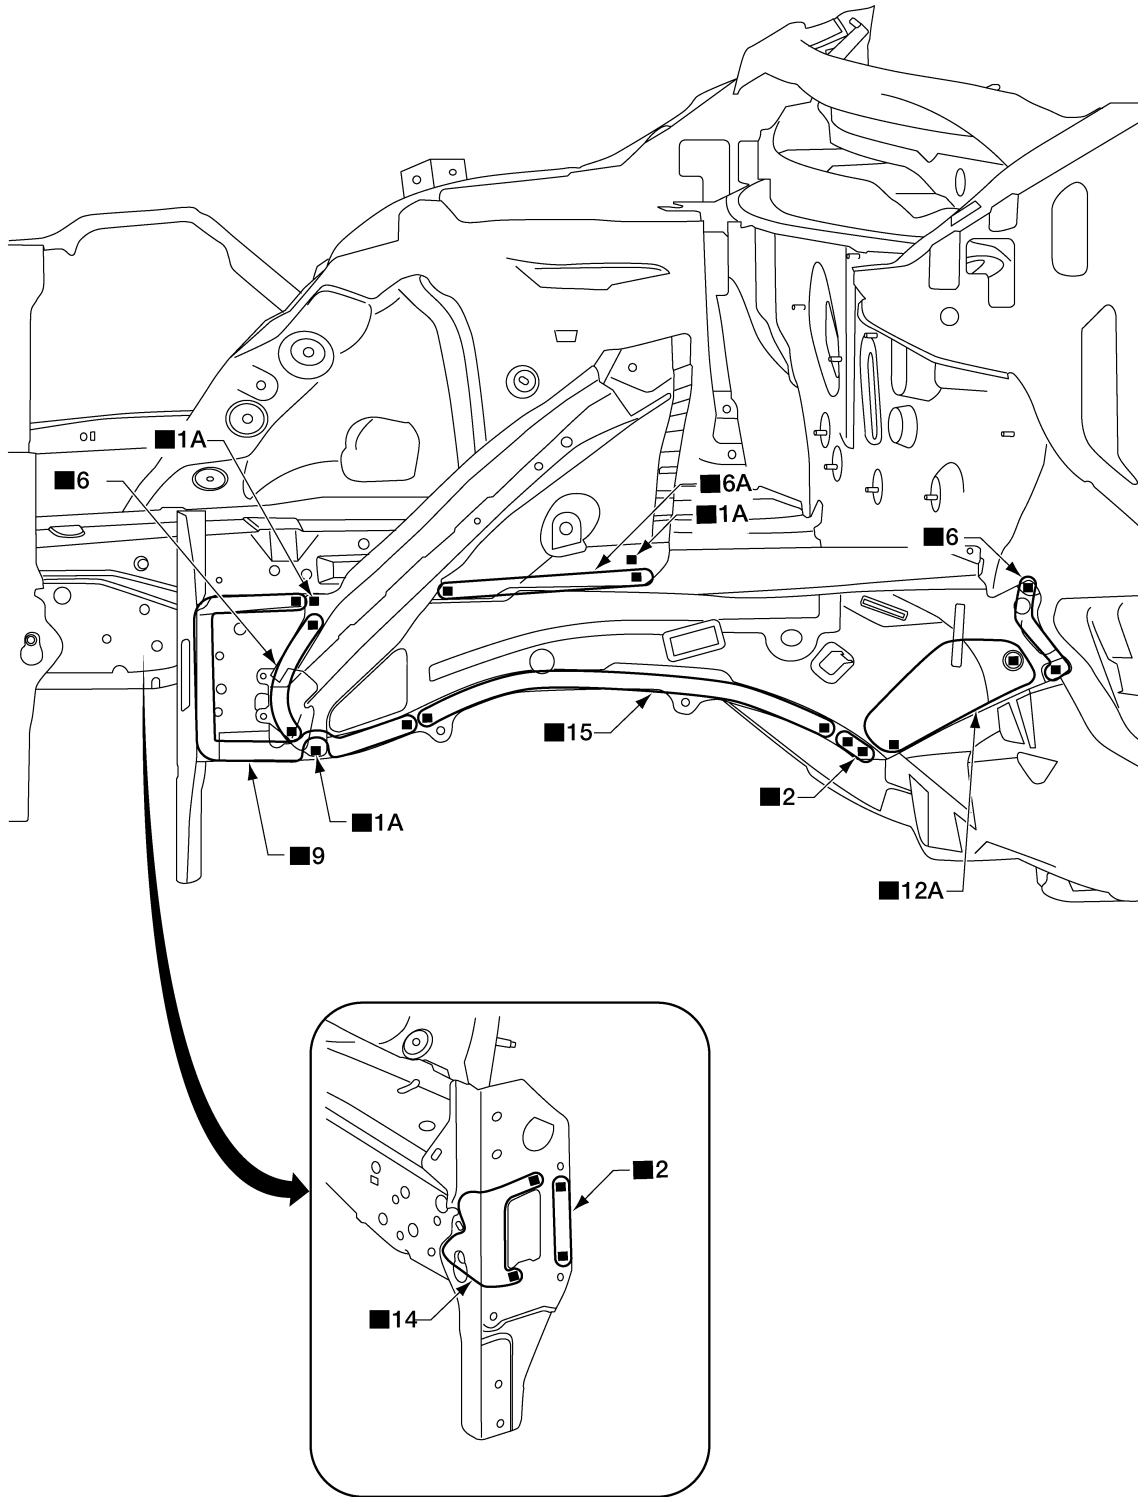
AWKIA3236ZZ

Front Side Member (Partial Replacement)

Work after the hoodledge has been removed.

Unit: mm (in)

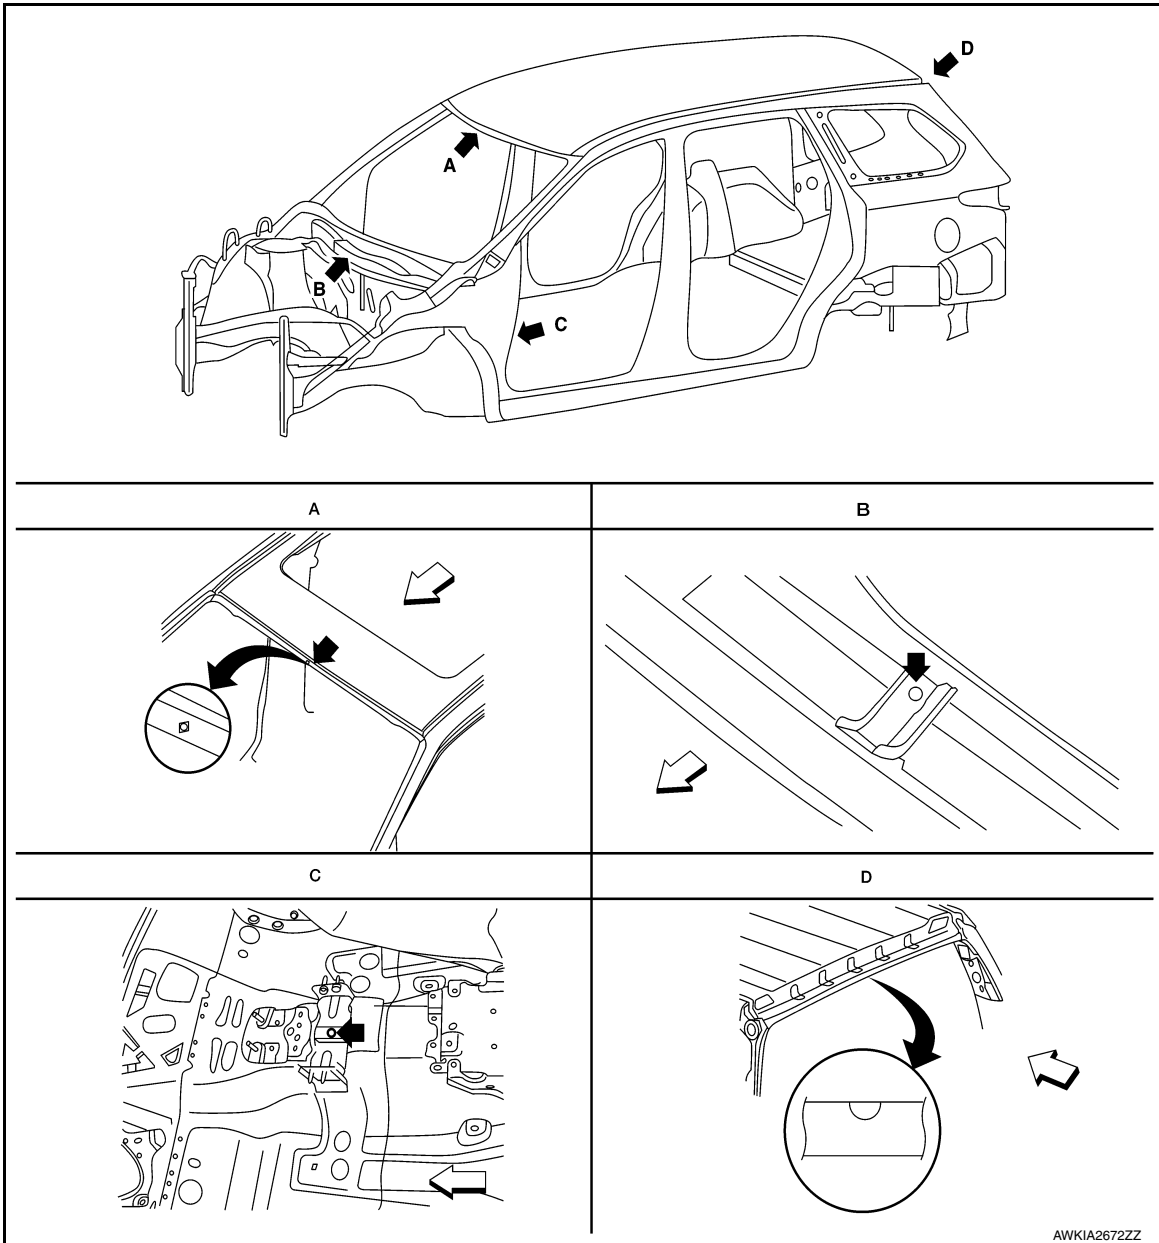
A mark is placed on each part of the body to indicate the vehicle center. When repairing the vehicle frame (members, pillars, etc.) damaged in an accident the most accurate and effective repair will be achieved by using these marks together with body alignment specifications.

Points	Portion	Marks
A	Front roof	Embossment
B	Center cowl top	Hole
C	Front floor	Hole
D	Rear roof	Notch

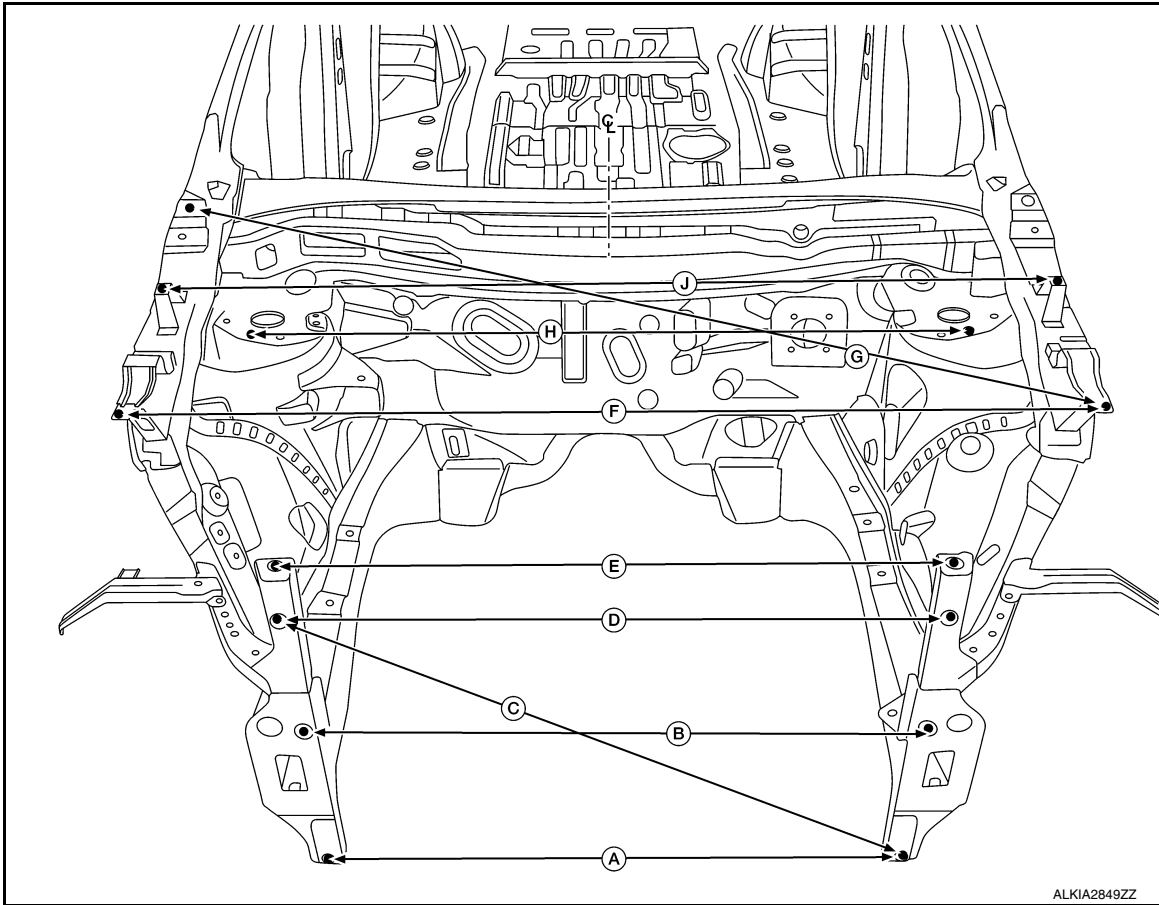
Unit: mm (in)

Position	Description	Measurement
A	Lower radiator support retaining hole 10 (0.4)	980 (38.6)
B	Upper inner bumper reinforcement retaining hole 10 (0.4)	973 (38.3)
C	Upper front radiator support retaining hole to lower radiator support retaining hole 10 (0.4)	1110 (43.7)
D	Upper front radiator support retaining hole 10 (0.4)	970 (38.2)
E	Top radiator support retaining hole 10 (0.4)	970 (38.2)
F	Front fender mounting bracket hole 8 (0.3)	1610 (63.4)
G	Rear hinge retaining hole 10 (0.4) to front fender bracket retaining hole 8 (0.3)	1590 (62.6)
H	Strut tower locator hole 12 (0.5)	1293 (50.9)
J	Center fender bracket retaining hole 8 (0.3)	1645 (64.8)

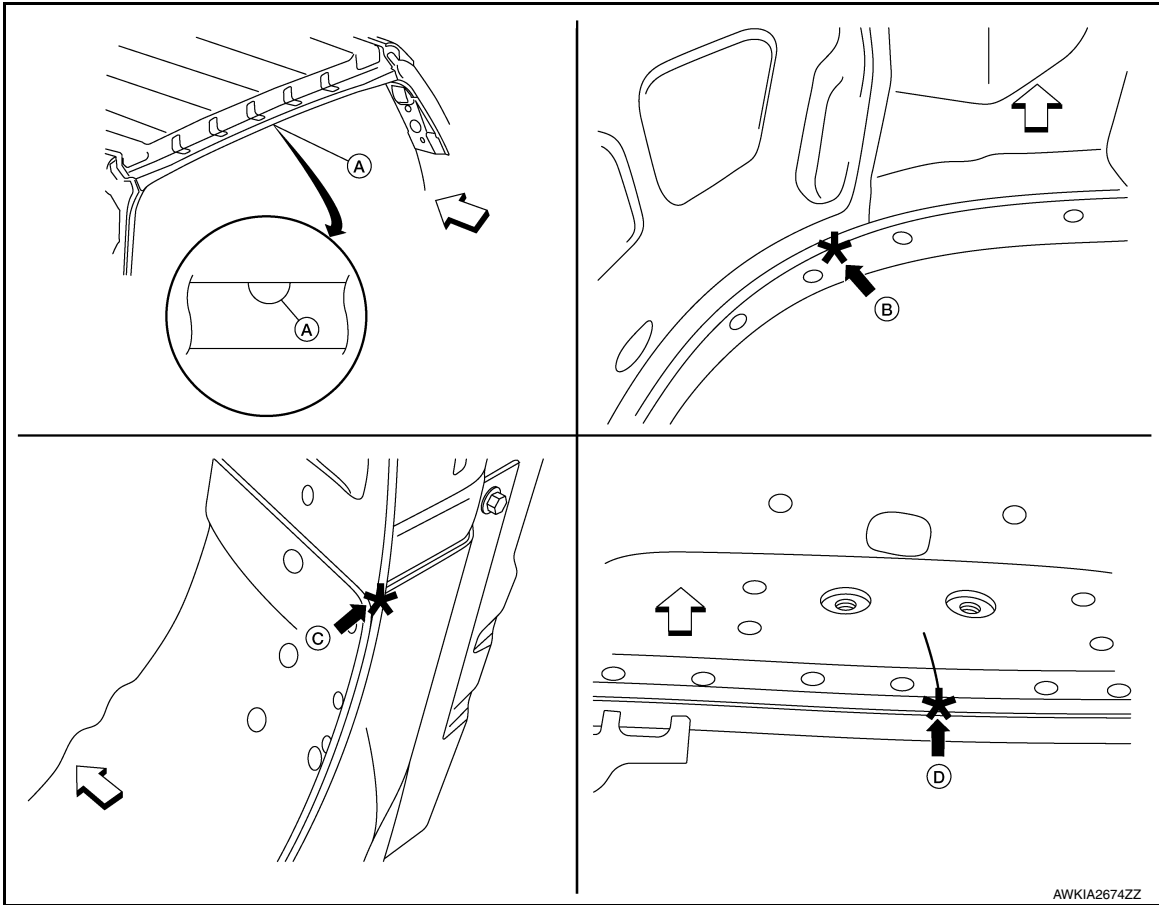
Point	Description	Point	Description
A	Roof flange end of center positioning mark	B	Back pillar main joggle
C	Upper rear panel joggle	D	Edge of rear panel between back door striker installing holes
