SECTION IP A INSTRUMENT PANEL C

REMOVAL AND INSTALLATION INSTRUMENT PANEL ASSEMBLY

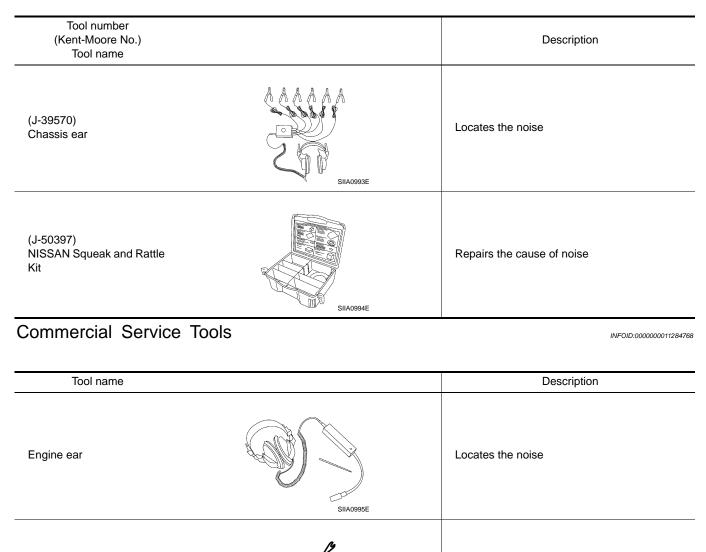
JMKIA3050ZZ

Removes clips, pawls, and metal clips

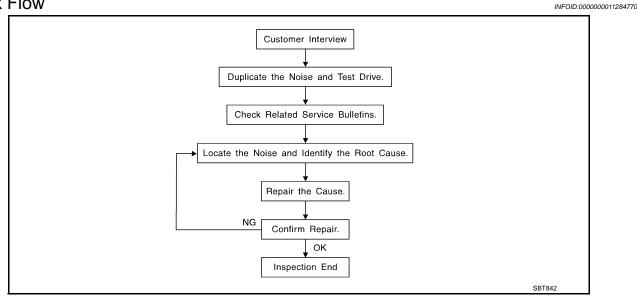
Work Flow

CUSTOMER INTERVIEW

Interview the customer if possible, to determine the conditions that exist when the noise occurs. Use the Diagnostic Worksheet during the interview to document the facts and conditions when the noise occurs and any customer comments. Refer to <u>IP-10</u>, "<u>Diagnostic Worksheet</u>". This information is necessary to duplicate the conditions that exist when the noise occurs.

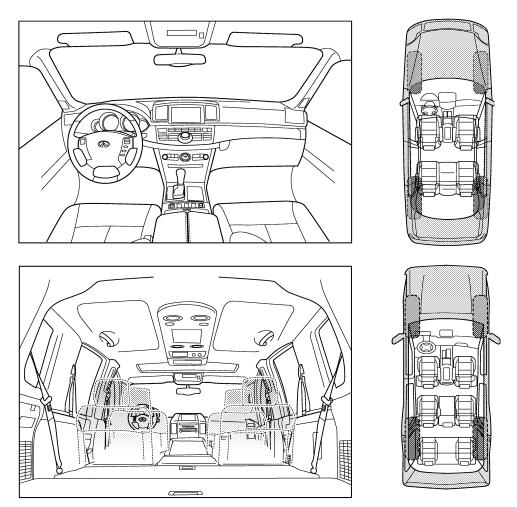
I. WHERE DOES THE NOISE COME FROM? (circle the area of the vehicle)

The illustrations are for reference only, and may not reflect the actual configuration of your vehicle.

Continue to page 2 of the worksheet and briefly describe the location of the noise or rattle. In addition, please indicate the conditions which are present when the noise occurs.

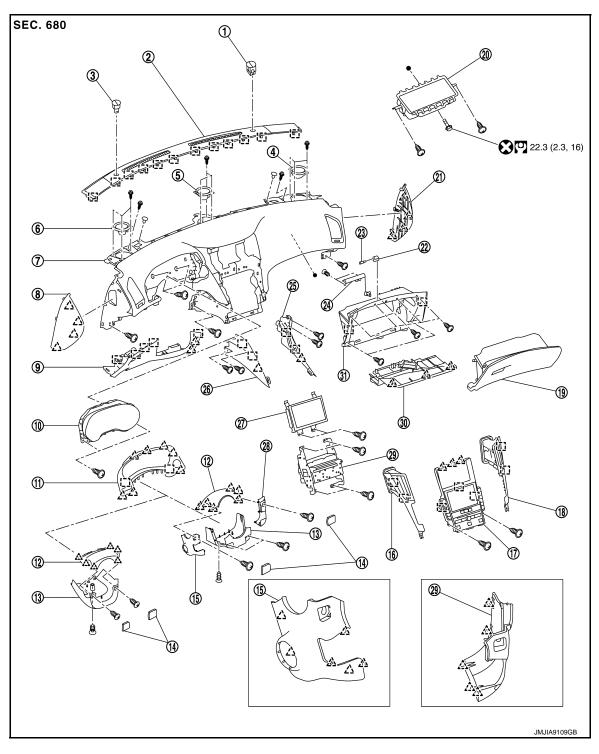
- ① Optical sensor
- (4) Squawker RH (with squawker)
- (7) Instrument panel assembly
- Combination meter
- (2) Front speaker grille
- (5) Center squawker (with squawker)
- (8) Instrument side finisher LH
- ① Cluster lid A

- ③ Sunload sensor
- 6 Squawker LH (with squawker)
- (9) Instrument lower panel LH
- (12) Steering column upper cover

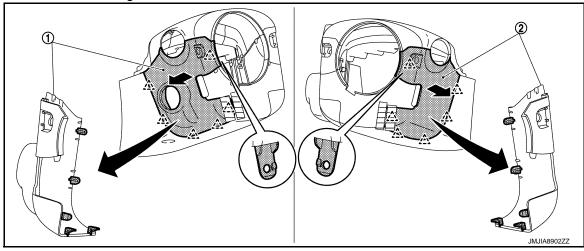
- JMJIAB900ZZ
- MJAB901ZZ
- Disengage pawls of steering column cover LH ① and steering column cover RH ② using a flat-bladed screwdriver.
- Pull up steering column upper cover, and remove steering column cover LH and steering column cover RH as shown in the figure.

2 : Pawl

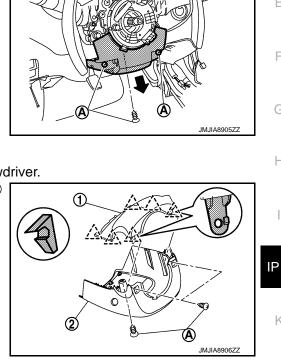
∠____: Pawl

Cover steering shaft with a shop cloth to prevent damage. a.

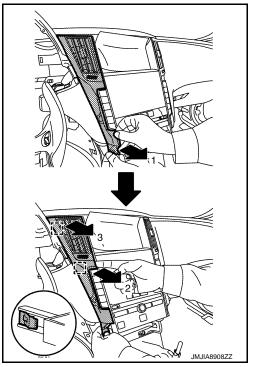
- 13. Remove combination meter. Refer to MWI-126, "Removal and Installation".
- 14. Remove instrument finisher C and D.
- a. Pull back instrument finisher, and then disengage the fixing metal clips according to the numerical order $1 \rightarrow 3$ as shown in the figure.
 - [] : Metal clip

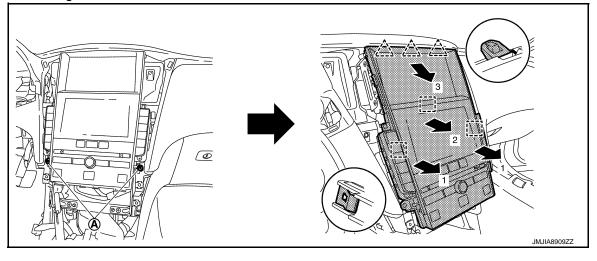
15. Remove integral switch.

- <u>^</u>:Pawl
- [] : Metal clip
- a. Remove fixing screw (A).

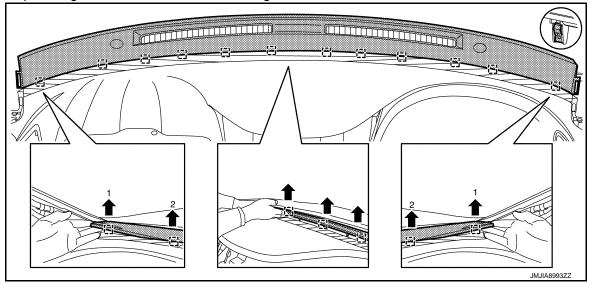
b. Disengage front speaker grille fixing metal clips starting from both sides and work toward the center of the front speaker grille as 1→2 as shown in the figure.

: Metal clip

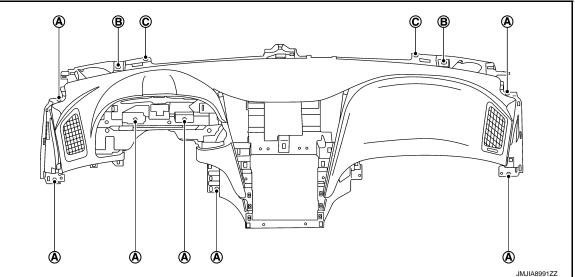
a. Remove instrument panel assembly fixing screws (A), mounting bolt (B) and clip (C).

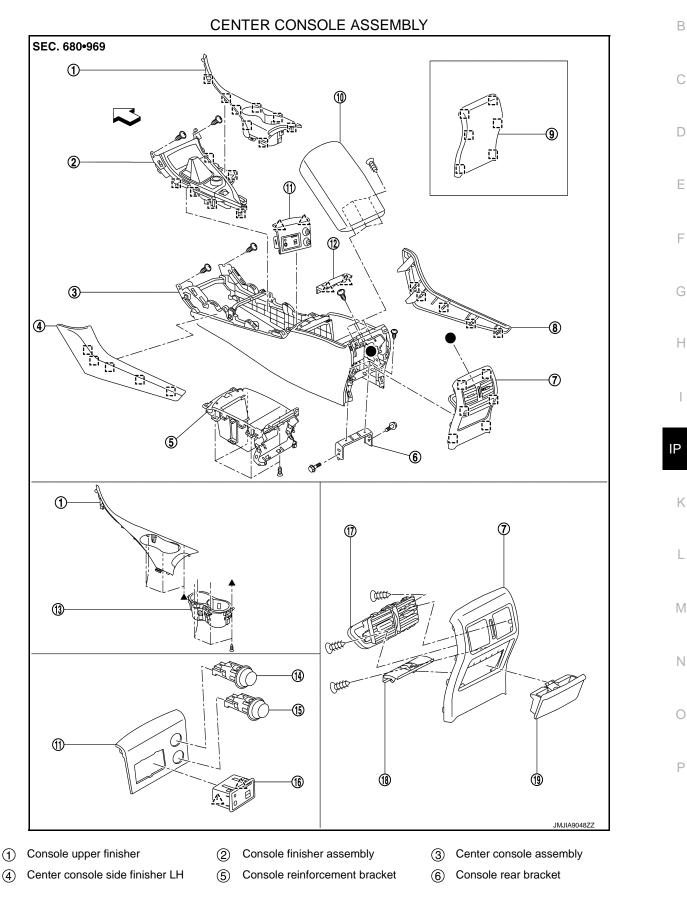
- Console rear finisher assembly \bigcirc (with rear ventilator)
- Console lid assembly 10
- Cup holder assembly (13)
- (16) External data input box
- Rear ventilator grille (19) (with rear ventilator)
- : Pawl Â
- : Metal clip
- : Vehicle front

- Center console side finisher RH (8)
- Center console finisher 1
- (14) Power socket assembly
- (17) Rear ashtray console bracket
- Console rear finisher assembly 9 (without rear ventilator)
- Console mask (12)
- Power socket assembly (15)
- (18) Rear ashtray console
- ullet, llet: Indicates that the part is connected at points with same symbol in actual vehicle.

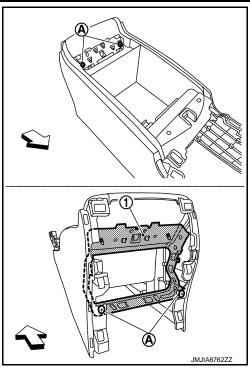
- 2. Remove console reinforcement fixing screws .
