SECTION **BRM**
BODY REPAIR

BODY REPAIR

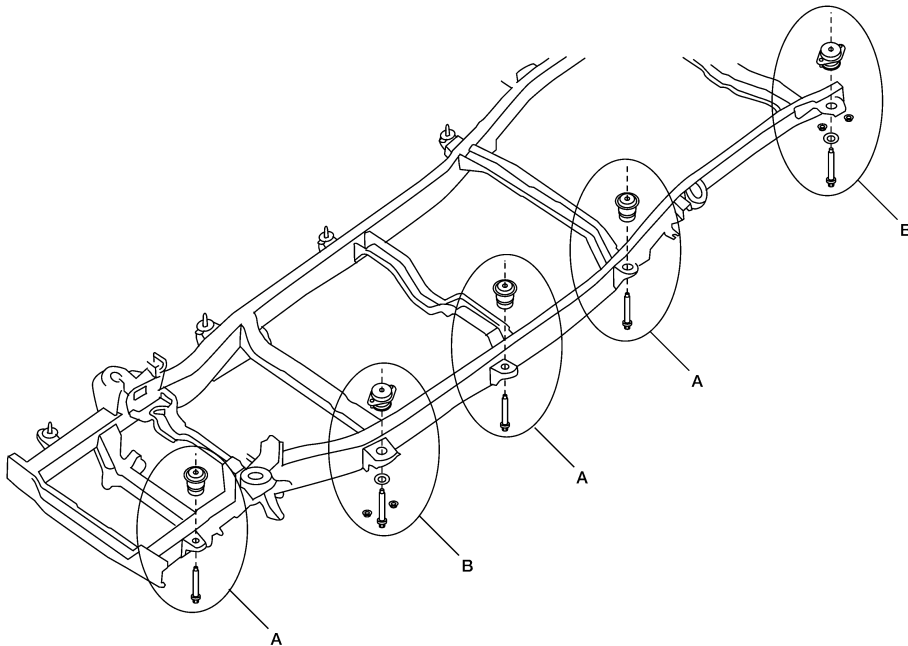
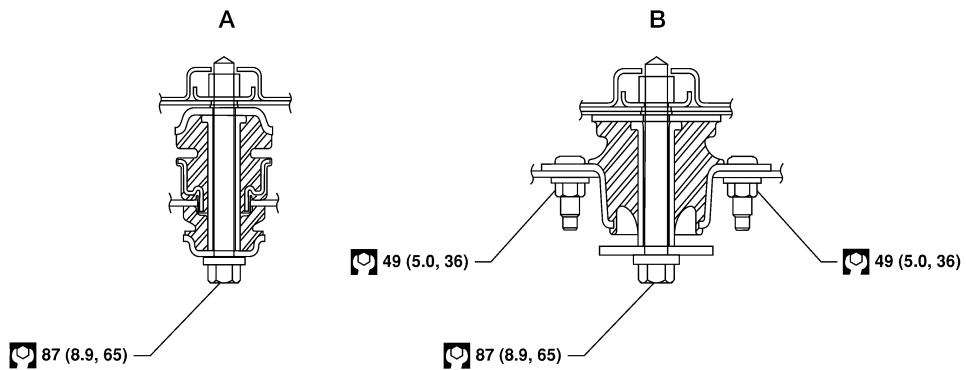
LIIA1564E

When removing, be sure to replace bolts and nuts (sealant applied bolts or self-lock nuts are used for all mounting).

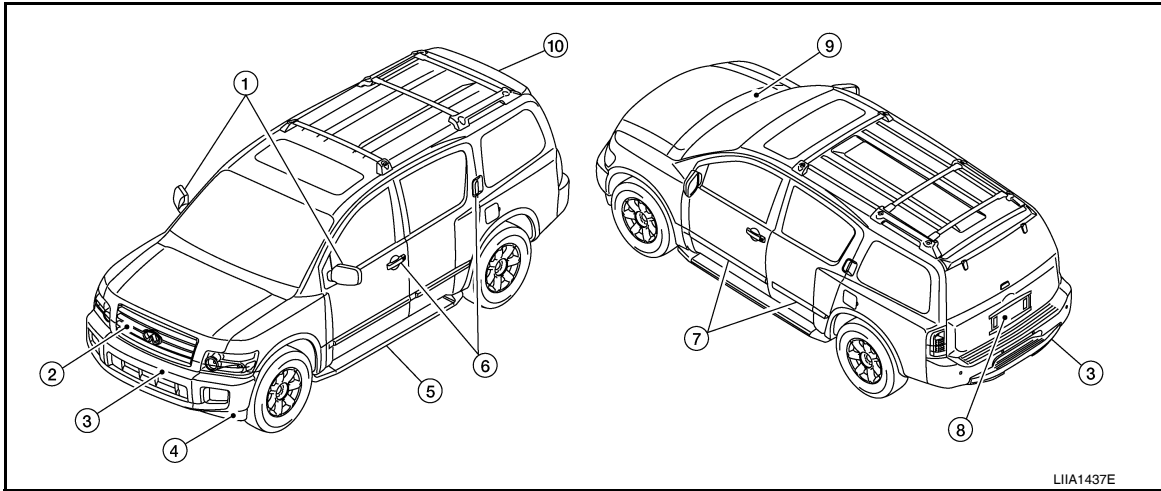
Body Exterior Paint Color

| Component | | | Color code | B30 | K32 | G10 | K11 | K12 | Q11 |
| | | | Description | Lake-shore Slate | Serengeti Sand | Liquid Onyx | Silver Graphite | Silver Indulgence | Tuscan Pearl |

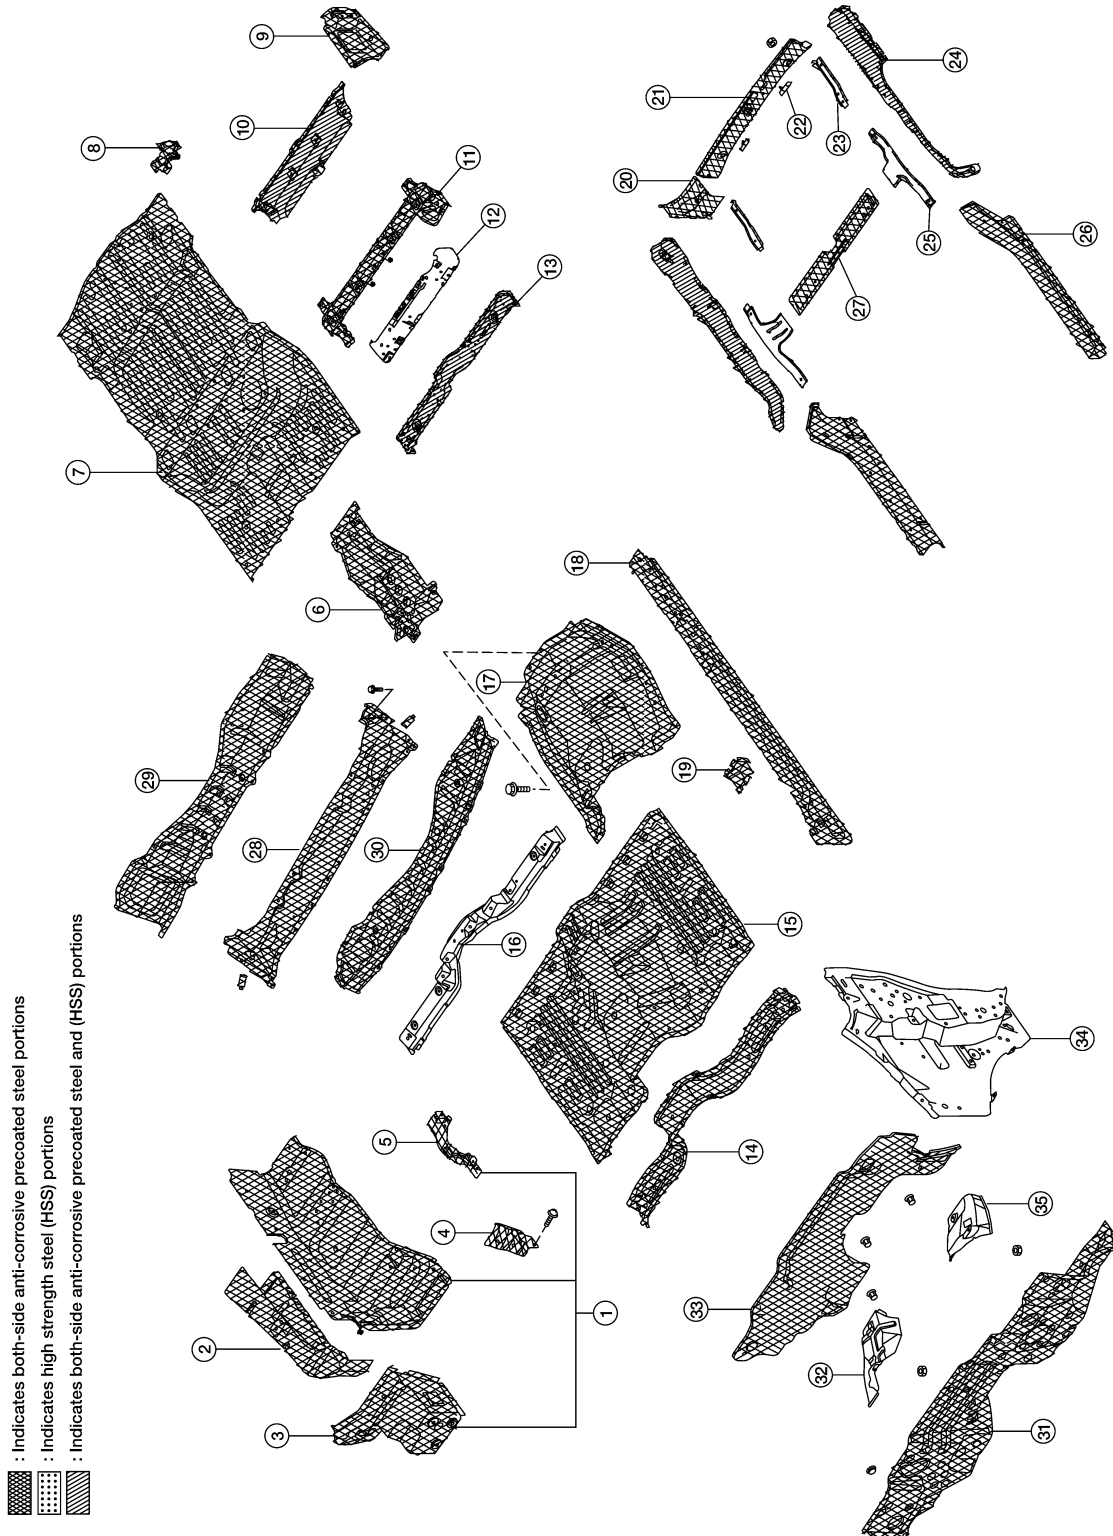
LIA0908E

UNDERBODY COMPONENT PARTS

1. Hoodledge assembly (RH, LH)
2. Hoodledge reinforcement (RH, LH)
3. Body mounting bracket (RH, LH)
4. Hoodledge front brace (RH), Battery mounting bracket (LH)

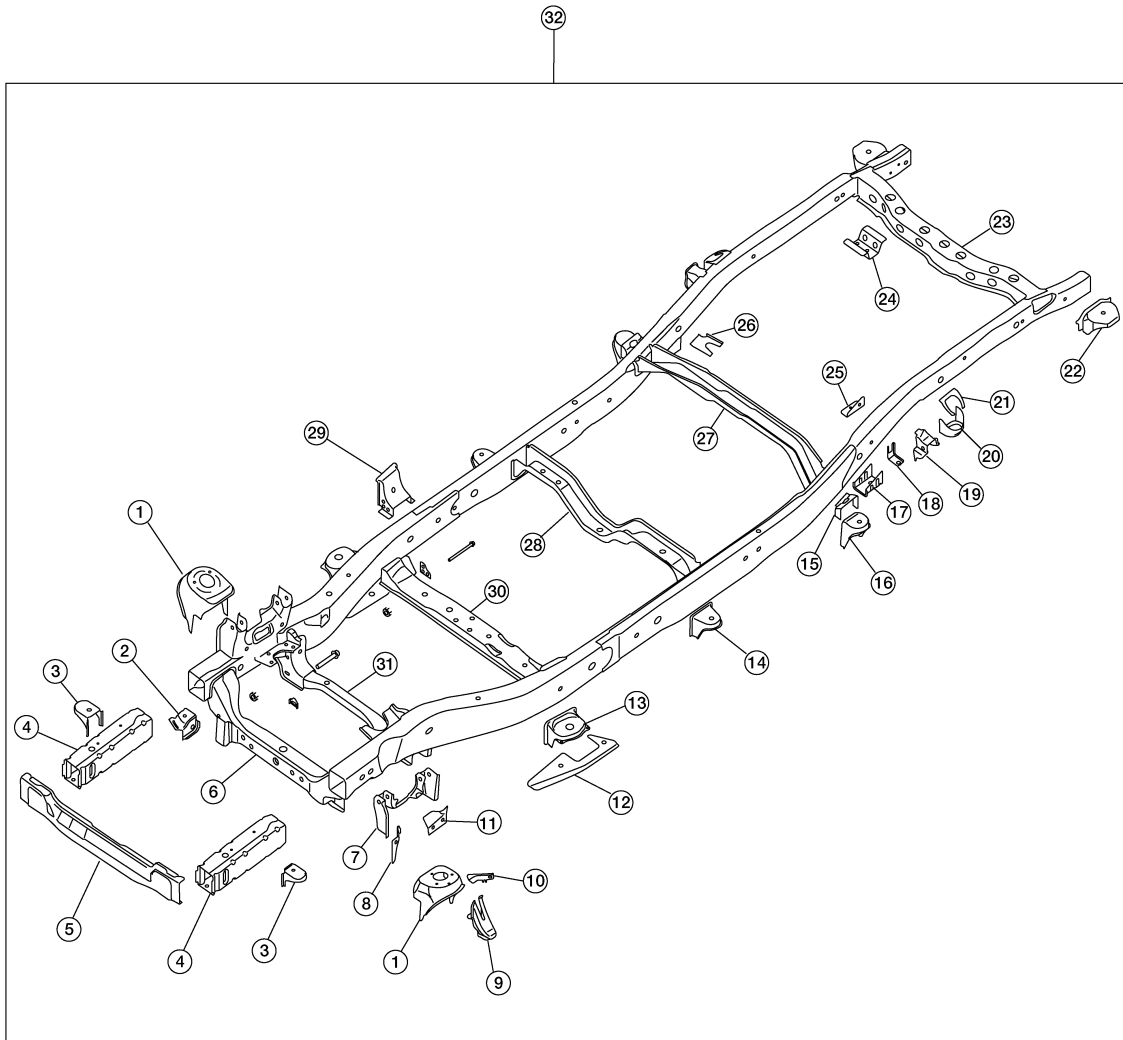
LIIA1594E

< SERVICE INFORMATION > FRAME COMPONENT PARTS

1. Front shock absorber bracket RH/LH
2. Front differential mounting bracket RH/LH
3. 1st cab mounting bracket RH/LH
4. Front side member extension assembly RH/LH
5. 1st crossmember assembly

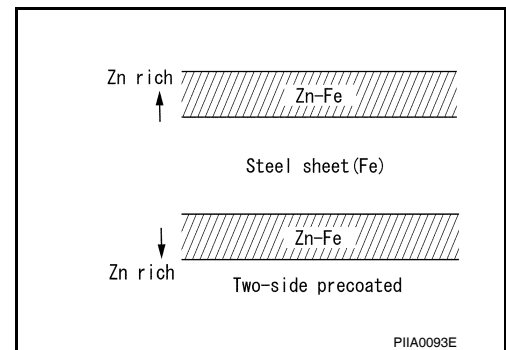
To improve repairability and corrosion resistance, a new type of anti-corrosive pre-coated steel sheet has been adopted replacing conventional zinc-coated steel sheet.

Galvannealed steel is electroplated and heated to form Zinc-iron alloy, which provides excellent and long term corrosion resistance with cationic electrode position primer.

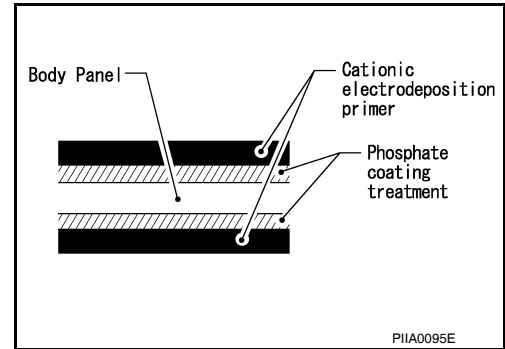
A phosphate coating treatment and a cationic electrodeposition primer, which provide excellent corrosion protection, are employed on all body components.

Confine paint removal during welding operations to an absolute minimum.

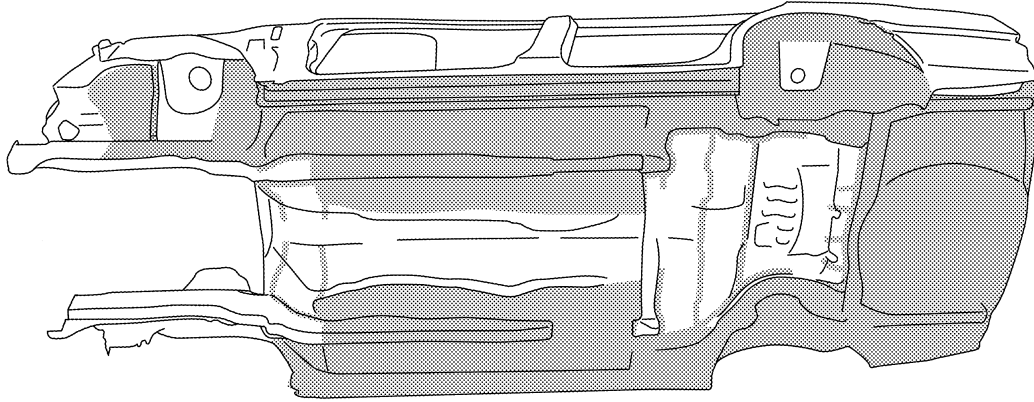
LIA0129E

The underside of the floor and wheelhouse are undercoated to prevent rust, vibration, noise and stone chipping. Therefore, when such a panel is replaced or repaired, apply undercoating to that part. Use an undercoating which is rust preventive, soundproof, vibration-proof, shock-resistant, adhesive, and durable.

: Indicates undercoated portions.

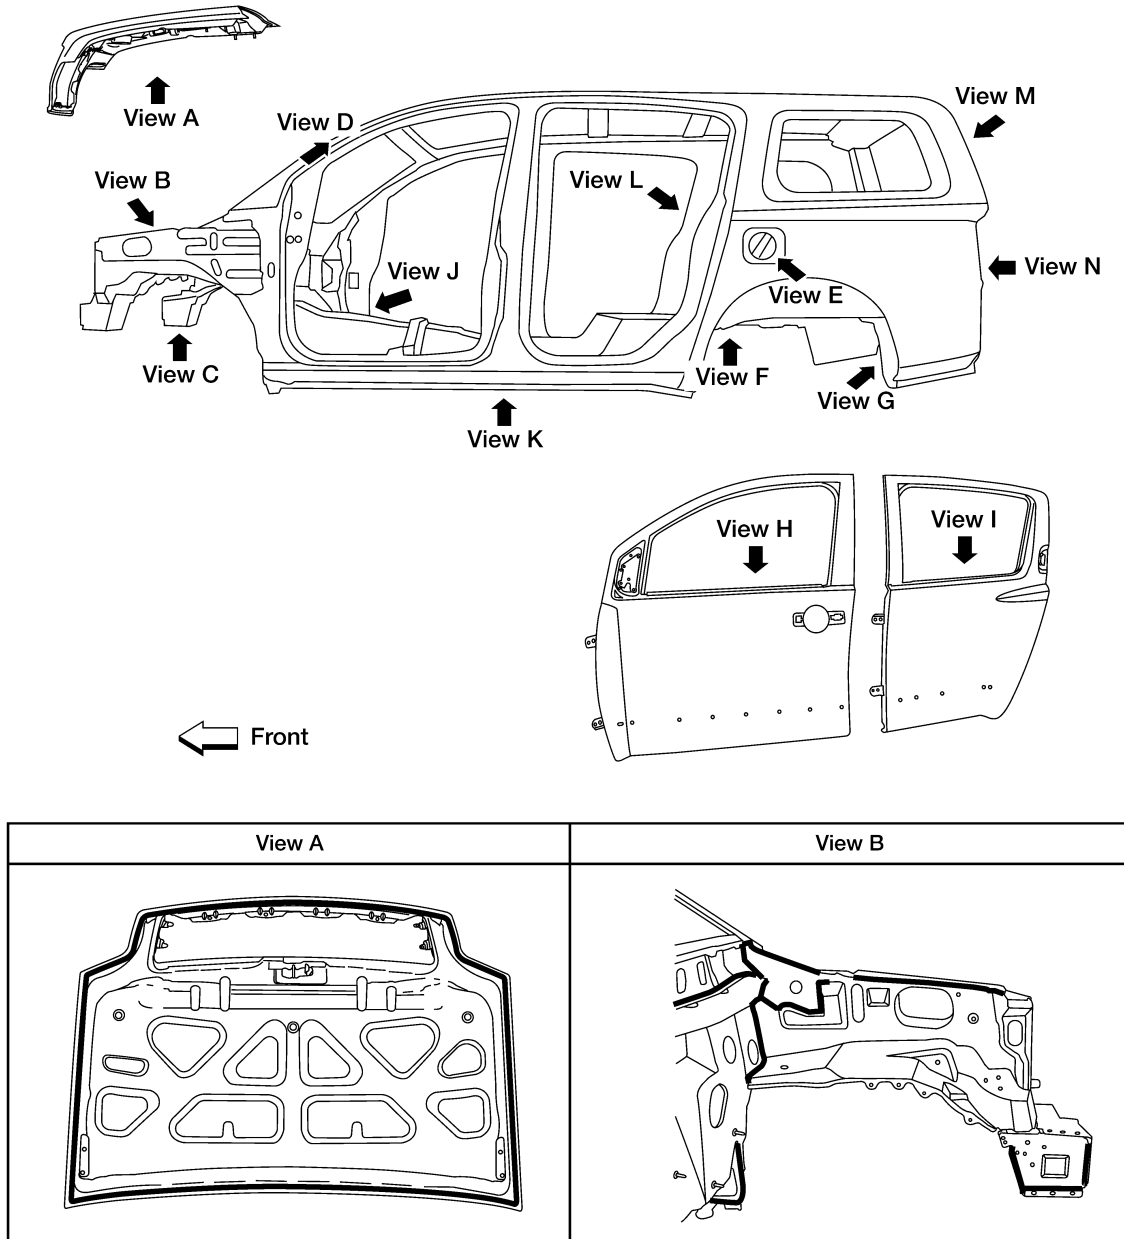
LIIA1439E

The following figure shows the areas which are sealed at the factory. Sealant which has been applied to these areas should be smooth and free from cuts or gaps. Care should be taken not to apply an excess amount of sealant and not to allow other unaffected parts to come into contact with the sealant.

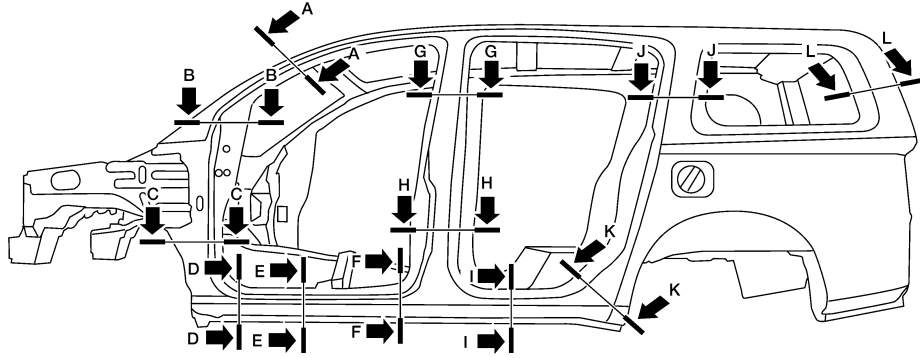
LIIA1113E

BODY CONSTRUCTION

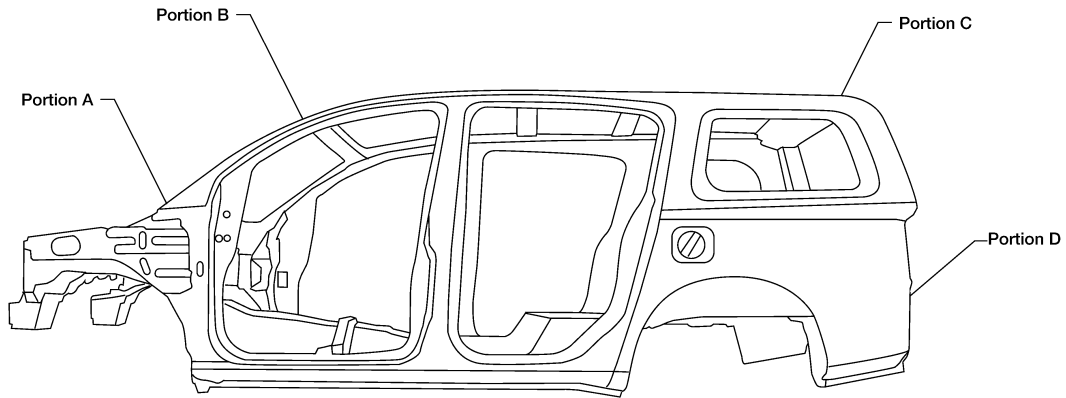
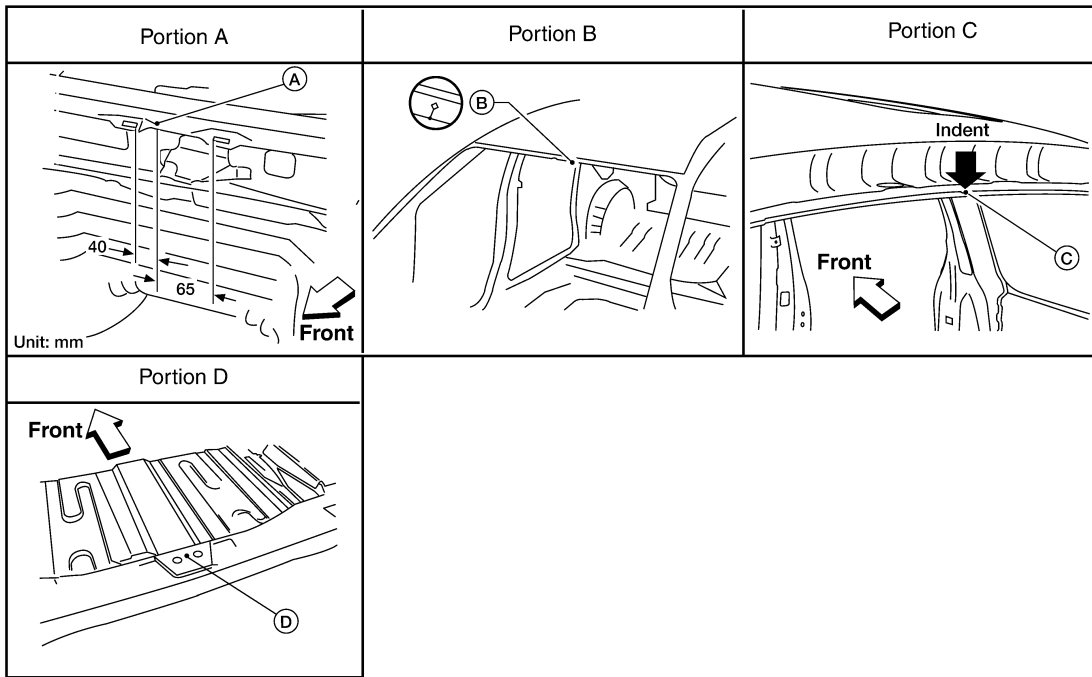
LIIA1440E

A mark has been placed on each part of the body to indicate the vehicle center. When repairing parts damaged by an accident which might affect the vehicle frame (members, pillars, etc.), more accurate and effective repair will be possible by using these marks together with body alignment specifications.

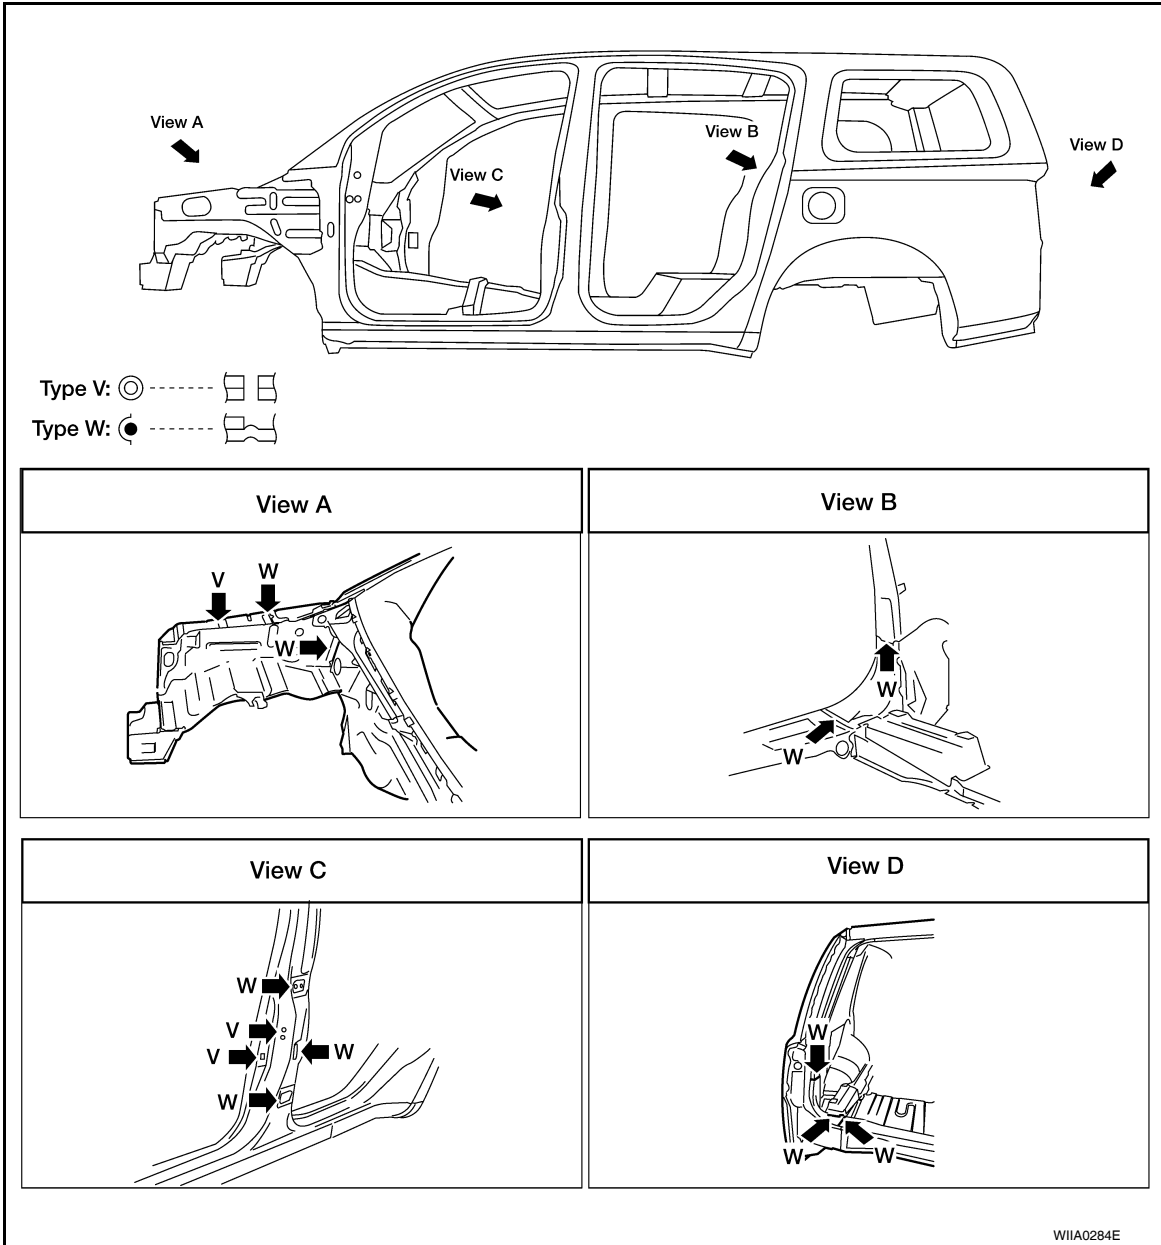
A mark has been placed on each body panel to indicate the parts matching positions. When repairing parts damaged by an accident which might affect the vehicle structure (members, pillars, etc.), more accurate and effective repair will be possible by using these marks together with body alignment specifications.

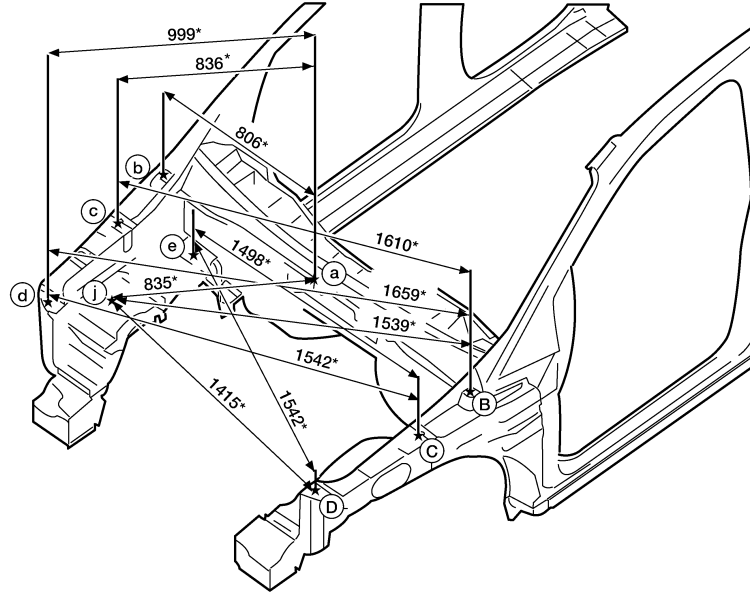
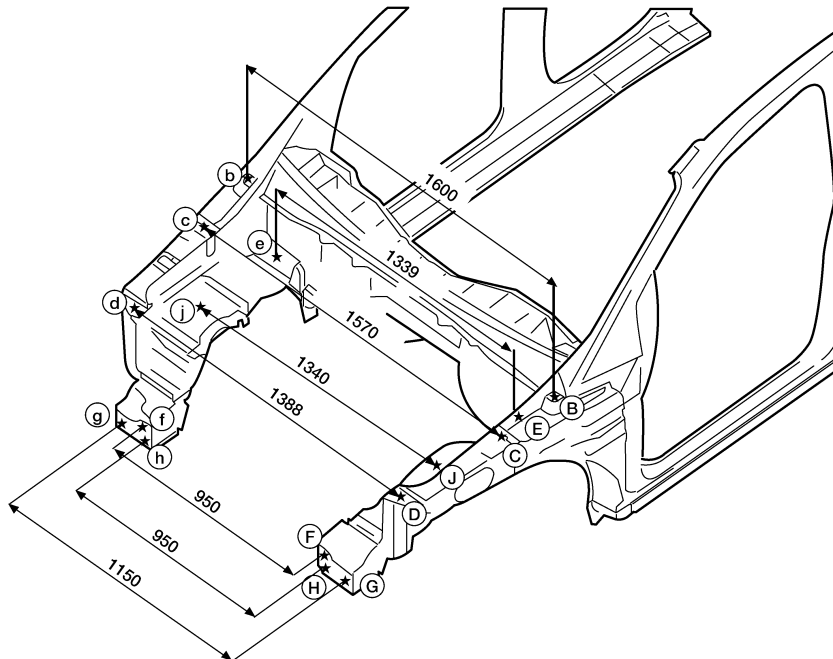
AWI1A1088GB

Figures marked with a (*) indicate symmetrically identical dimensions on both right and left hand sides of the vehicle.

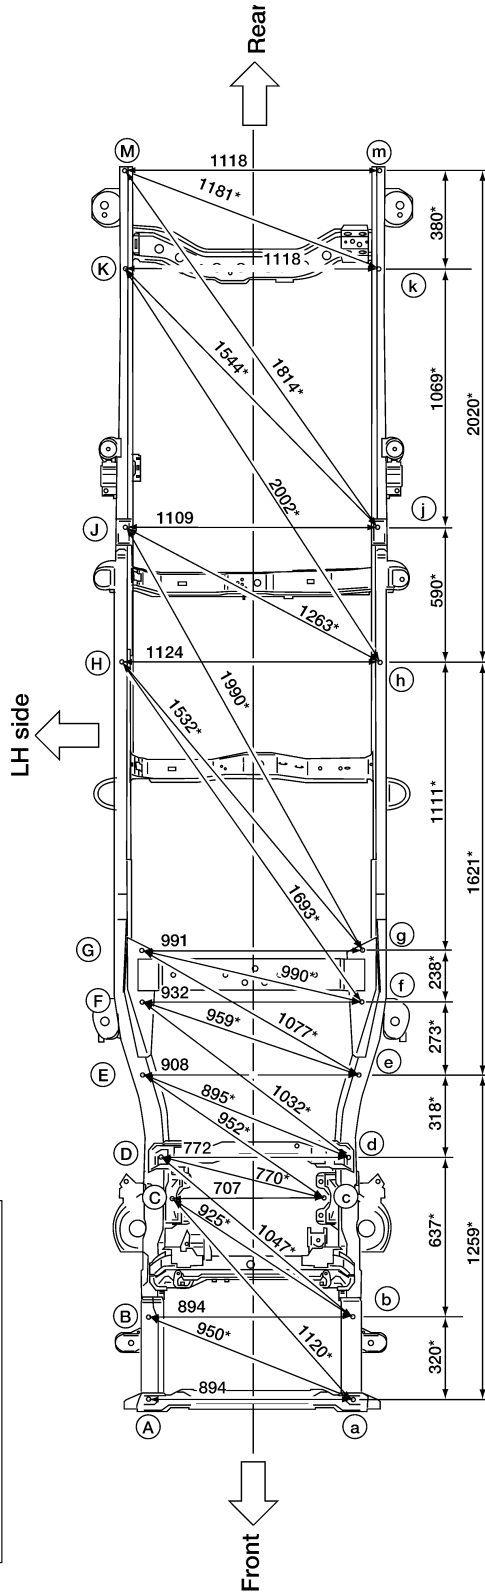
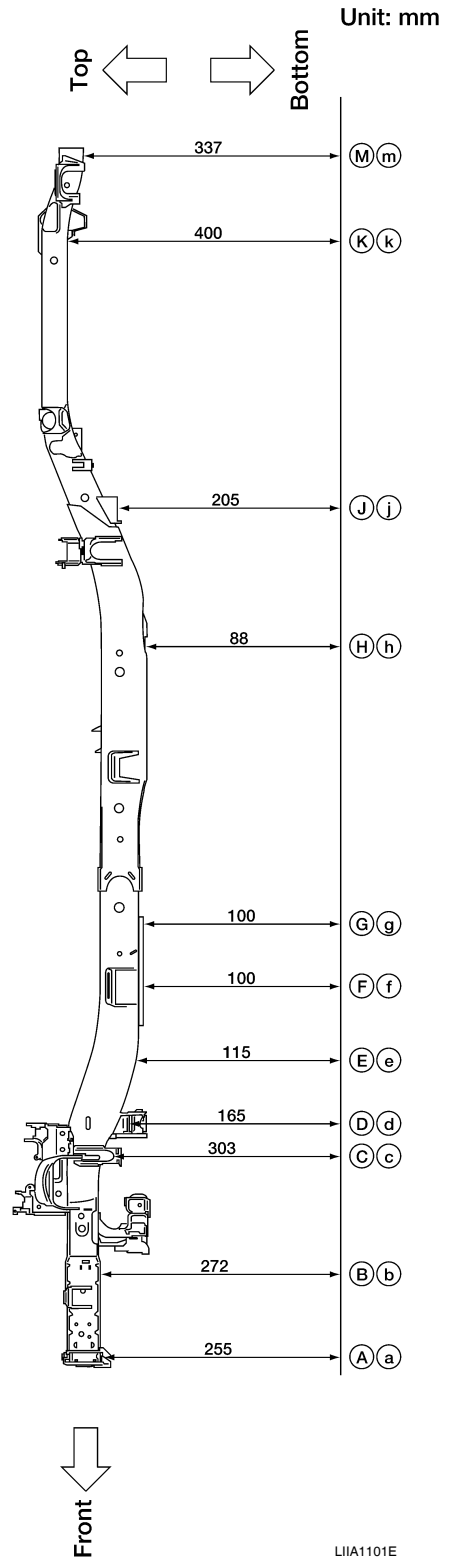
LIA1101E

Figures marked with a (*) indicate symmetrically identical dimensions on both right and left hand sides of the vehicle.

As viewed from underside.

All dimensions indicated in this figure are actual.

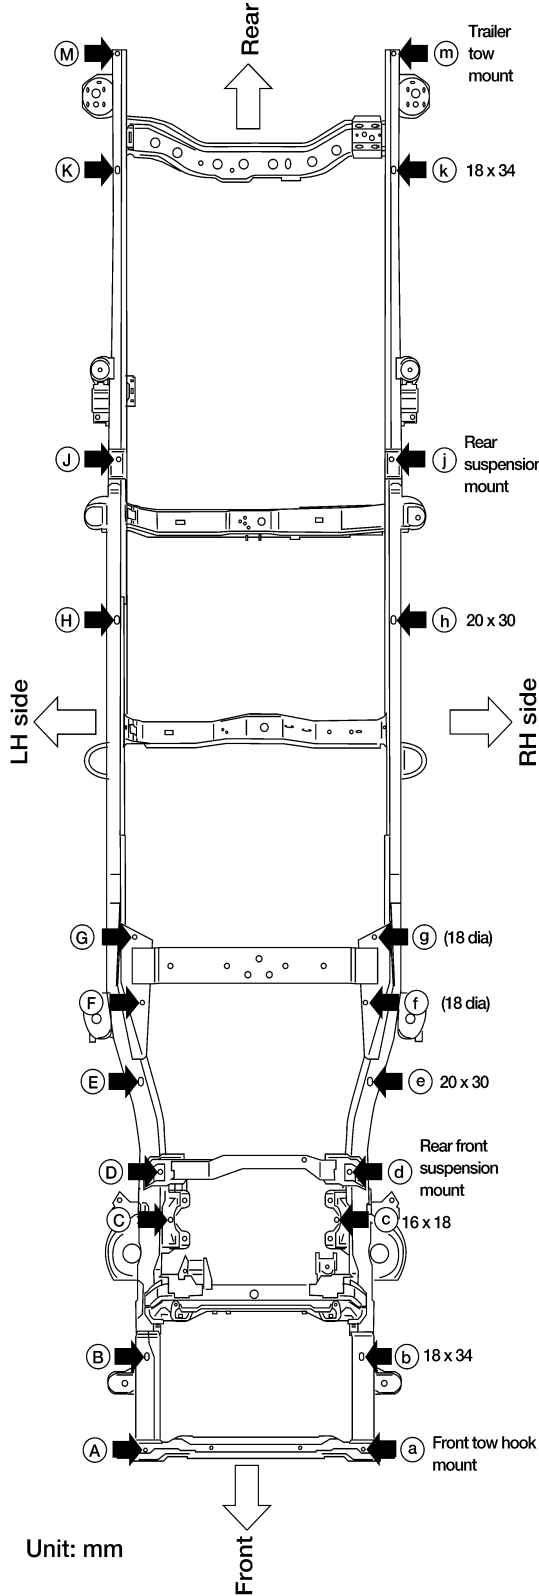
MEASUREMENT POINTS

Coordinates:

- (A, a)
X : ± 447
Y : -747
Z : 255
- (B, b)
X : ± 447
Y : -427
Z : 272
- (C, c)
X : ± 353
Y : 35
Z : 303
- (D, d)
X : ± 386
Y : 198
Z : 165
- (E, e)
X : ± 454
Y : 504
Z : 115
- (F, f)
X : ± 466
Y : 777
Z : 100
- (G, g)
X : ± 495
Y : 1013
Z : 100
- (H, h)
X : ± 562
Y : 2122
Z : 88
- (J, j)
X : ± 555
Y : 2700
Z : 205
- (K, k)
X : ± 559
Y : 3751
Z : 400
- (M, m)
X : ± 559
Y : 4126
Z : 337

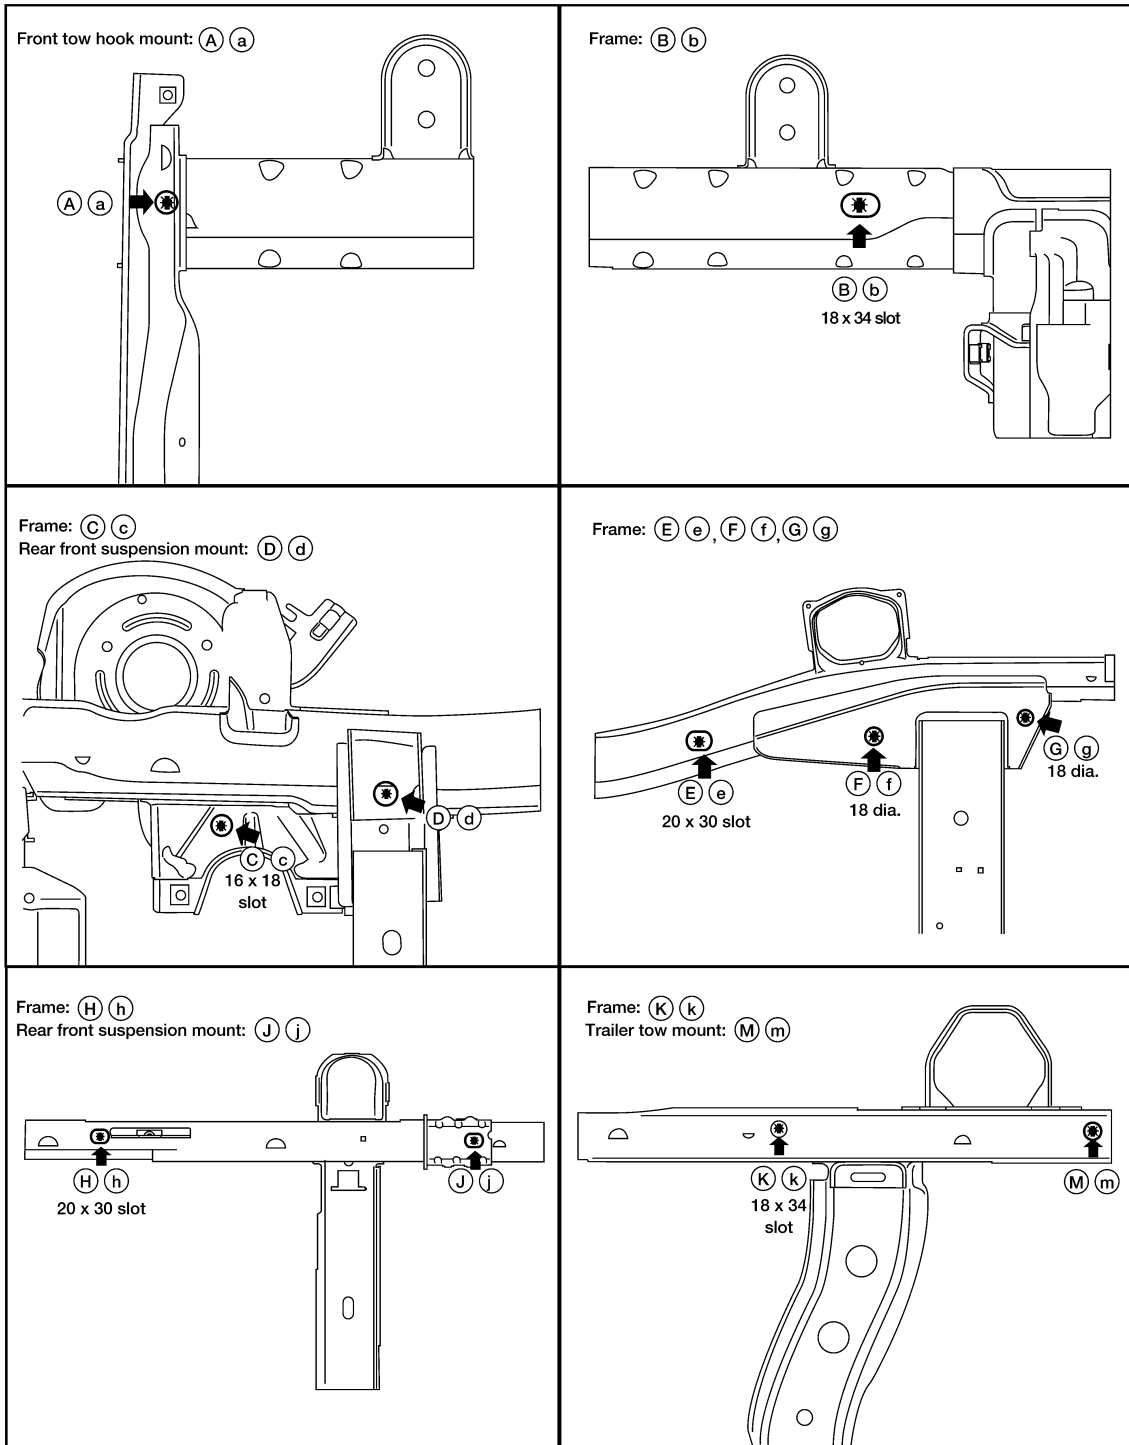
LIIA1509E

| Coordinates: | | (A) a | (B) b | (C) c | (D) d | (E) e | (F) f | (G) g | (H) h | (J) j | (K) k | (M) m |
| X : | ± | 447 | ± 447 | ± 353 | ± 386 | ± 454 | ± 466 | ± 495 | ± 562 | ± 555 | ± 559 | ± 559 |
| Y : | | -747 | -427 | 35 | 198 | 504 | 777 | 1013 | 2122 | 2700 | 3751 | 4126 |
| Z : | | 255 | 272 | 303 | 165 | 115 | 100 | 100 | 88 | 205 | 400 | 337 |

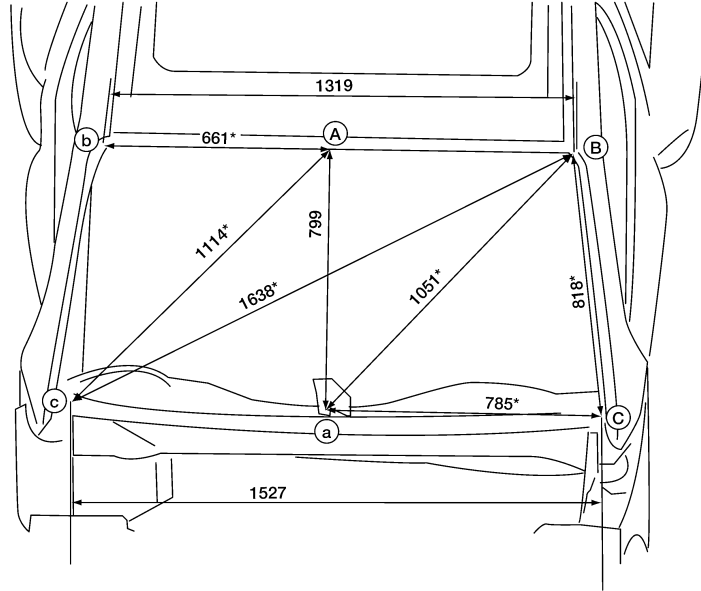
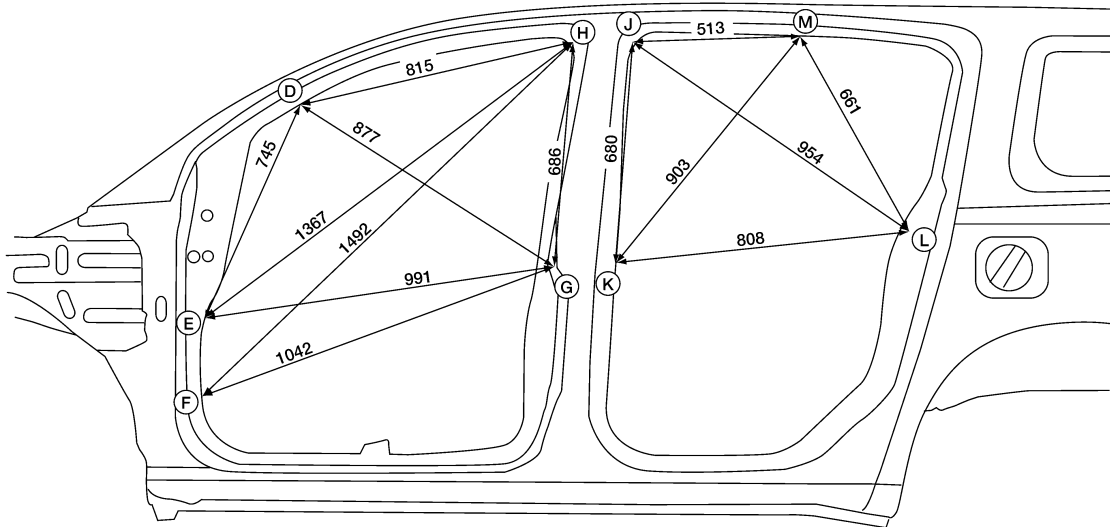
LIIA1510E

Figures marked with a (*) indicate symmetrically identical dimensions on both right and left hand sides of the vehicle.

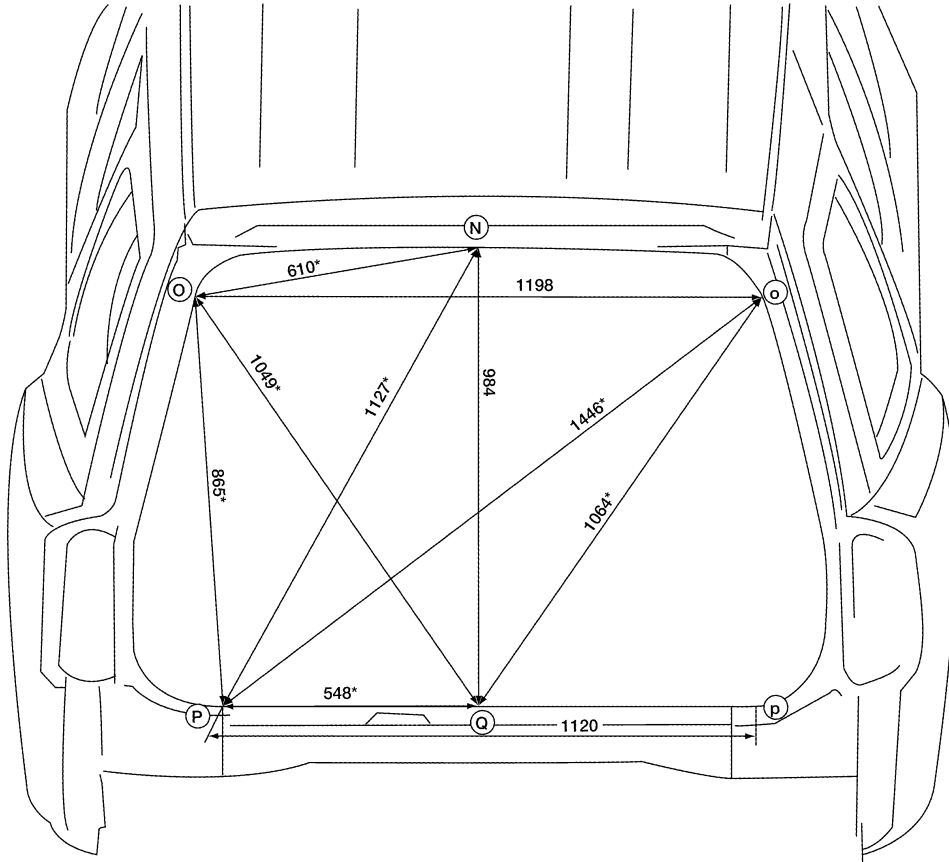
LIA1511E

Figures marked with a (*) indicate symmetrically identical dimensions on both right and left hand sides of the vehicle.

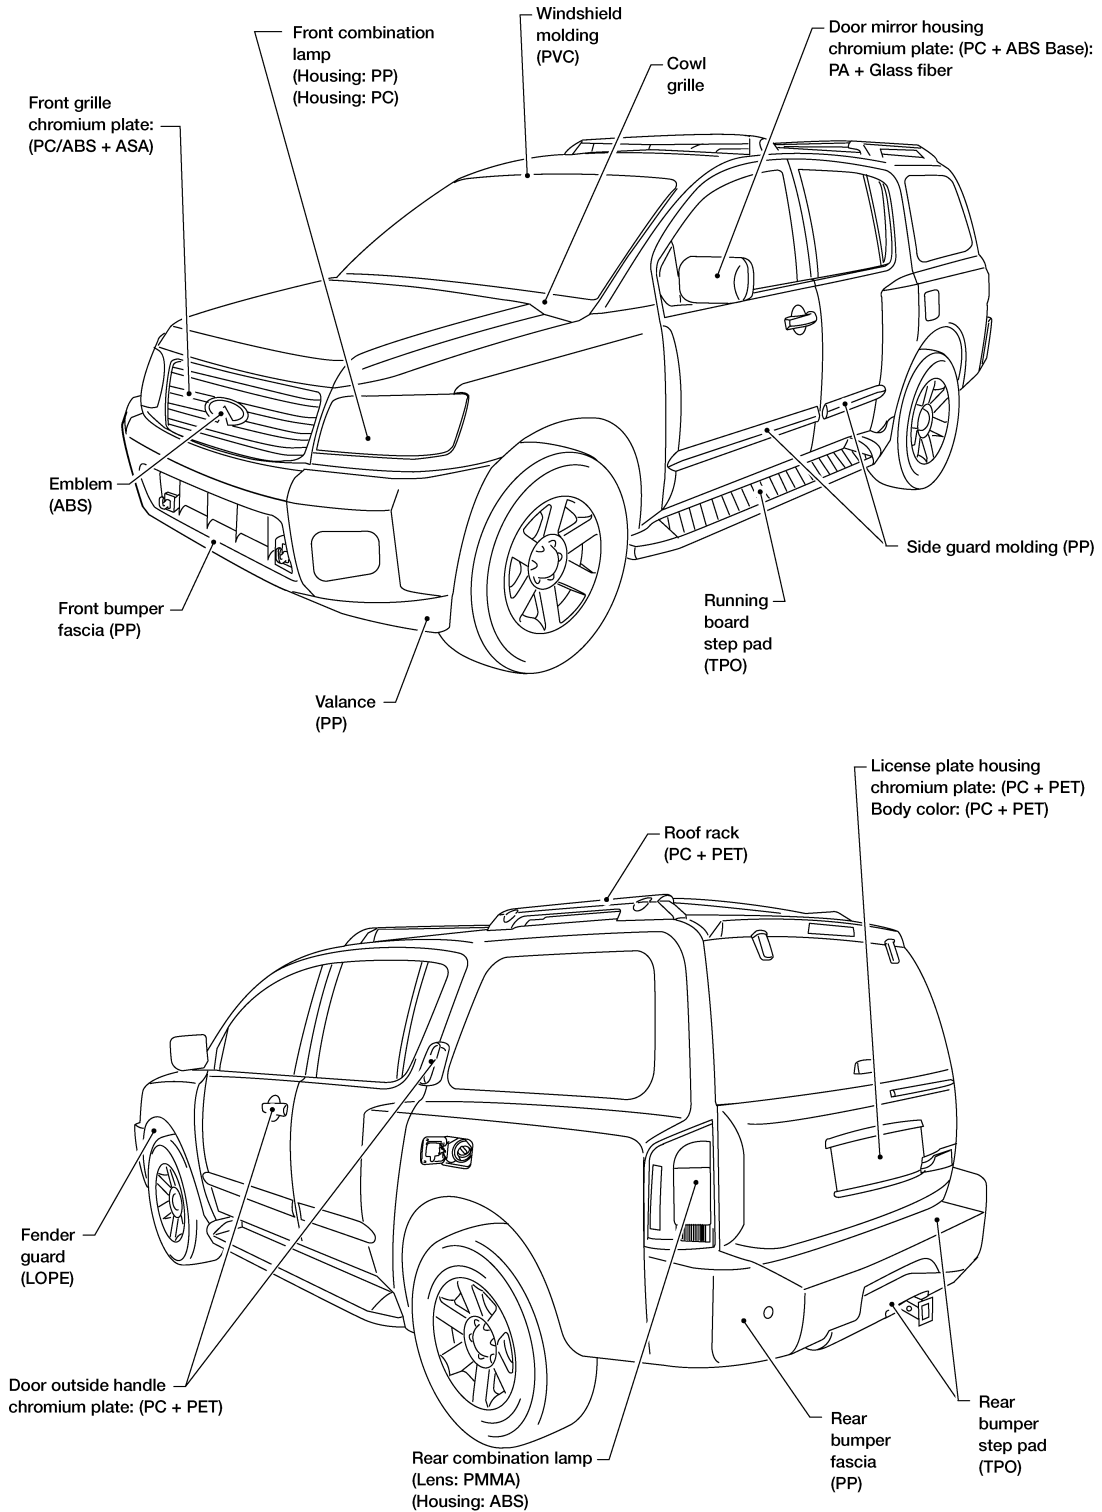
LIIA1441E

LOCATION OF PLASTIC PARTS

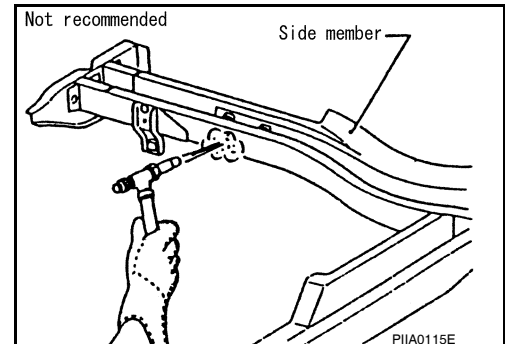
- The repair of reinforcements (such as side members) by heating is not recommended since it may weaken the component. When heating is unavoidable, do not heat HSS parts above 550°C (1,022°F). Verify heating temperature with a thermometer. (Crayon-type and other similar type thermometer are appropriate.)

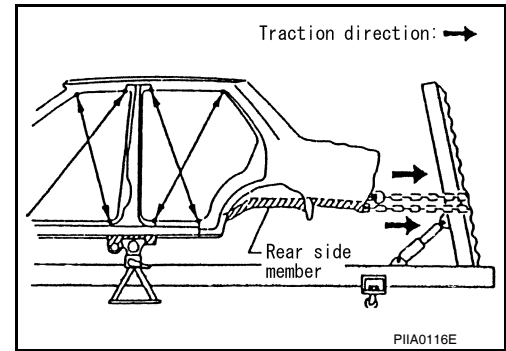
- When straightening body panels, use caution in pulling any HSS panel. Because HSS is very strong, pulling may cause deformation in adjacent portions of the body. In this case, increase the number of measuring points, and carefully pull the HSS panel.

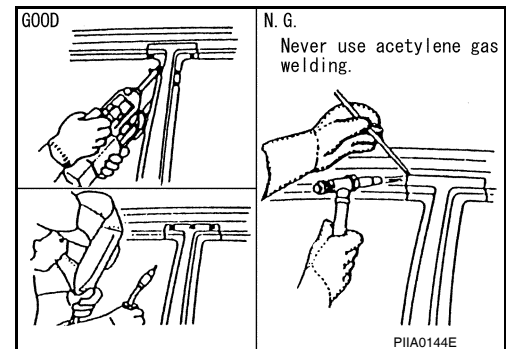
- When welding HSS panels, use spot welding whenever possible in order to minimize weakening surrounding areas due to heat. If spot welding is impossible, use M.I.G. welding. Do not use gas (torch) welding because it is inferior in welding strength.

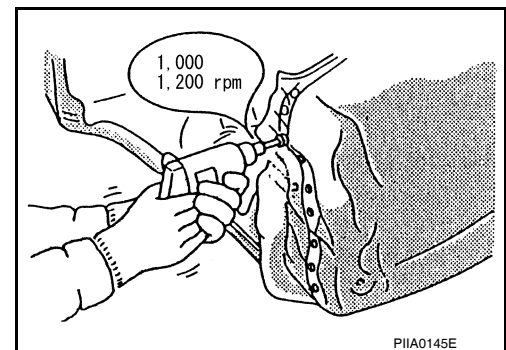
- The spot weld on HSS panels is harder than that of an ordinary steel panel. Therefore, when cutting spot welds on a HSS panel, use a low speed high torque drill (1,000 to 1,200 rpm) to increase drill bit durability and facilitate the operation.
- SP150 HSS panels with a tensile strength of 785 to 981 N/mm² (80 to 100 kg/mm², 114 to 142 klb/sq in), used as reinforcement in the door guard beams, is too strong to repair. When these HSS parts are damaged, the outer panels also sustain substantial damage; therefore, the assembly parts must be replaced.

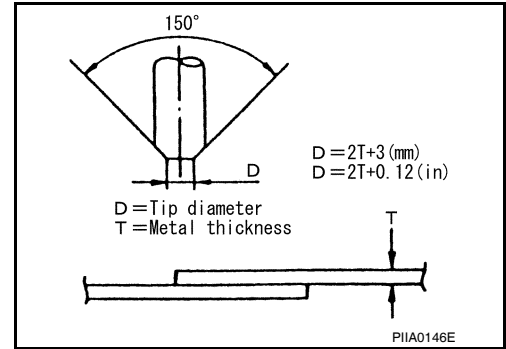
- The electrode tip diameter must be sized properly according to the metal thickness.

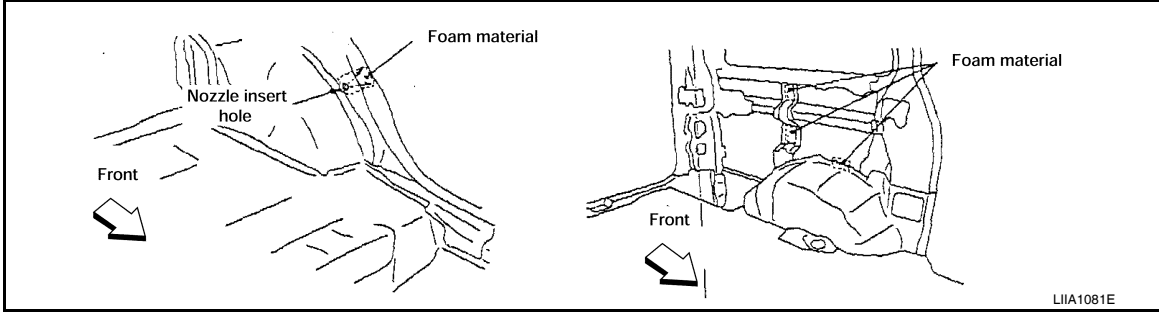
- Insert nozzle into hole near fill area and fill foam material or fill in enough to close gap with the service part.

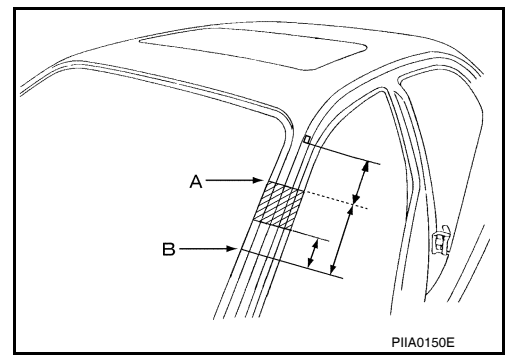
- Front pillar butt joint can be determined anywhere within shaded area as shown in the figure. The best location for the butt joint is at position A due to the construction of the vehicle. Refer to the front pillar section.

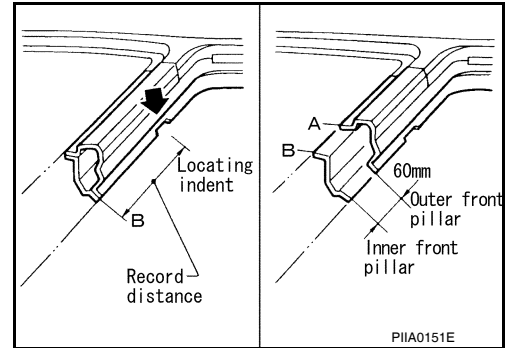
- Determine cutting position and record distance from the locating indent. Use this distance when cutting the service part. Cut outer front pillar over 60 mm above inner front pillar cut position.

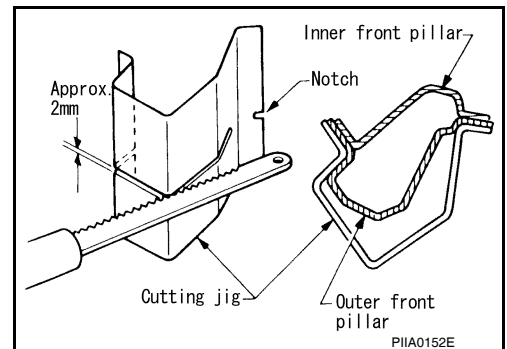
- Prepare a cutting jig to make outer pillar easier to cut. Also, this will permit service part to be accurately cut at joint position.

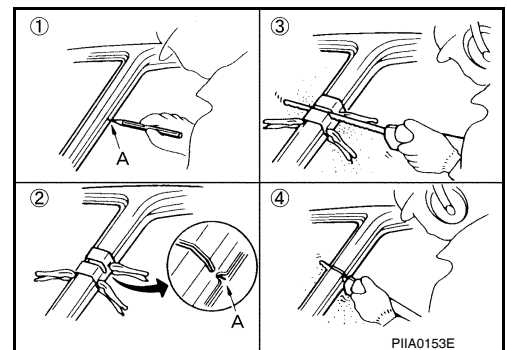
- An example of cutting operation using a cutting jig is as follows.

1. Mark cutting lines.
A: Cut position of outer pillar
B: Cut position of inner pillar
2. Align cutting line with notch on jig. Clamp jig to pillar.
3. Cut outer pillar along groove of jig. (At position A)
4. Remove jig and cut remaining portions.
5. Cut inner pillar at position B in same manner.

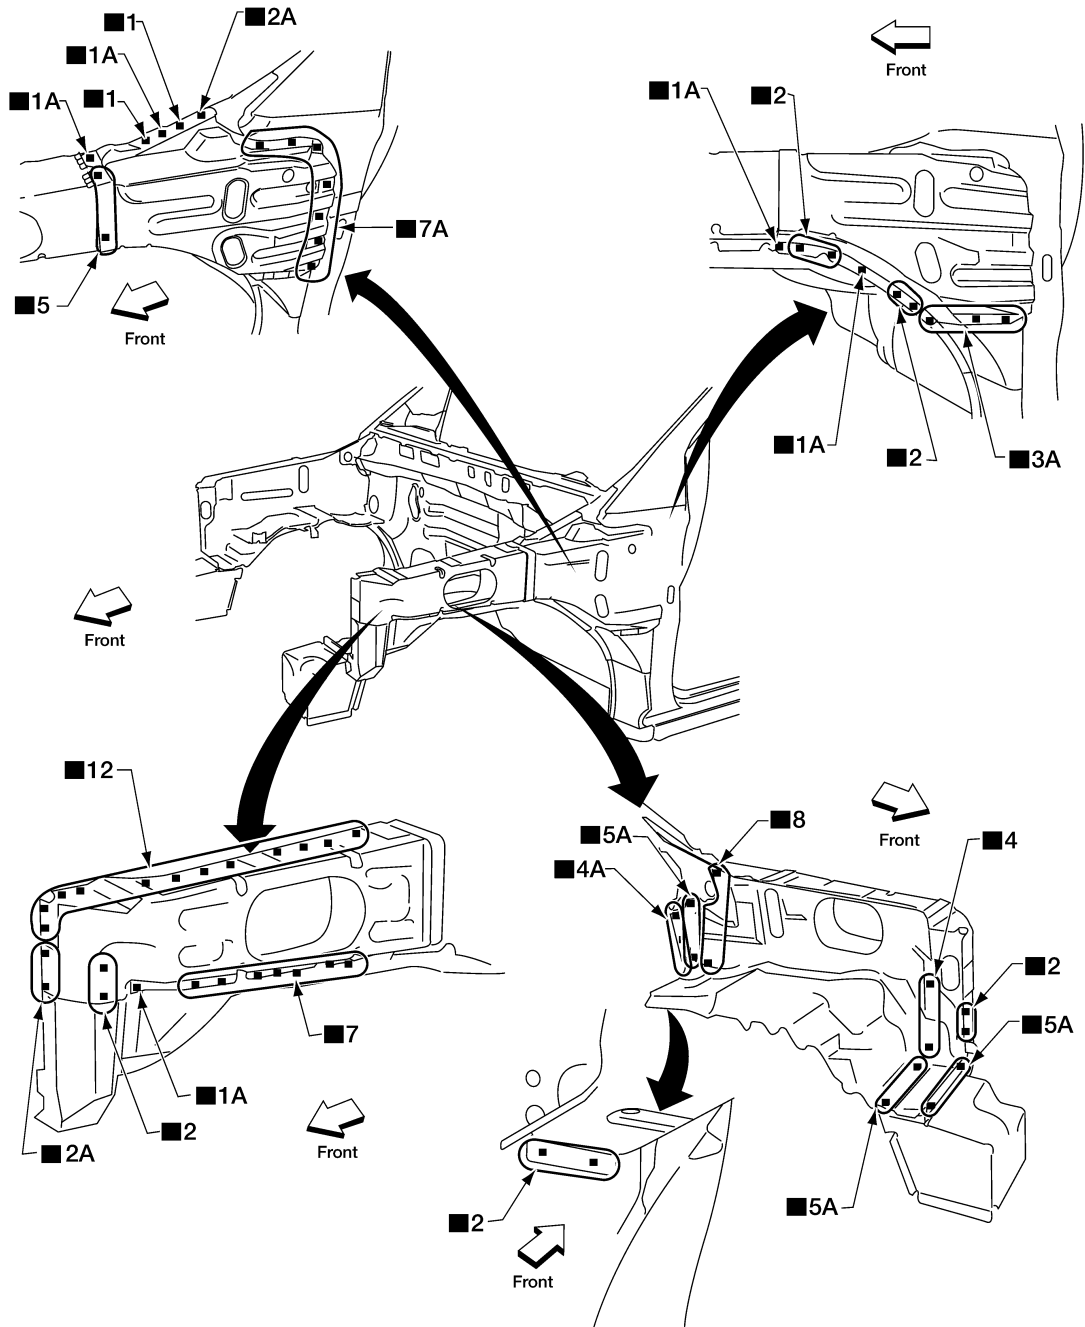
- Work after radiator core support has been removed.

Service Joint
