SECTION **BRM**
BODY REPAIR

BODY REPAIR

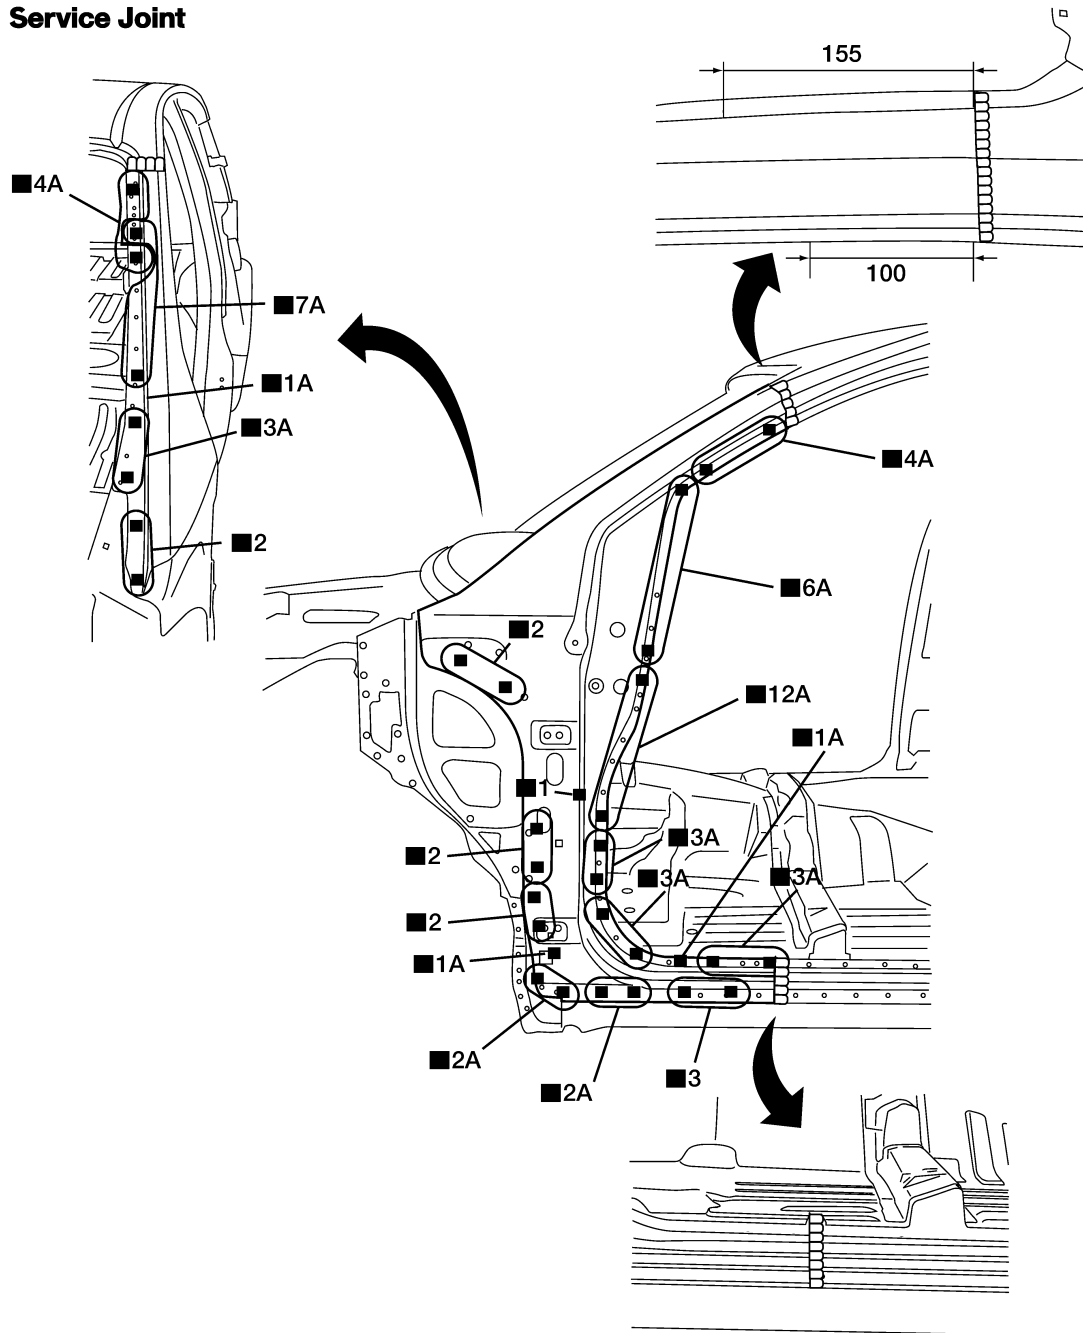
- Work after rear hoodledge reinforcement has been removed.

Service Joint

2-spot welds

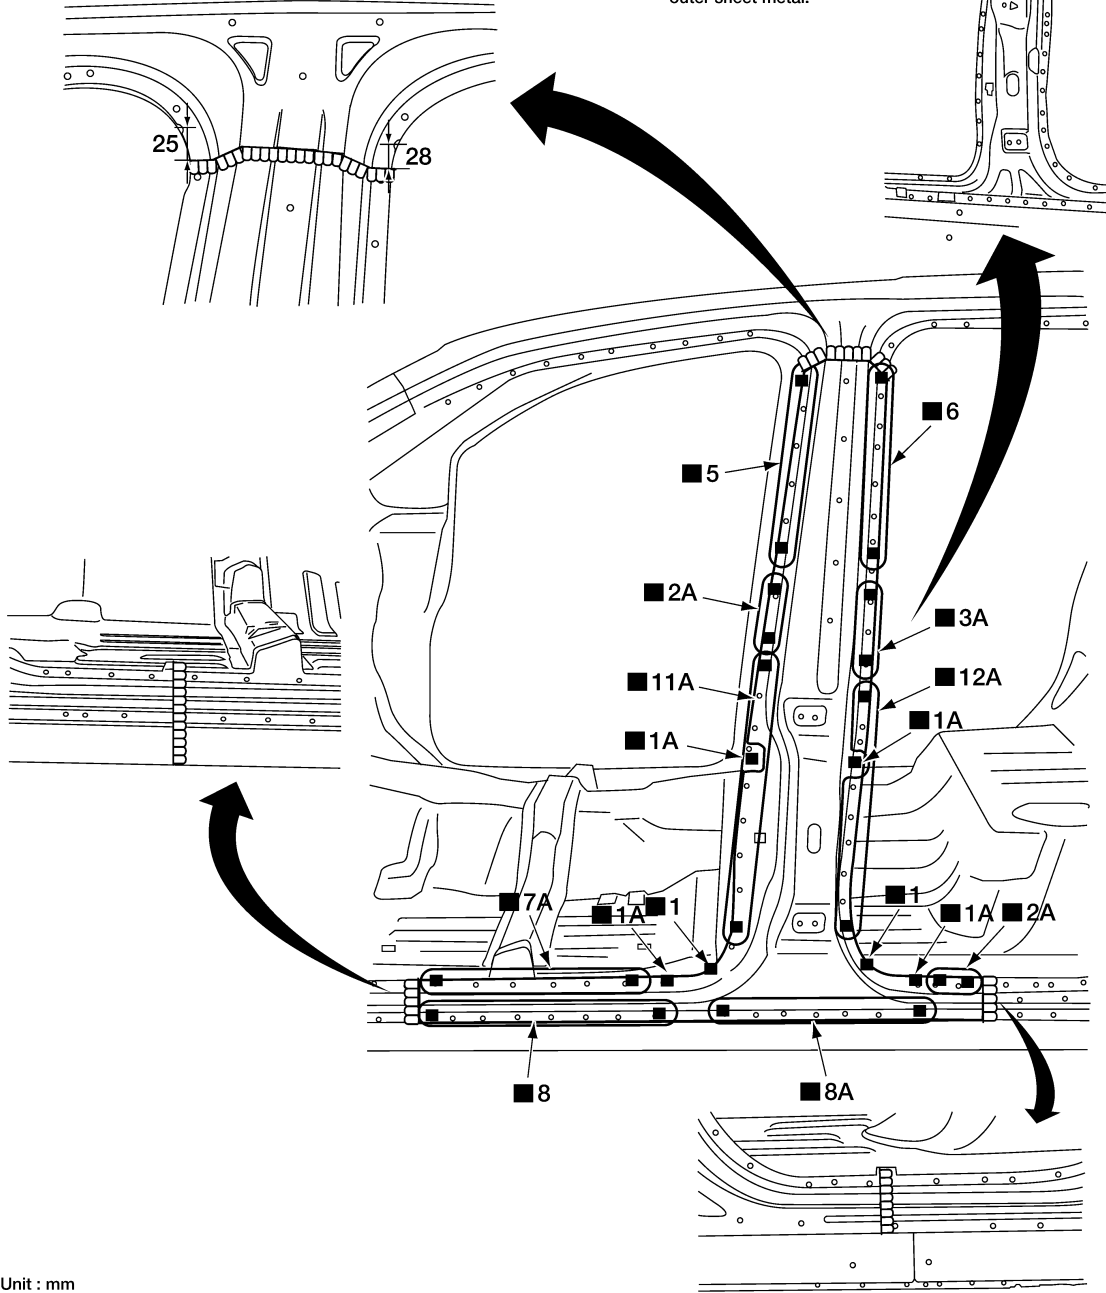
Service Joint

* Reinforcement is retained with the same welds as the b-pillar outer sheet metal.

Unit : mm

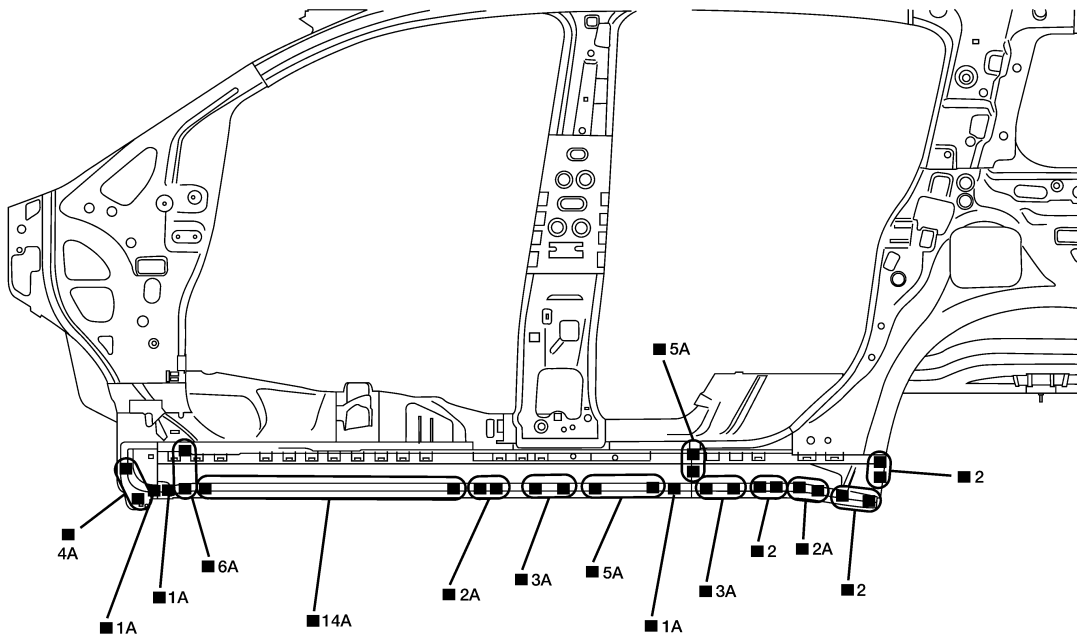
OUTER SILL

Service Joint

2-spot welds

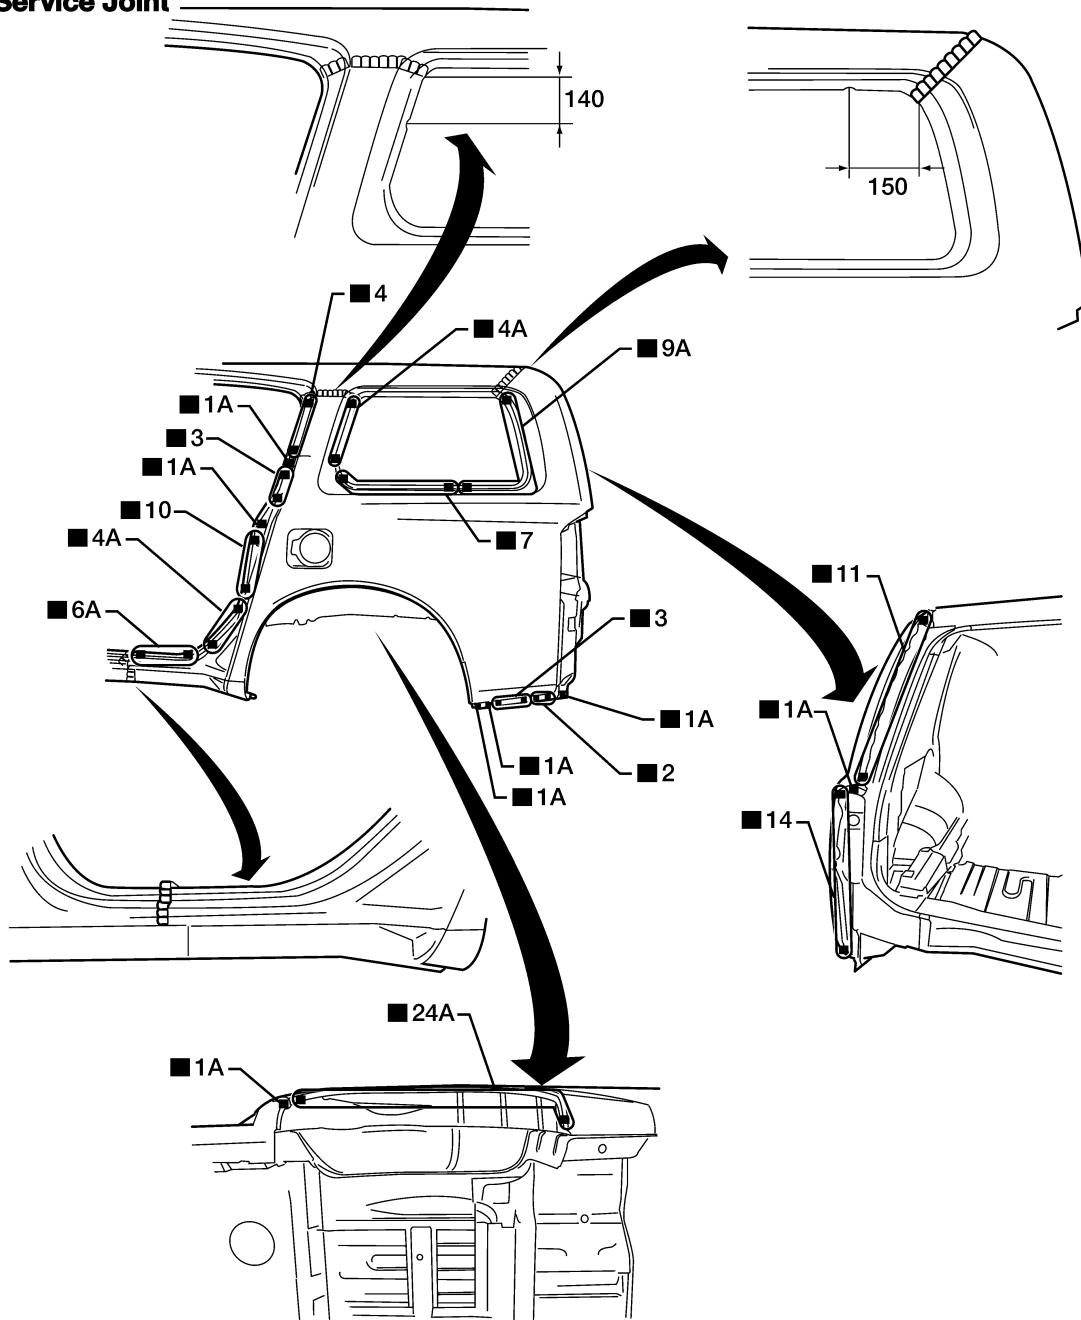
REAR FENDER

Service Joint

2-spot welds

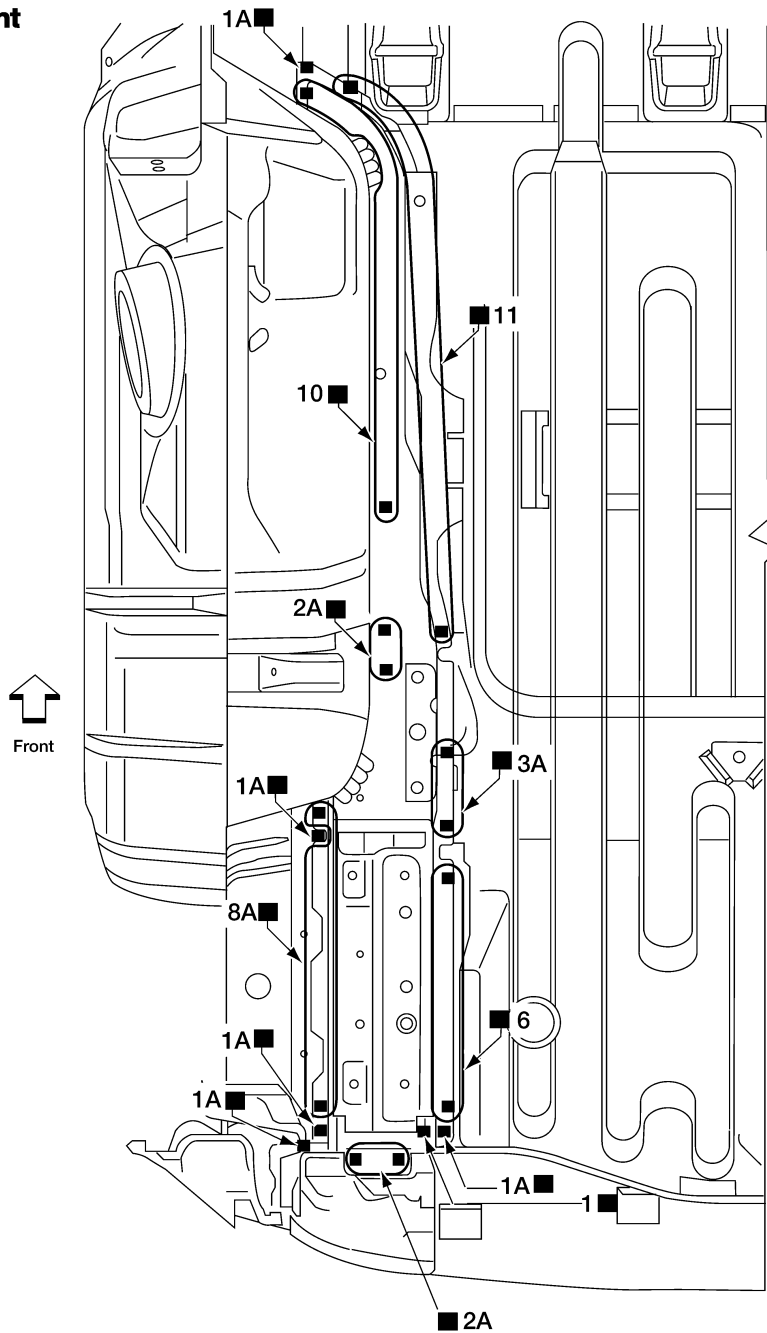
REAR SIDE MEMBER

Service Joint

2-spot welds

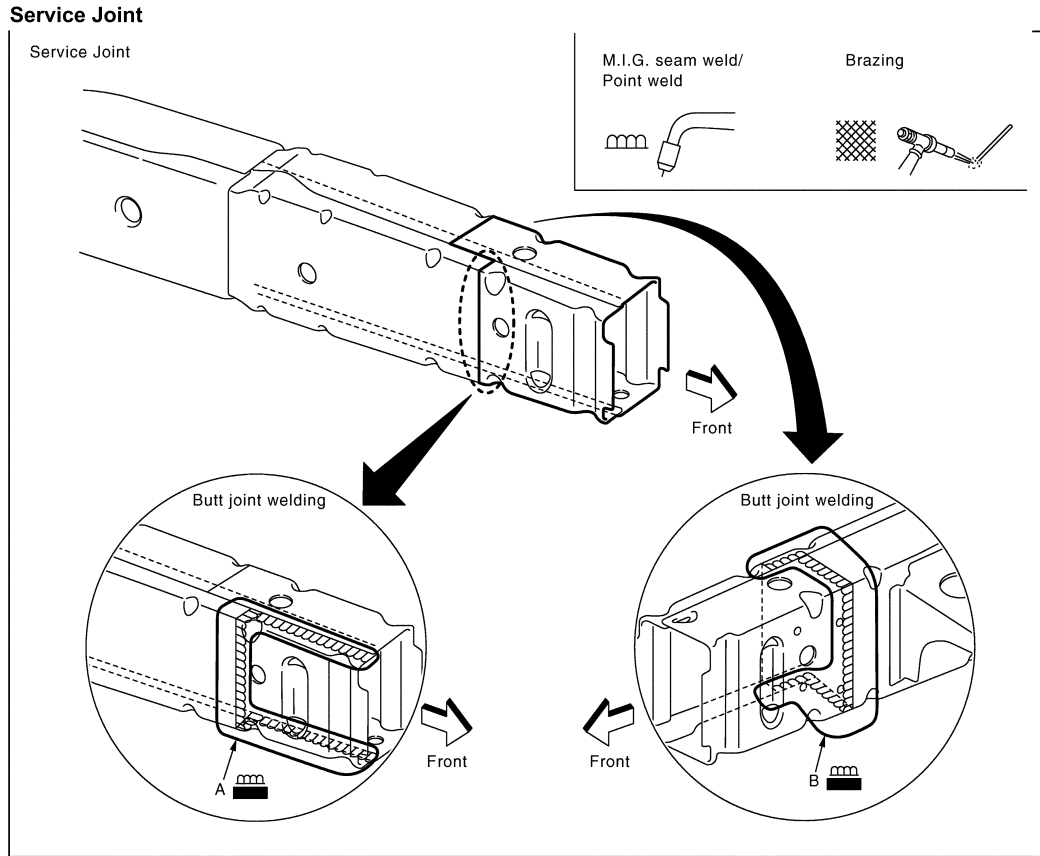
LIIA1083E

- Work after 1st crossmember has been removed.

Portions to be welded:

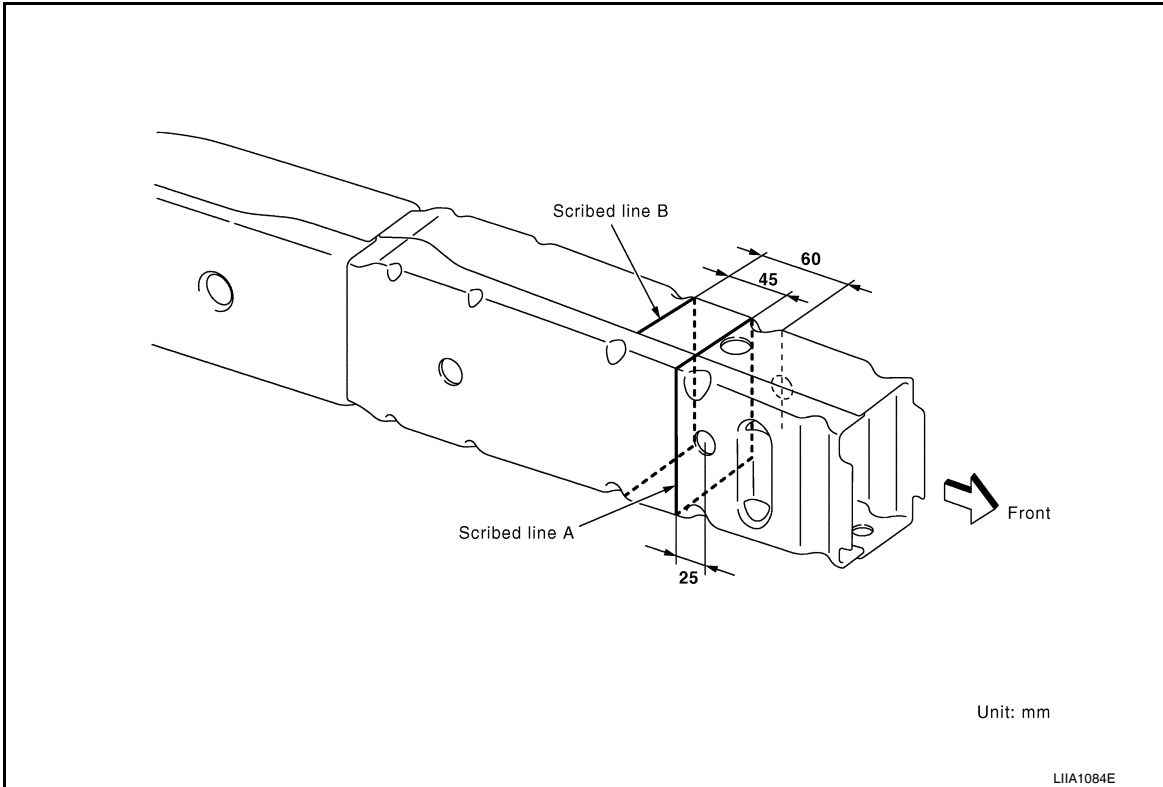
- Scribe a straight line on the outer side rail crush horn and inner side rail crush horn along the hole center as shown in the figure.

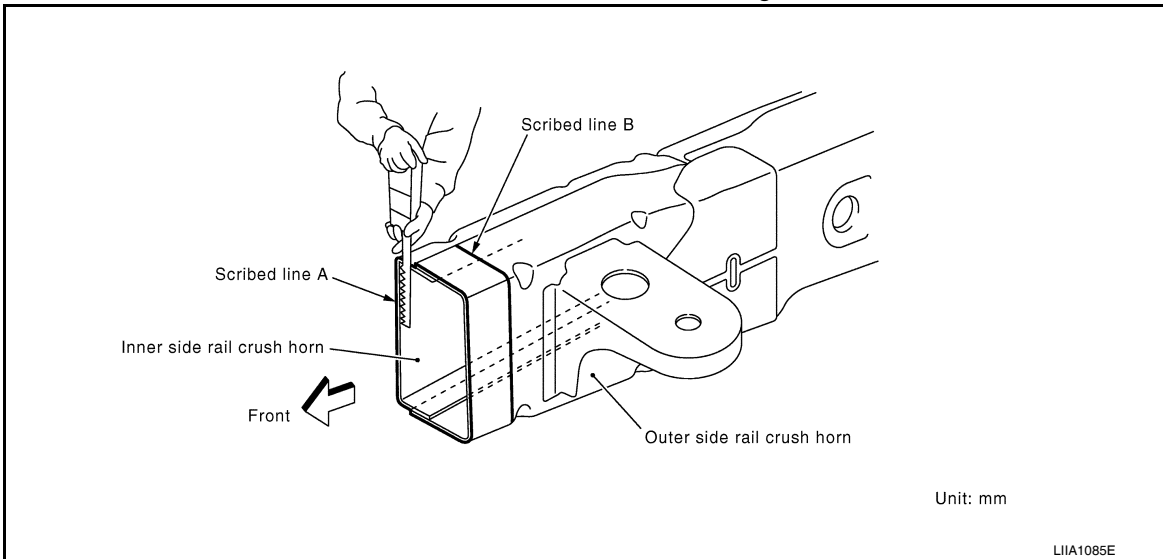
- Cut off outer side rail crush horn and inner side rail crush horn along scribed line A. Do not cut on the hole.

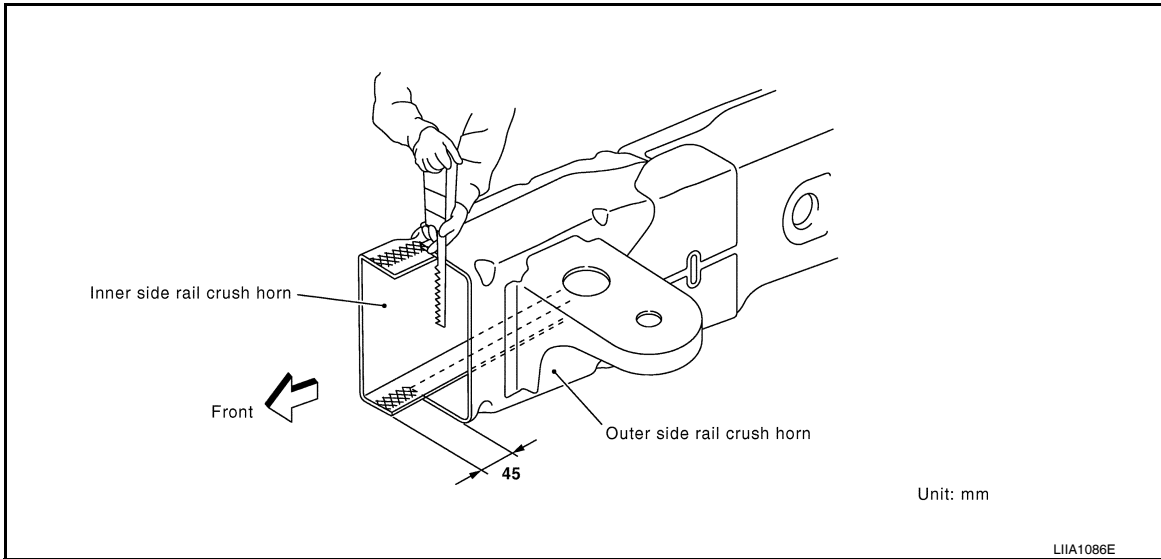
- Cut inner side rail crush horn at 45 mm backward cut position of cut line A. (along line B)

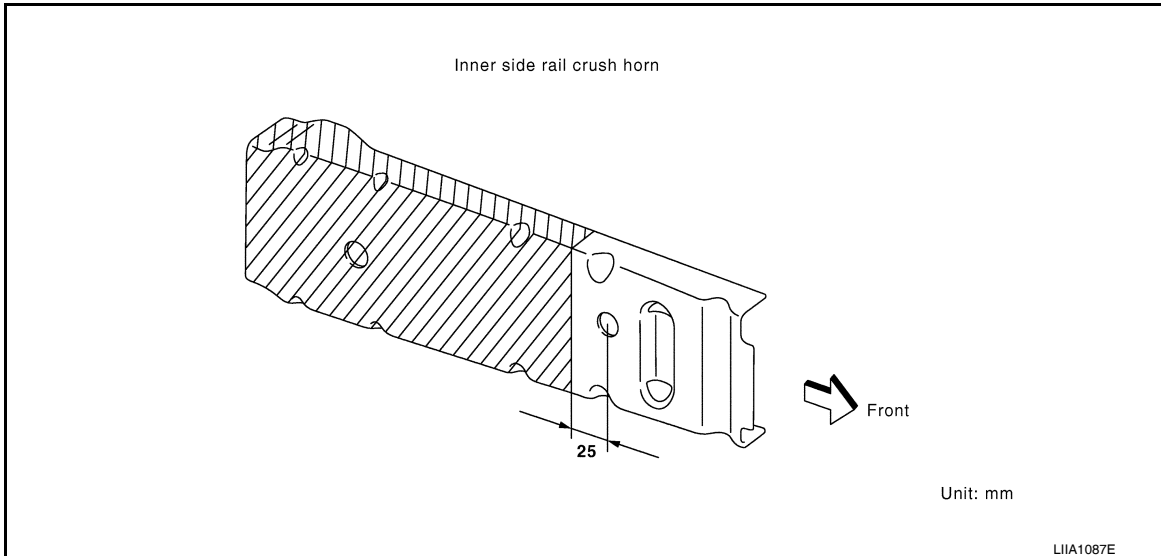
Installation Notes

- Scribe a straight line on the inner side rail crush horn along the hole center as shown in the figure. Cut off inner side rail crush horn along scribed line.

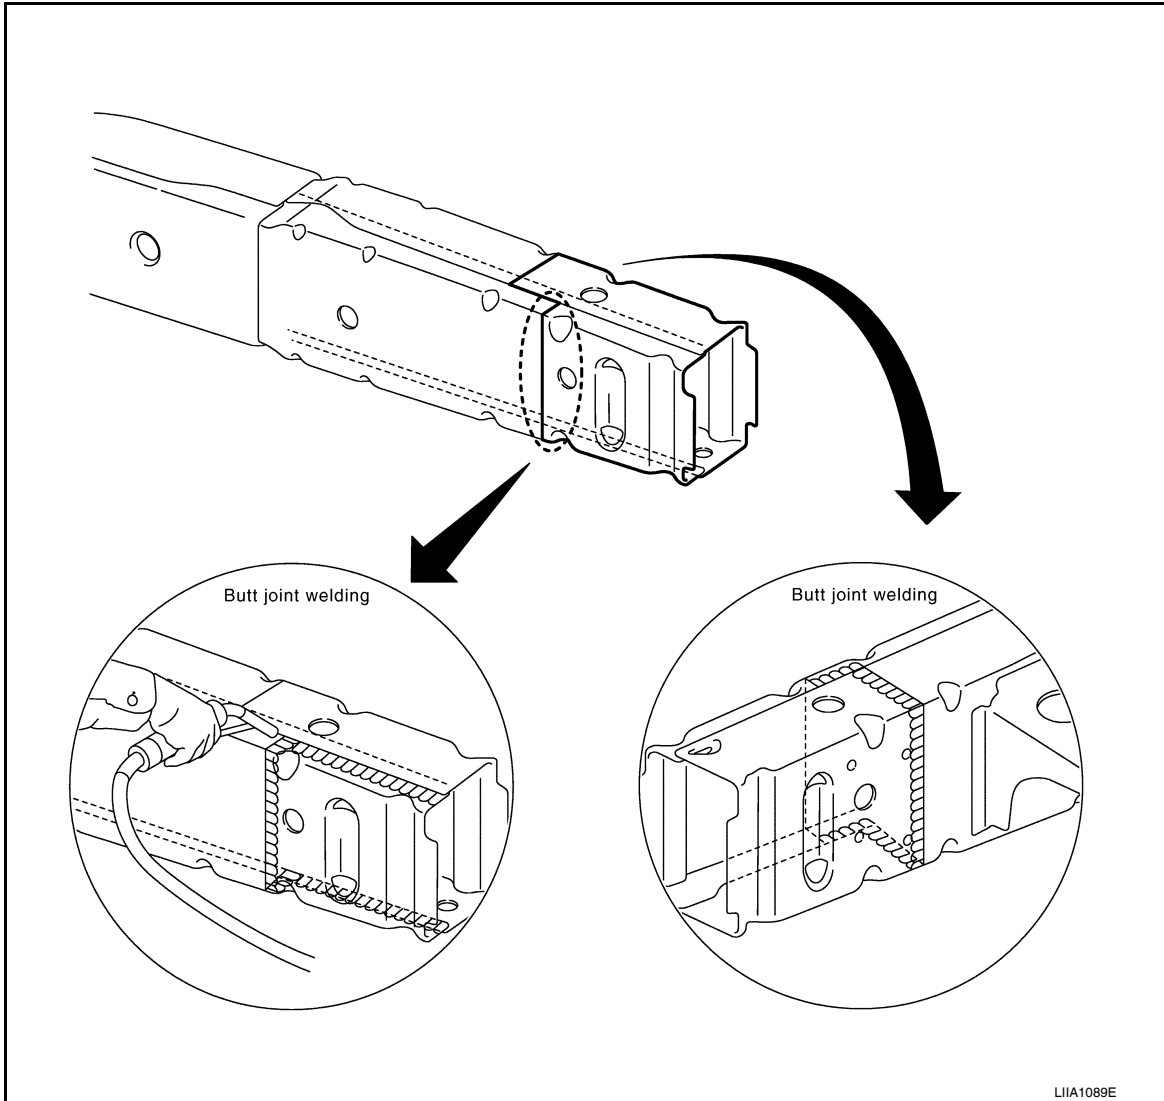
- Weld part to be butt-welded and seam-welded corner to corner as shown in the figure.
