SECTION **BRM**  
BODY REPAIR

A  
B  
C  
D  
E  
F  
G  
H  
I  
J  
L  
M  
N  
O  
P

CONTENTS

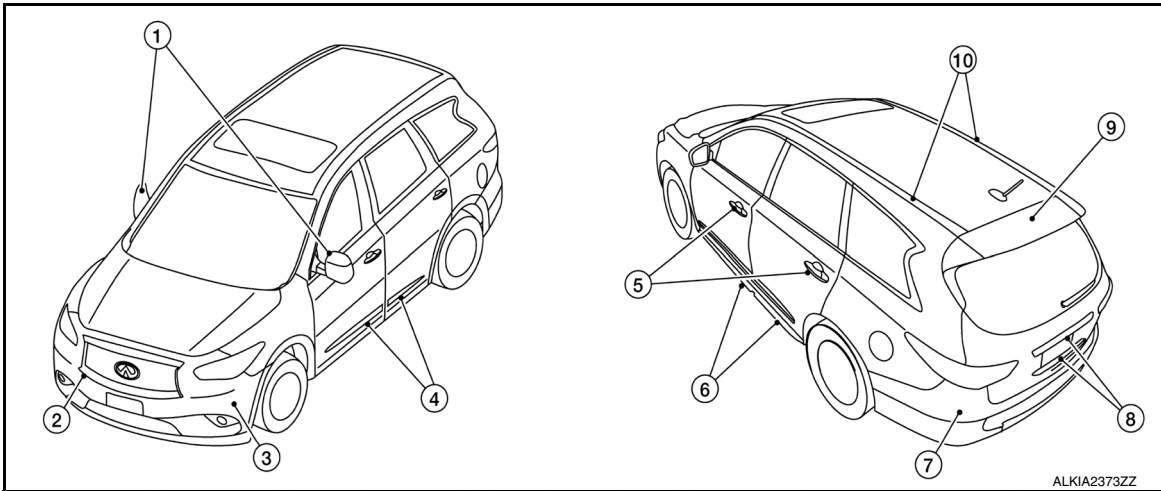
ALKIA2373ZZ

Component			Color code	EAJ	FAJ	K23	K50	KH3	NAB	QAA
			Description	Green	Blue	Silver	Gray	Black	Dark Red	White
			Paint type	M	M	M	M	S	M	P
			Hard clear coat	t	t	t	t	t	t	t
1	Door mirror	Base	Black	KH3	KH3	KH3	KH3	KH3	KH3	KH3
		Housing	Body color	EAJ	FAJ	K23	K50	KH3	NAB	QAA
2	Front grille		Chromium Plate	Cr2P	Cr2P	Cr2P	Cr2P	Cr2P	Cr2P	Cr2P
3	Front bumper fascia		Body color	EAJ	FAJ	K23	K50	KH3	NAB	QAA
4	Side guard molding		Chromium Plate	Cr2P	Cr2P	Cr2P	Cr2P	Cr2P	Cr2P	Cr2P
5	Door outside handle		Chromium Plate	Cr2P	Cr2P	Cr2P	Cr2P	Cr2P	Cr2P	Cr2P
6	Sill molding		Black	KH3	KH3	KH3	KH3	KH3	KH3	KH3
7	Rear bumper fascia		Body color	EAJ	FAJ	K23	K50	KH3	NAB	QAA
8	Back door outer finisher		Chromium Plate	Cr2P	Cr2P	Cr2P	Cr2P	Cr2P	Cr2P	Cr2P
9	Rear spoiler		Body color	EAJ	FAJ	K23	K50	KH3	NAB	QAA
10	Roof side molding		Body color	EAJ	FAJ	K23	K50	KH3	NAB	QAA

M= Metallic, S= Solid, 2S= Solid and Clear, 2P= 2-coat Pearl, 3P= 3-coat pearl, P = Pearl, Black is solvent based, all others are water based, t = TMAC clear coat

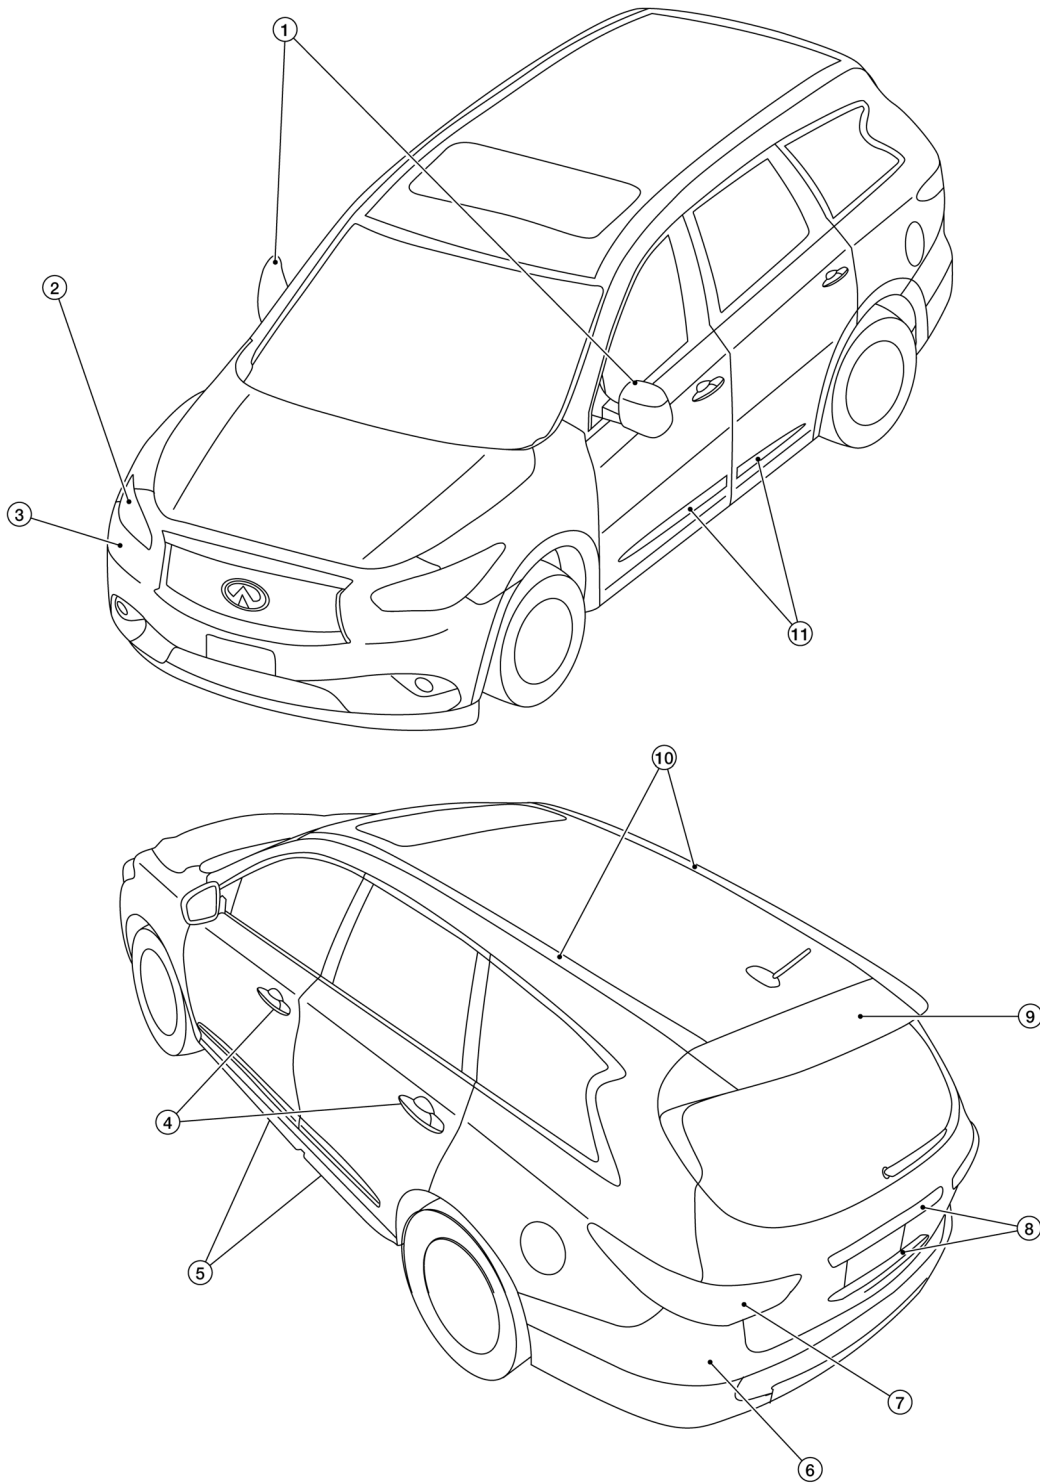
ALKIA2372ZZ

Item	Component	Abbreviation	Material
1.	Door mirror	Base	PA Polyamide (Nylon)
		Housing	ABS Acrylonitrile Butadiene Styrene
2.	Front combination lamp	Lens	PC Polycarbonate
		Housing	PP Polypropylene
3.	Front bumper fascia	PP	Polypropylene

Item	Component	Abbreviation	Material
4.	Door outside handle	Grip	PC Polycarbonate
		Escutcheon	PA Polyamide (Nylon)
5.	Sill molding	TPO	Thermoplastic Olefine
6.	Rear bumper fascia	PP	Polypropylene
7.	Rear combination lamp	Lens	PMMA Poly Methyl Methacrylate
		Housing	ASA Acrylonitrile Styrene Acrylate
8.	Back door outer finisher (upper/lower)	ABS + PC	Acrylonitrile Butadiene Styrene + Polycarbonate
9.	Rear spoiler	ABS + PC	Acrylonitrile Butadiene Styrene + Polycarbonate
10.	Roof side molding	ABS + PC	Acrylonitrile Butadiene Styrene + Polycarbonate
11.	Body side molding	PC	Polycarbonate

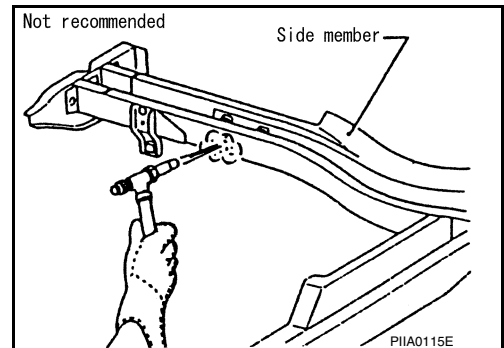
- The repair of reinforcements (such as side members) by heating is not recommended since it may weaken the component. When heating is unavoidable, do not heat HSS parts above 550°C (1,022°F).

Verify heating temperature with a thermometer.

(Crayon-type and other similar type thermometers are appropriate.)

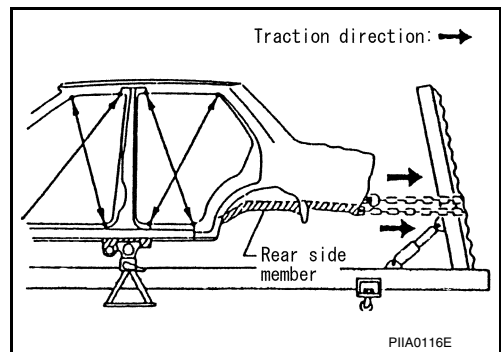
- When straightening body panels, use caution in pulling any HSS panel. Because HSS is very strong, pulling may cause deformation in adjacent portions of the body. In this case, increase the number of measuring points and carefully pull the HSS panel.

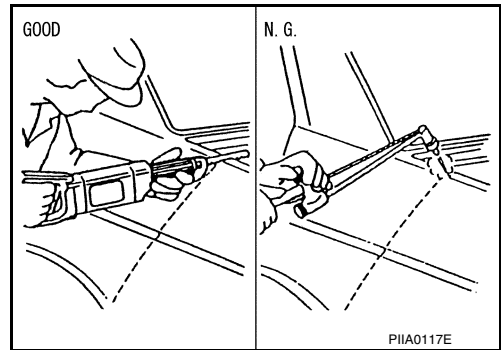
- When cutting HSS panels, avoid gas (torch) cutting if possible. Instead, use a saw to avoid weakening surrounding areas due to heat. If gas (torch) cutting is unavoidable, allow a minimum margin of 50 mm (1.97 in).

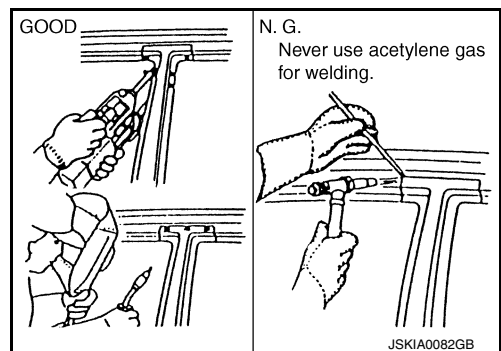
- When welding HSS panels, use spot welding whenever possible in order to minimize weakening surrounding areas due to heat. If spot welding is impossible, use MIG. welding. Do not use gas (torch) for welding because it is inferior in welding strength.

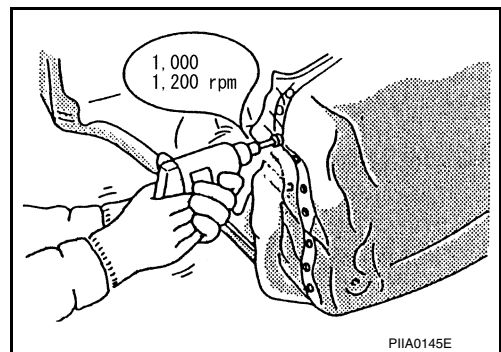
- The spot weld on HSS panels is harder than that of an ordinary steel panel. Therefore, when cutting spot welds on a HSS panel, use a low speed high torque drill (1,000 to 1,200 rpm) to increase drill bit durability and facilitate the operation.

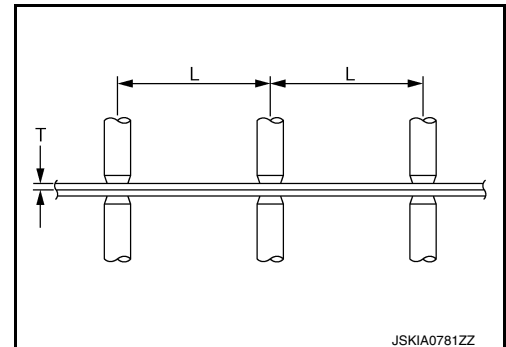
- Follow the specifications for the proper welding pitch.

Unit: mm (in)

Thickness (T)	Minimum pitch (L)
0.6 (0.024)	10 (0.39) or over
0.8 (0.031)	12 (0.47) or over
1.0 (0.039)	18 (0.71) or over
1.2 (0.047)	20 (0.79) or over
1.6 (0.063)	27 (1.06) or over
1.8 (0.071)	31 (1.22) or over

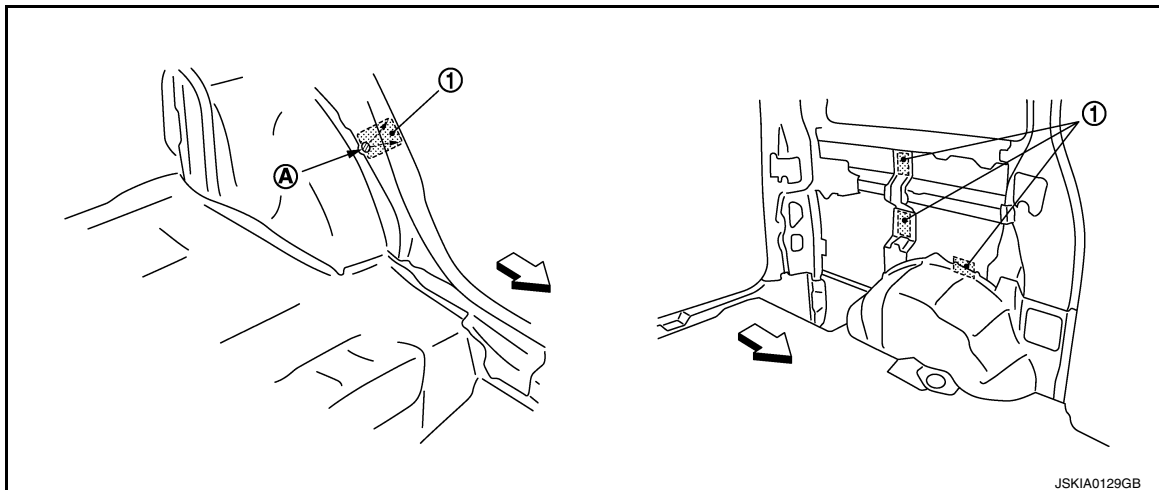
1. Fill procedures after installation of service part.
  - a. Eliminate foam material remaining on vehicle side.
  - b. Clean area after eliminating form insulator and foam material.
  - c. Install service part.
  - d. Insert nozzle into hole near fill area and fill foam material or fill enough to close gap with the service part.

- 1. Urethane foam
- A. Nozzle insert hole
- ↔ Front

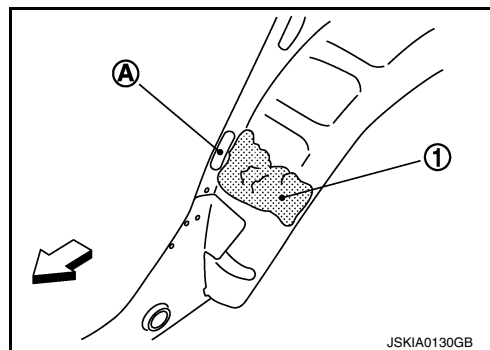
2. Fill procedures before installation of service part:
  - a. Eliminate foam material remaining on vehicle side.
  - b. Clean area after eliminating foam insulator and foam material.
  - c. Fill with enough foam material on the wheelhouse outer side to close the gap with the service part while avoiding the flange area.

- 1. Urethane foam
  - A. Fill while avoiding flange area
- ⇐ Front

d. Install service part.

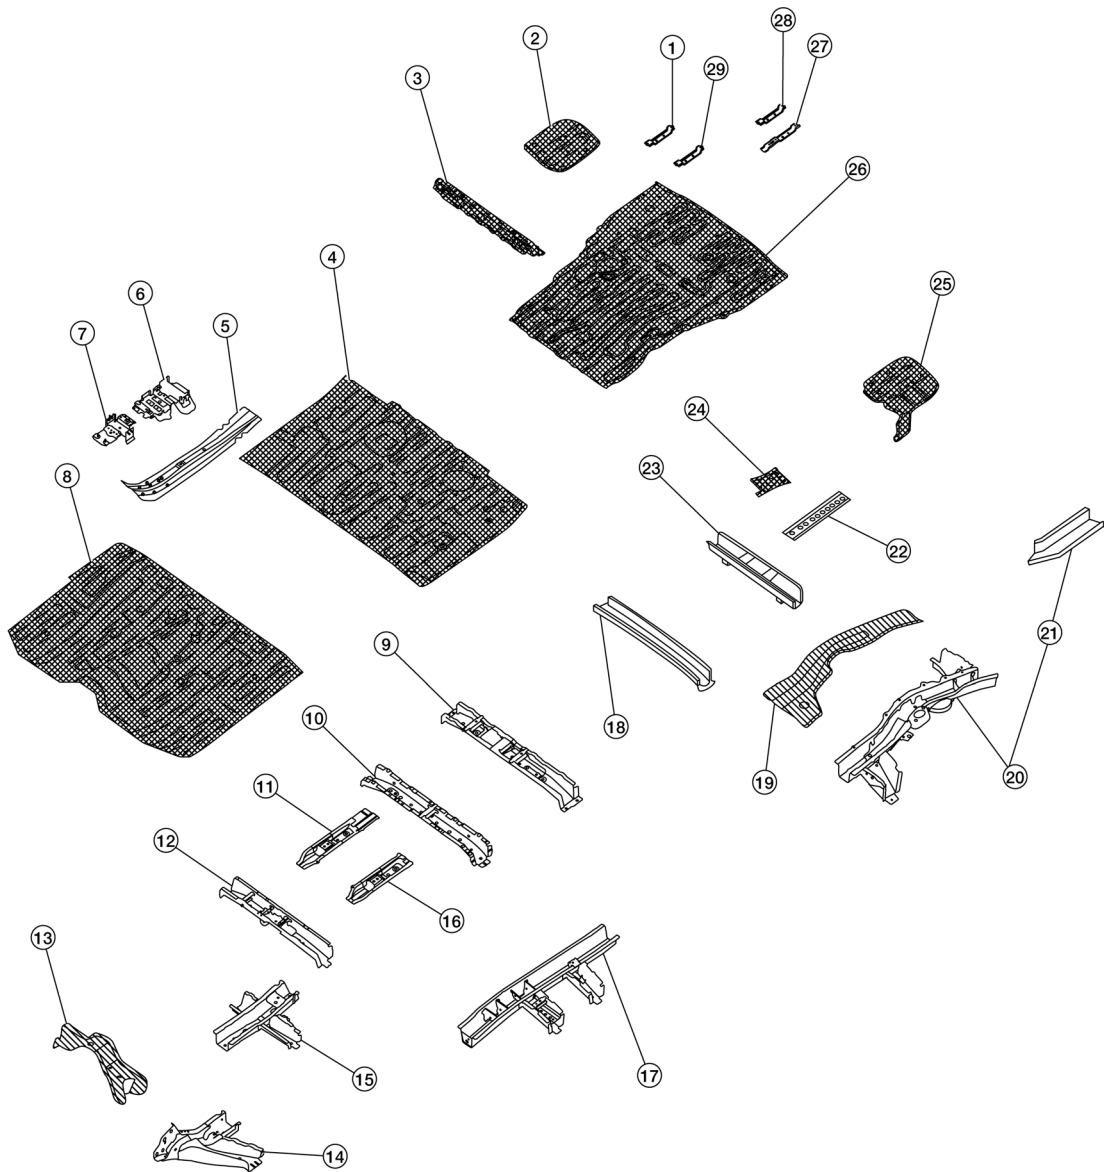
ALKIA2385ZZ

: Both sided anti-corrosive precoated steel portions

: High strength steel (HSS) portions

: Both sided anti-corrosive steel and HSS portions

Item	Part name	Material
1.	Front woofer bracket (LH)	—
2.	Rear floor side assembly (RH)	SP781B
3.	Lower seatback support assembly	SP123B
4.	Rear floor front	SP781B

5.	Front side member stiffener	SP151-1350Hv
6.	Trim mounting bracket assembly	—
7.	Instrument stay bracket assembly	—
8.	Front floor front	SP781B
9.	5th crossmember assembly	—

10.	4th crossmember assembly	—
11.	Rear inner belt anchor reinforcement assembly (RH)	—
12.	3rd crossmember assembly	—
13.	Front suspension member lower mounting assembly	SP781-440

14.	Front side member assembly (LH/RH)	—
15.	Front side member extension assembly (LH/RH)	—
16.	Rear inner belt anchor reinforcement assembly (LH)	—
17.	Front side member rear extension assembly (LH/RH))	—

18.	6th crossmember assembly	—
19.	Rear floor front extension assembly (LH/RH)	—
20.	Rear side member assembly (LH/RH)	—
21.	Rear side member extension assembly (LH/RH)	—

22.	Rear member center assembly	—
23.	7th crossmember assembly	—
24.	Spare tire mounting bracket	SP781B
25.	Rear floor side assembly (LH)	SP781B
26.	Rear floor rear	SP781B

27.	Rear woofer bracket (LH)	—
28.	Rear woofer bracket (RH)	—
29.	Front woofer bracket (RH)	—

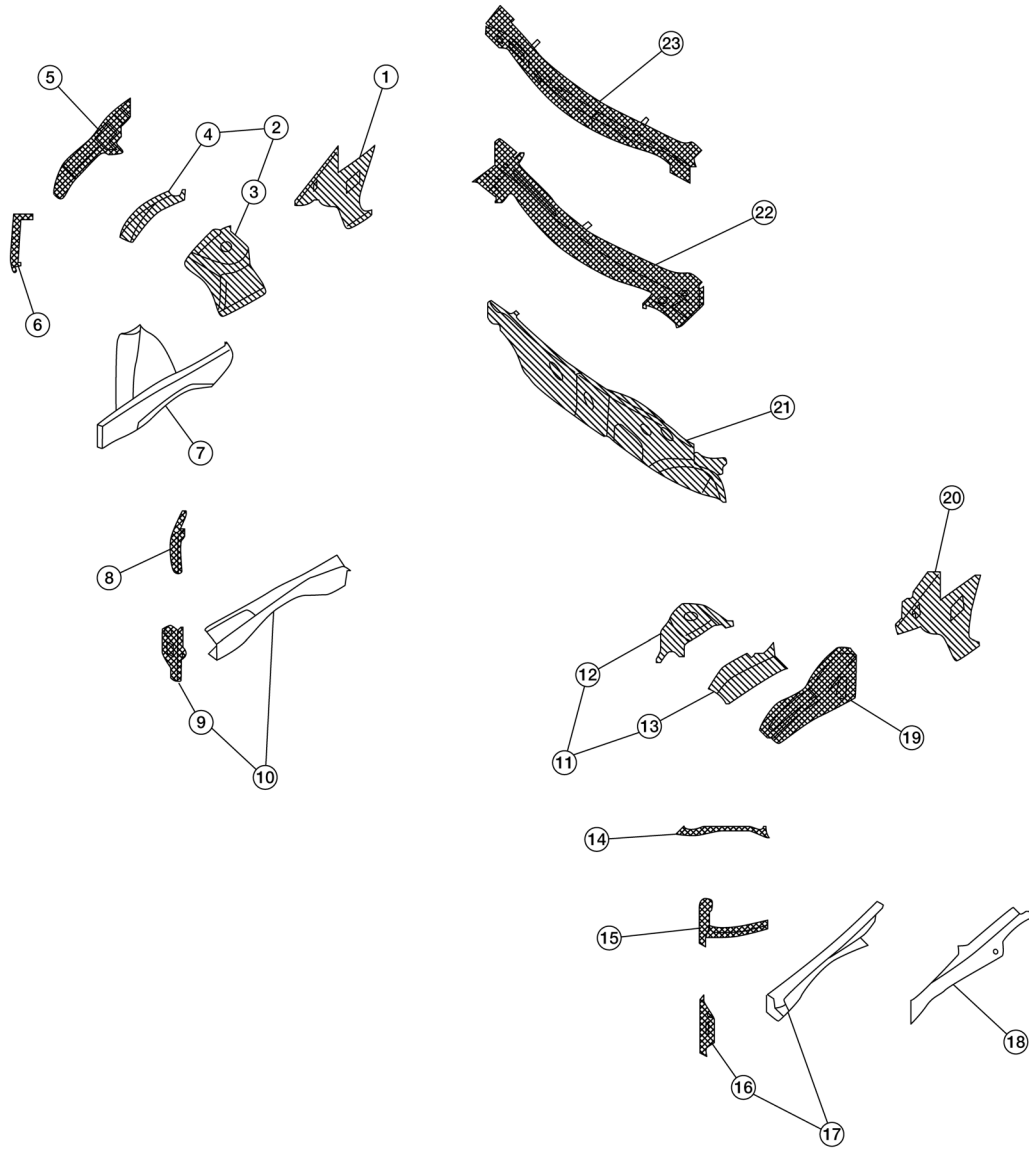
ALKIA2386ZZ

: Both sided anti-corrosive precoated steel portions
-

: High strength steel (HSS) portions
-

: Both sided anti-corrosive steel and HSS portions

Item	Part name	Material
1.	Dash side assembly (RH)	SP781-390B
2.	Hoodledge assembly (RH)	—
3.	Hoodledge lower assembly (RH)	SP231-440P
4.	Upper hoodledge (RH)	SP231-440P

5.	Hoodledge extension (RH)	SP781B
6.	Upper radiator core support (RH)	SP782B
7.	Front side member closing plate assembly (RH)	—
8.	Radiator core side support (RH)	—

9.	Front side member connector (RH)	SP221B
10.	Front side member assembly (RH)	—
11.	Hoodledge assembly (LH)	—
12.	Hoodledge lower assembly (LH)	SP231-440P

13.	Upper hoodledge (LH)	SP231-440P
14.	Upper radiator core support (LH)	SP782B
15.	Radiator core side support (LH)	—
16.	Front side member connector (LH)	SP221B

17.	Front side member assembly (LH)	—
18.	Front side member closing plate assembly (LH)	—
19.	Hoodledge extension (LH)	SP781B
20.	Dash side assembly (LH)	SP781-390B

21.	Lower dash assembly	SP781-390B
22.	Upper dash assembly	SP781B
23.	Cowl assembly	—

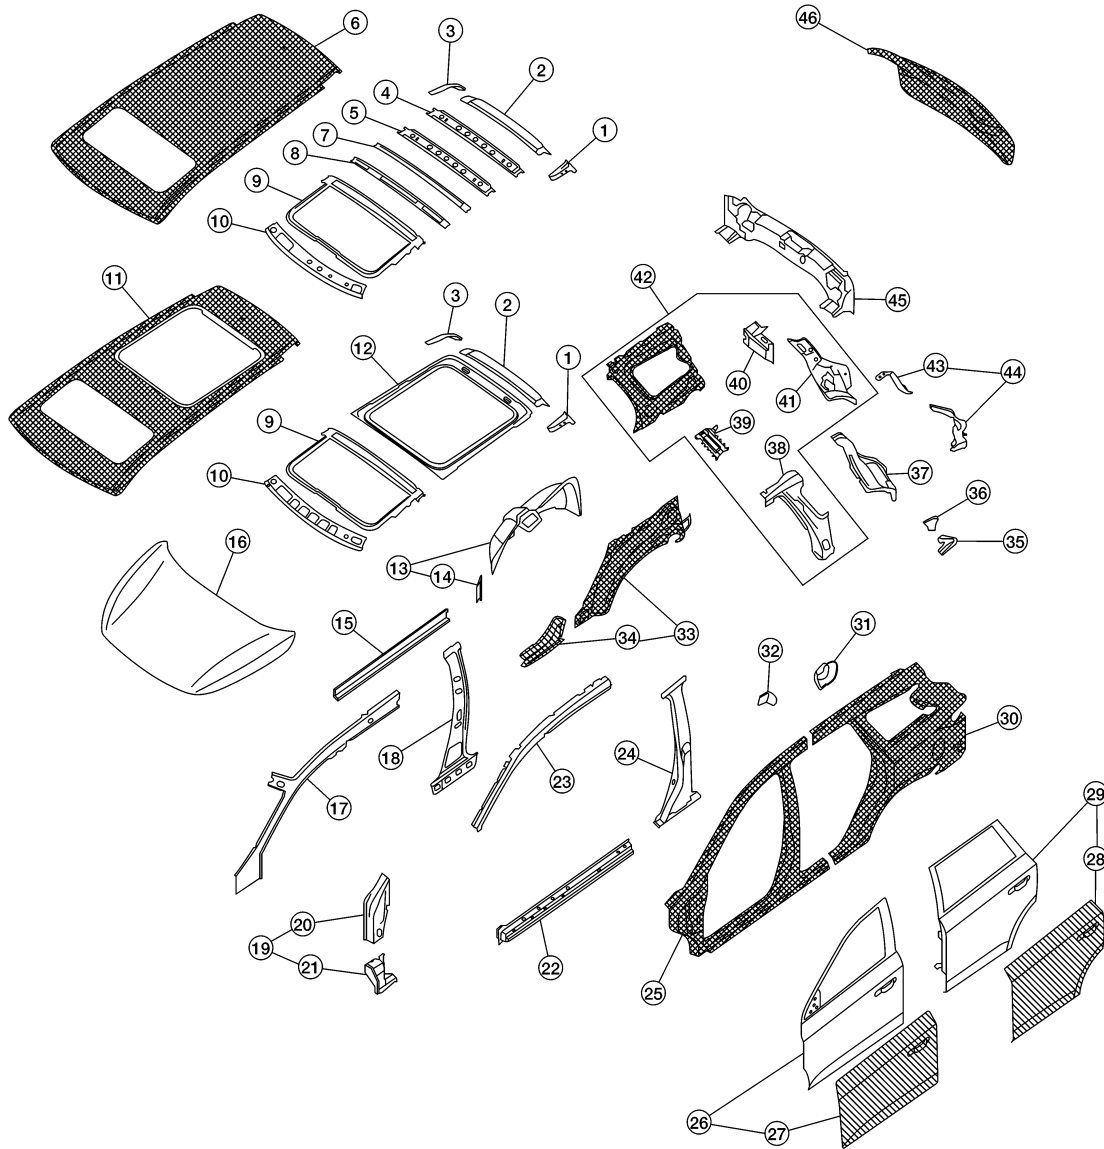
AWKIA2652ZZ

Both sided anti-corrosive pre-coated steel portions
-

High strength steel (HSS) portions
-

Both sided anti-corrosive steel and HSS portions

Item	Part name	Material
1.	Roof corner reinforcement (LH)	SP121BQ
2.	Rear roof rail assembly	—
3.	Roof corner reinforcement (RH)	SP121BQ
4.	6th roof bow, standard roof	SP129BQ

5.	5th roof bow, standard roof	SP129BQ
6.	Standard roof	SP121AQ
7.	4th roof bow, standard roof	SP129BQ
8.	3rd roof bow, standard roof	SP123BQ
9.	Roof reinforcement assembly, standard roof	SP121BQ

20.	Front pillar upper hinge brace (LH/RH)	SP153-590Q
21.	Front pillar lower hinge brace (LH/RH)	SP152-440Q
22.	Outer sill reinforcement assembly (LH/RH)	—

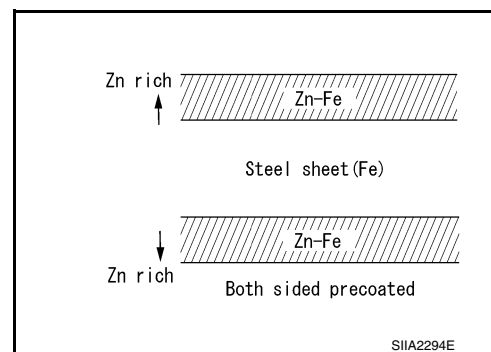
Galvannealed steel is electroplated and heated to form zinc-iron alloy, which provides excellent and long term corrosion resistance with cationic electrodeposition primer.

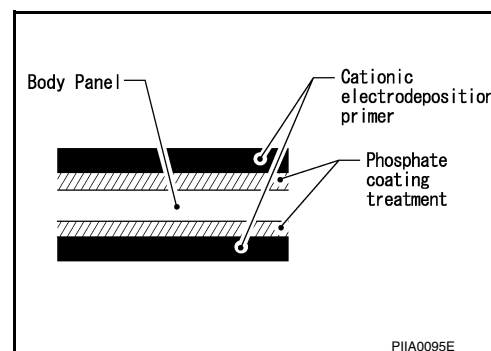
A phosphate coating treatment and a cationic electrodeposition primer, which provide excellent corrosion protection, are employed on all body components.

**Confine paint removal during welding operations to an absolute minimum.**

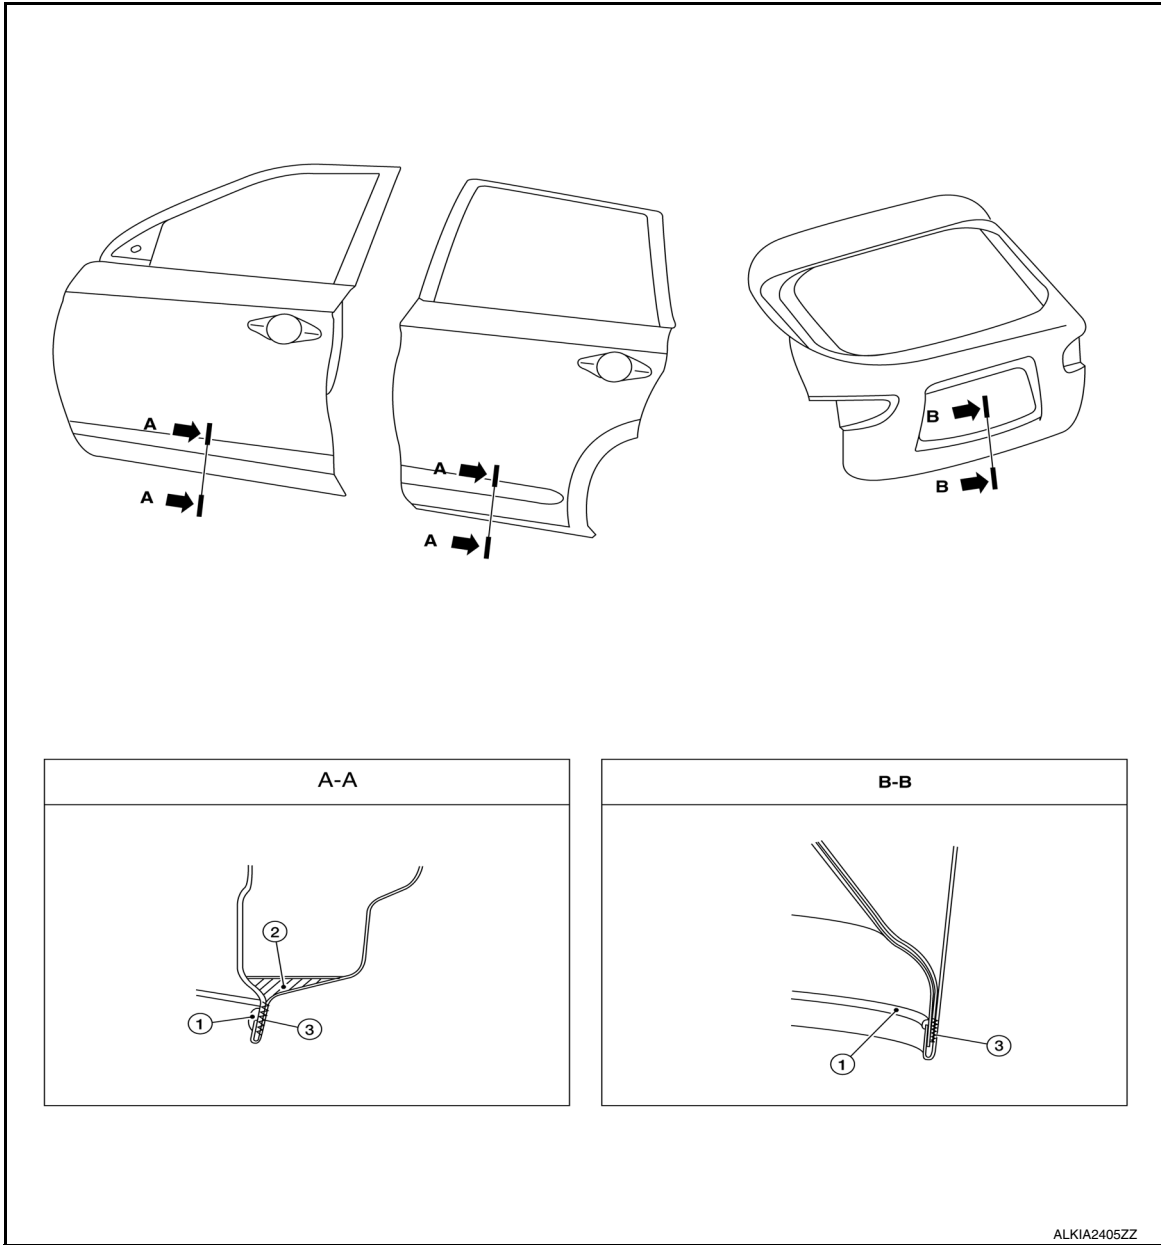
To improve corrosion resistance, anti-corrosive wax is applied inside the body sill and inside other closed sections. Accordingly, when replacing these parts, be sure to apply anti-corrosive wax to the appropriate areas of the new parts. Select an excellent anti-corrosive wax which will penetrate after application and has a long shelf life.

1. Body caulk

2. Anti-corrosive wax

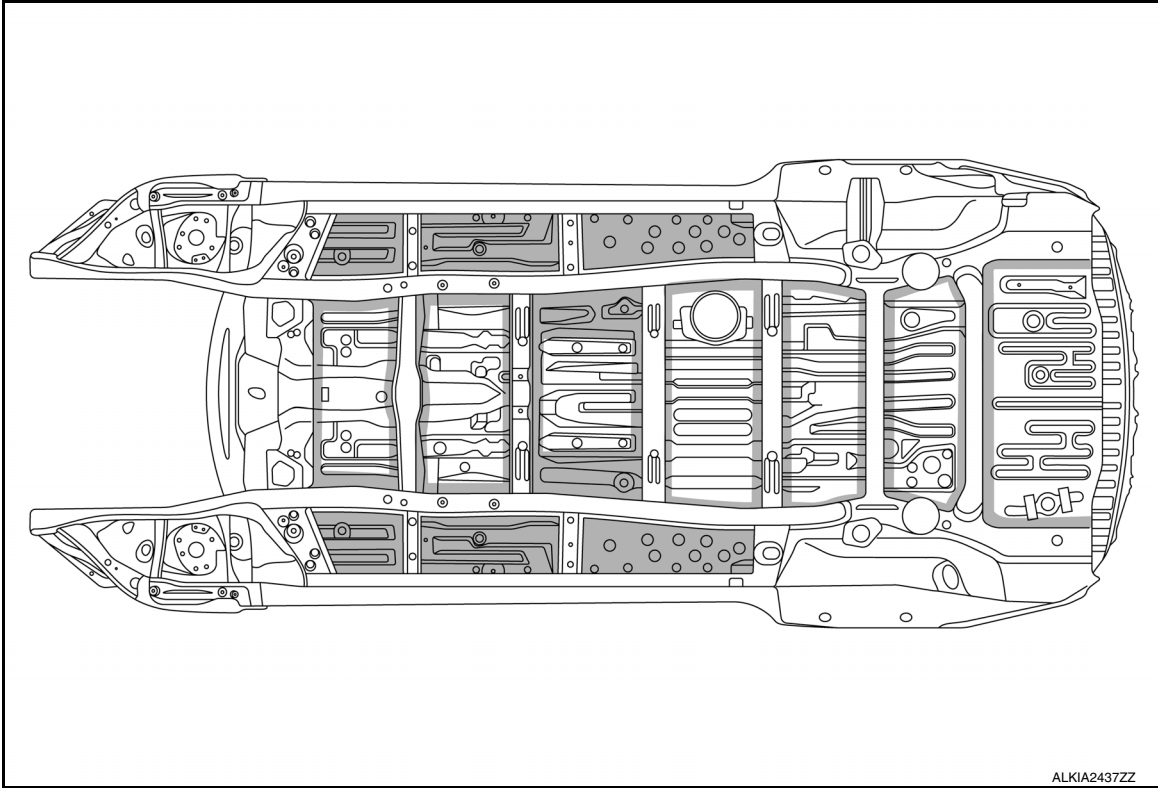
The underside of the floor and wheelhouse are undercoated to prevent rust, vibration, noise and stone chipping. Therefore, when such a panel is replaced or repaired, apply undercoating to that part. Use an undercoating which is rust preventive, soundproof, vibration-proof, shock-resistant, adhesive, and durable.

Undercoated areas are shaded.

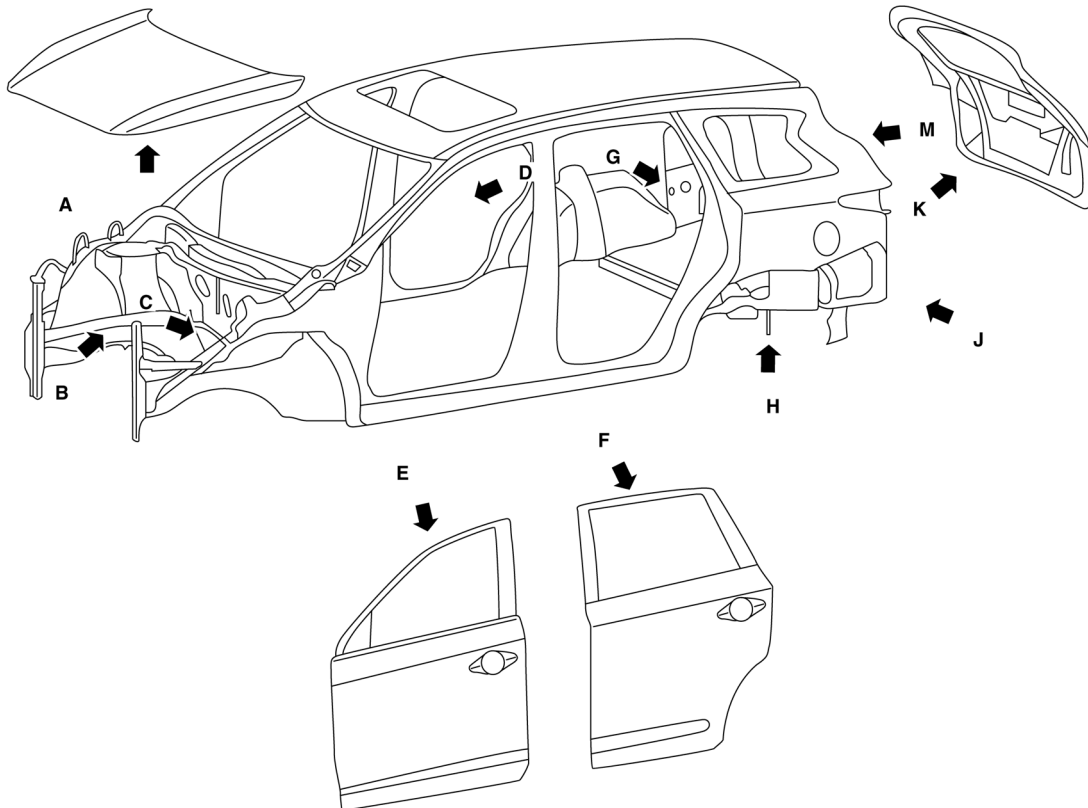
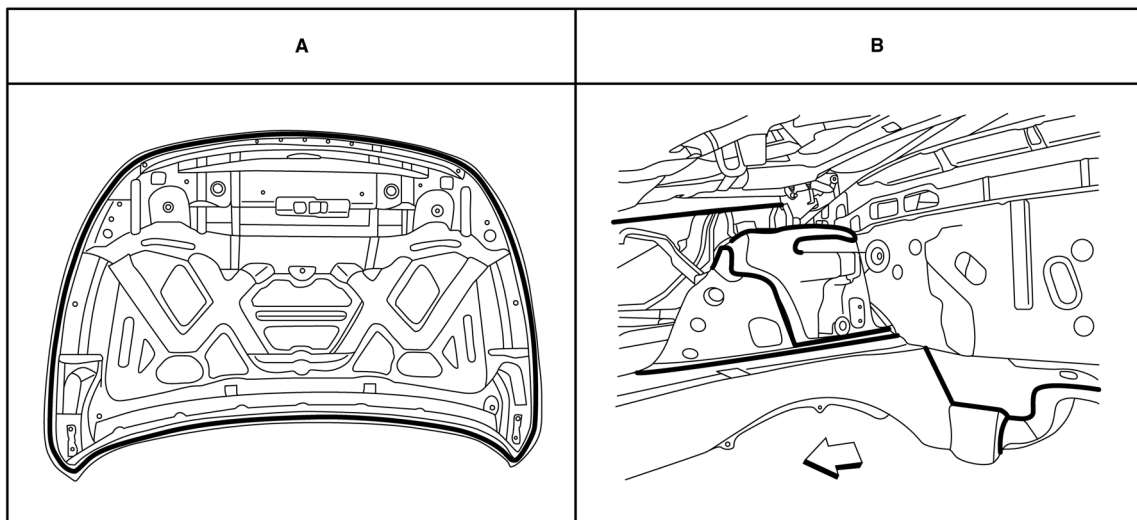
ALKIA2378ZZ

The following figure shows the areas which are sealed at the factory. Sealant which has been applied to these areas should be smooth and free from cuts or gaps. Care should be taken not to apply an excess amount of sealant and not to allow other unaffected parts to come into contact with the sealant.

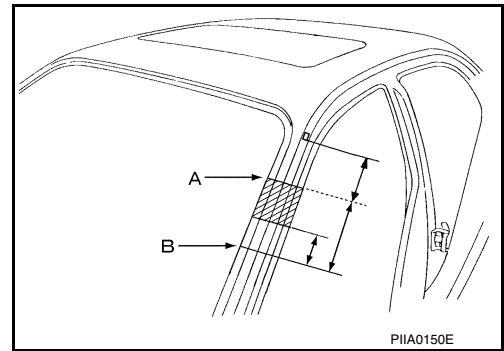
- Front pillar butt joint can be determined anywhere within shaded area as shown in the figure. The best location for the butt joint is at position A due to the construction of the vehicle. Refer to the front pillar section.

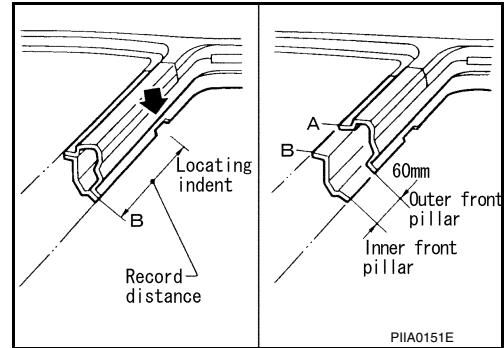
- Determine cutting position and record distance from the locating indent. Use this distance when cutting the service part. Cut outer front pillar over 60 mm (2.4 in) above inner front pillar cut position.

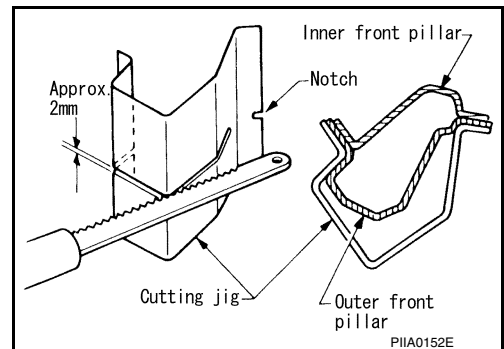
- Prepare a cutting jig to make the outer pillar easier to cut. Also, this will permit the service part to be accurately cut at the joint position.

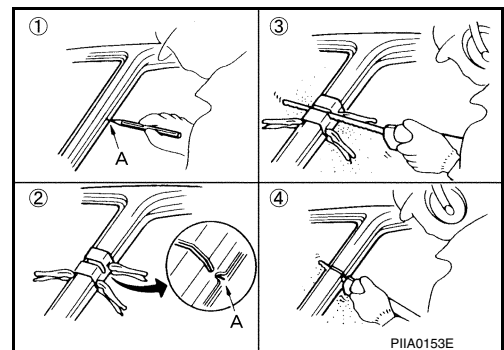
- An example of cutting operation using a cutting jig is as follows:

1. Mark cutting lines.  
A: Cut position of outer pillar
2. Align cutting line with notch on jig. Clamp jig to pillar.
3. Cut outer pillar along groove of jig. (At position A)
4. Remove jig and cut remaining portions.

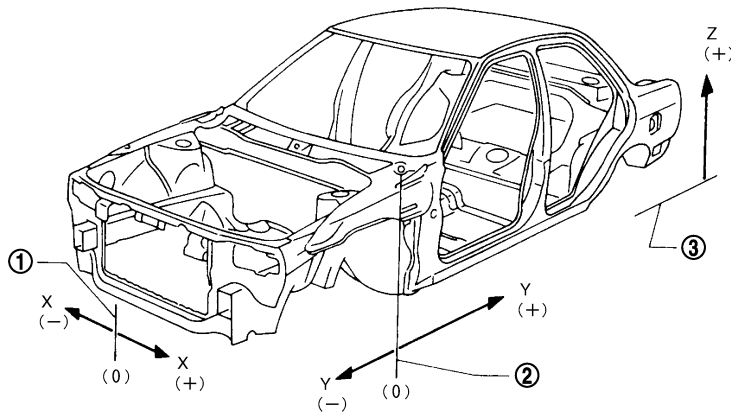
JSKIA0073GB

- All dimensions indicated in the figures are actual.
- When using a tracking gauge, adjust both pointers to equal length. Then check the pointers and gauge itself to make sure there is no free play.
- When a measuring tape is used, check to be sure there is no elongation, twisting or bending.
- Measurements should be taken at the center of the mounting holes.
- An asterisk (\*) following the value at the measuring point indicates that the measuring point on the other side is symmetrically the same value.
- The coordinates of the measurement points are the distances measured from the standard line of "X", "Y" and "Z".
- "Z": Imaginary base line [200 mm (7.87 in) below datum line ("0Z" at design plan)]

1. Vehicle center

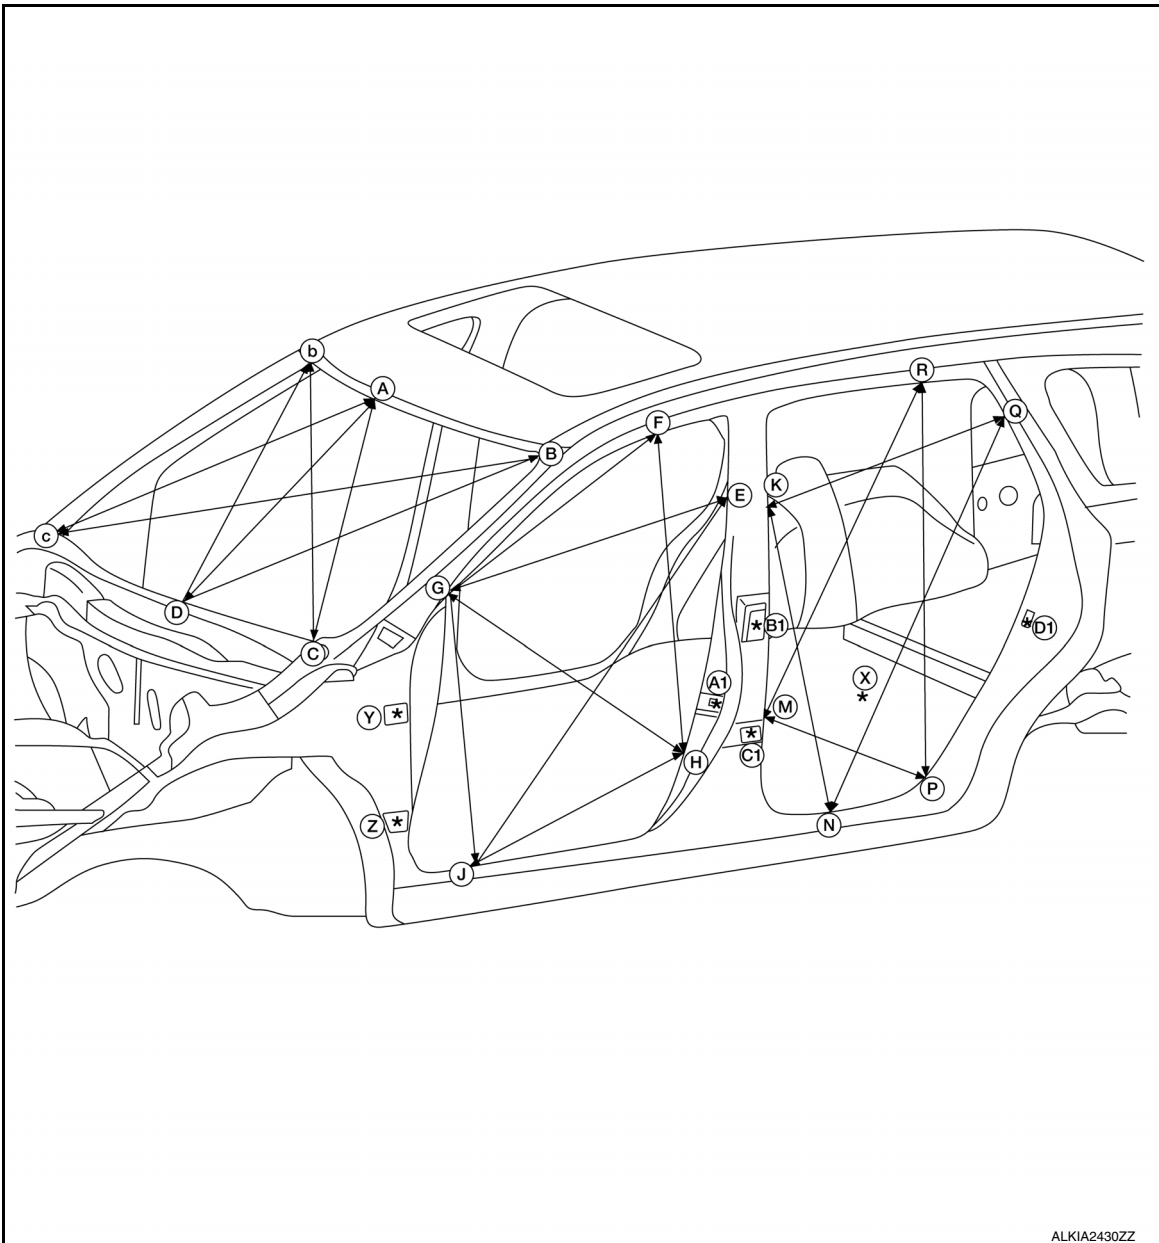
ALKIA2430ZZ

Dimensions marked with "\*" indicate symmetrically identical dimensions on both the LH and RH side of the vehicle.

Coordinates	Measurement	Coordinates	Measurement	Coordinates	Measurement
A-C*	1070.63 (42.15)	A-D	855.50 (34.86)	C-b*	1611.94 (63.46)
D-B*	1138.82 (44.84)	E-J*	1256.45 (49.47)	F-H*	898.75 (35.38)
G-E*	1910.84 (35.86)	G-F*	753.15 (29.65)	G-H*	932.50 (36.71)
G-J*	807.46 (31.79)	J-H*	686.20 (27.02)	K-N*	992.54 (39.08)
K-Q*	765.81 (30.15)	M-P*	593.58 (23.37)	M-R*	1091.02 (42.95)
Q-N*	1207.16 (47.53)	R-P*	1094.92 (43.11)	Y-D1*	2101.67 (82.74)
A1-D1*	1044.44 (41.12)	A1-Y*	1079.32 (42.49)	A1-Z*	1074.30 (42.30)
B1-D1*	917.80 (36.13)	C1-D1	976.50 (38.44)	R-X	1303.24 (51.31)
r-X	1257.45 (49.51)	K-X	1355.65 (53.37)	k-X	1305.74 (51.41)
Q-X	1249.05 (49.18)	q-X	1197.86 (47.16)*	W-F*	1474.34 (58.04)
W-E*	1529.04 (60.20)*	W-G	1090.94 (42.95)

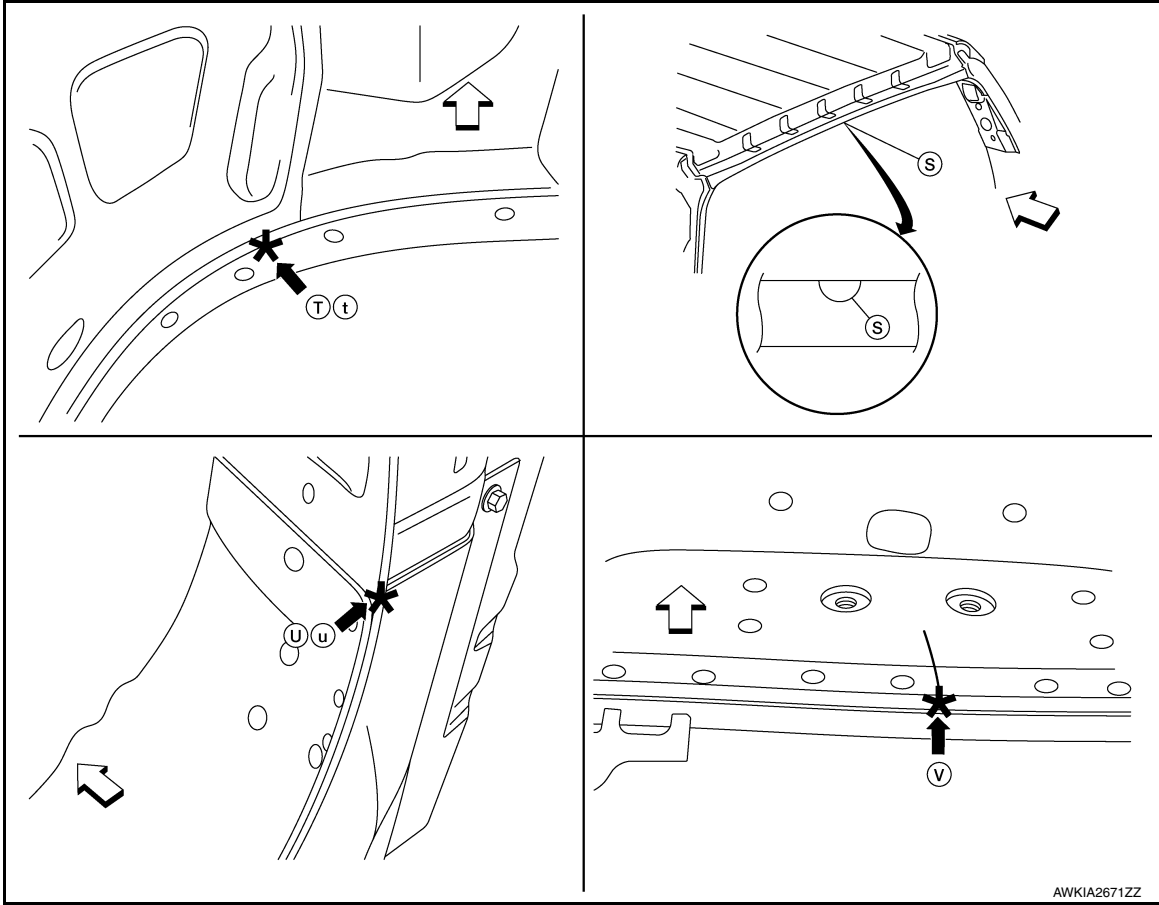
Point	Description	Point	Description
S	Roof flange end of center positioning mark	T, t	Back pillar main joggle
U, u	Upper rear panel joggle	V	Edge of rear panel between back door striker installing holes
