IP-9 2016 Titan NAM Revision: March 2016

INSTRUMENT PANEL ASSEMBLY

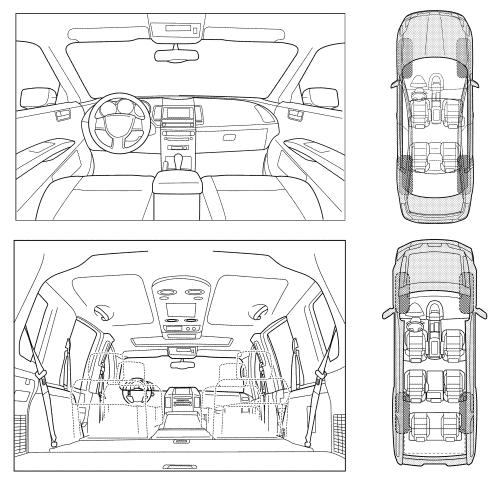
I. WHERE DOES THE NOISE COME FROM? (circle the area of the vehicle)

The illustrations are for reference only, and may not reflect the actual configuration of your vehicle.

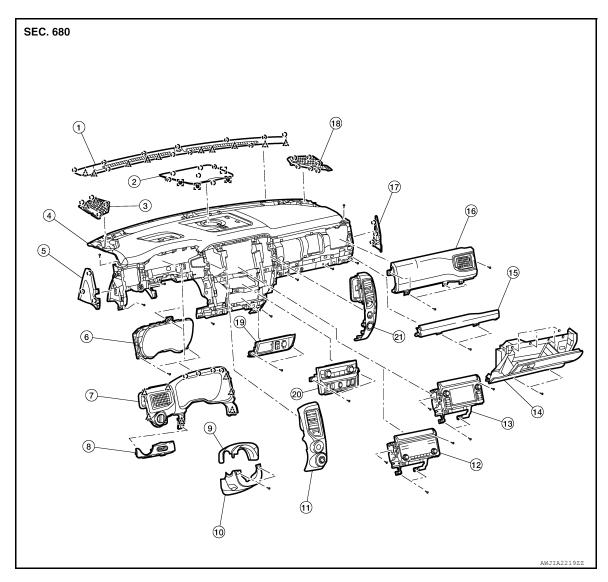
Exploded View

- 1. Front defroster grille
- 4. Instrument panel assembly
- 7. Cluster lid A
- 10. Steering column lower cover
- 13. AV control unit (if equipped)
- 16. Upper instrument panel
- 19. Cluster lid C lower

- 2. Center speaker grille
- 5. Instrument side finisher (LH)
- 8. Instrument finisher A
- 11. Cluster lid C finisher (LH)
- 14. Glove box assembly and housing
- 17. Instrument side finisher (RH)
- 20. Cluster lid C

- 3. Speaker grille (LH)
- 6. Combination meter
- 9. Steering column upper cover
- 12. Audio unit
- 15. Instrument finisher B
- 18. Speaker grille (RH)
- 21. Cluster lid C finisher (RH)

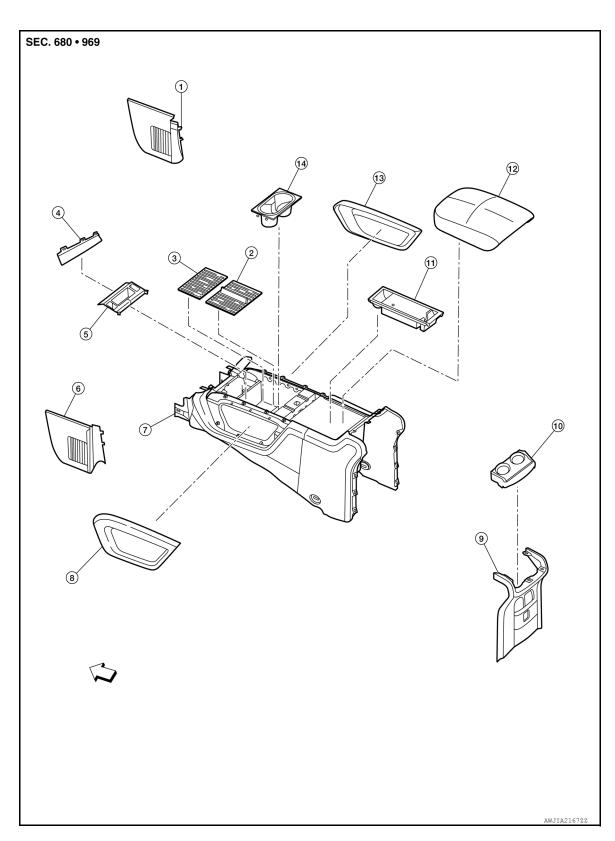
Exploded View

- 1. Instrument stay cover (RH)
- 4. Front console cover
- 7. Center console
- 2. Rubber mat
- Console switch finisher
- 8. Console finisher (LH)
- 3. Console mat
- 6. Instrument stay cover (LH)
- 9. Center console rear finisher
