CONTENTS

IP-9 2014 Versa Sedan Revision: April 2013

INSTRUMENT PANEL ASSEMBLY

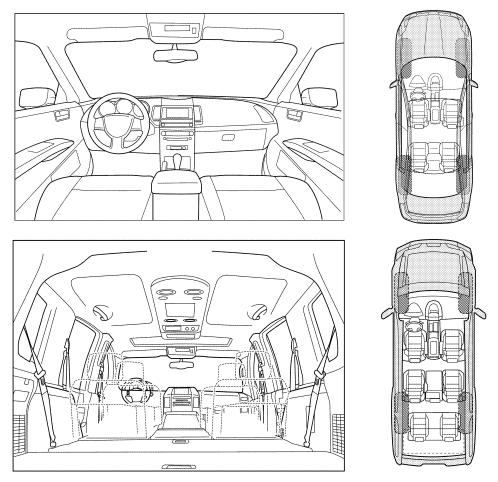
-1-LAIA0072E

I. WHERE DOES THE NOISE COME FROM? (circle the area of the vehicle)

The illustrations are for reference only, and may not reflect the actual configuration of your vehicle.

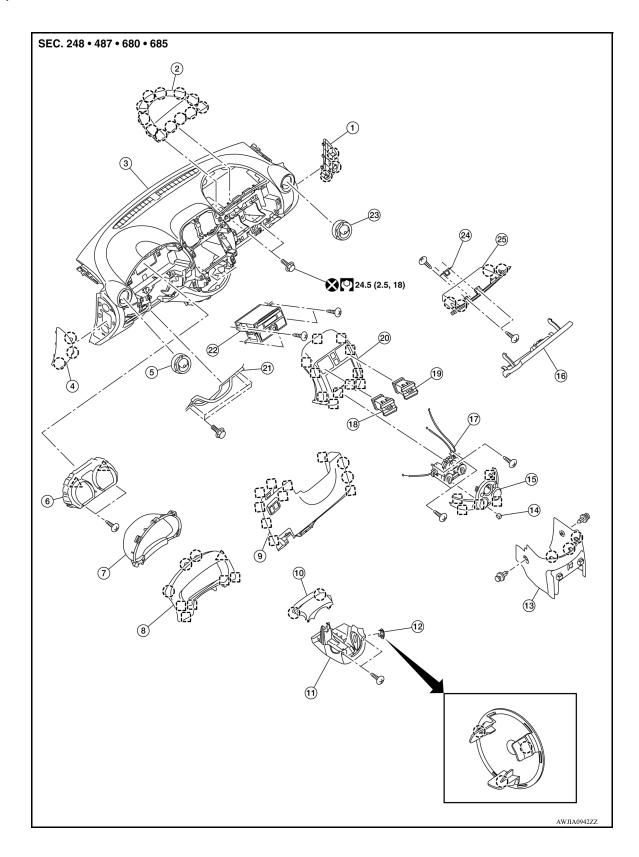
Exploded View

1. Instrument side finisher (RH) 2. Passenger air bag module 3. Instrument panel assembly 4. Instrument side finisher (LH) 5. Ventilator grilles (LH) 6. Combination meter Combination meter finisher Cluster lid A Instrument lower panel LH 7. Steering column upper cover 11. Steering column lower cover 12. Steering lock escutcheon 13. Center console lower Control knob 15. A/C control finisher 16. Glove box lid 17. A/C control 18. Ventilator grilles center (LH) 19. Ventilator grilles center (RH) 20. Cluster lid C 21. Lower knee protector (LH) 22. Audio unit or AV control unit (if 23. Ventilator grilles (RH) 24. Glove box striker equipped) 25. Glove box Metal clip ____ Clip

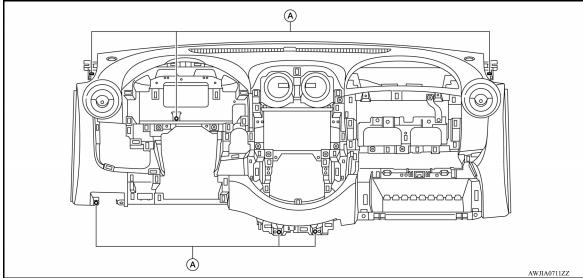
- 15. Remove A/C control. Refer to HAC-48, "Removal and Installation".
- 16. Remove glove box assembly. Refer to IP-22, "Removal and Installation".
- 17. Remove passenger air bag module. Refer to SR-17, "Removal and Installation".
- 18. Remove instrument panel assembly.
- a. Remove instrument panel assembly screws (A).

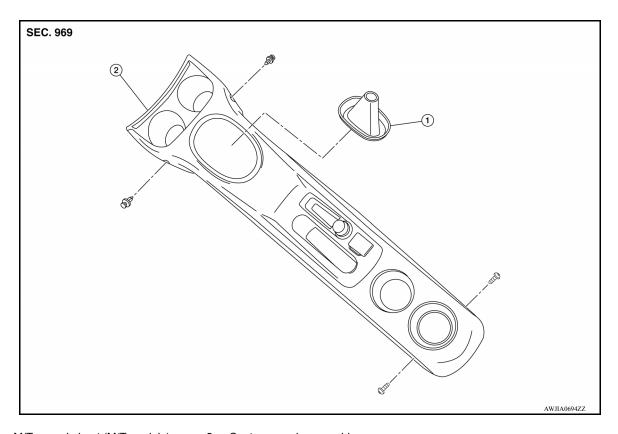
Exploded View

- 1. M/T console boot (M/T models)
- 2. Center console assembly

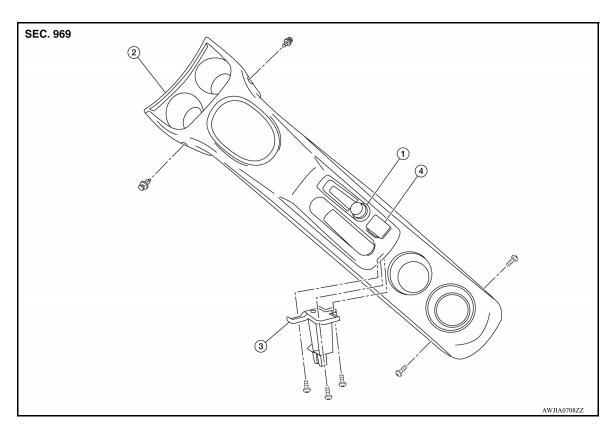
Exploded View

1. Power socket

- 2. Center console assembly
- 3. Center console support
