2006 Xterra

INSTRUMENT PANEL ASSEMBLY

Removal and Installation INSTRUMENT PANEL Removal

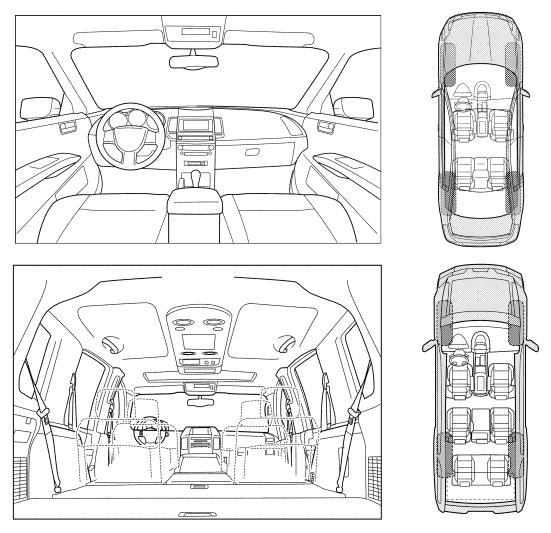
I. WHERE DOES THE NOISE COME FROM? (circle the area of the vehicle)

The illustrations are for reference only, and may not reflect the actual configuration of your vehicle.

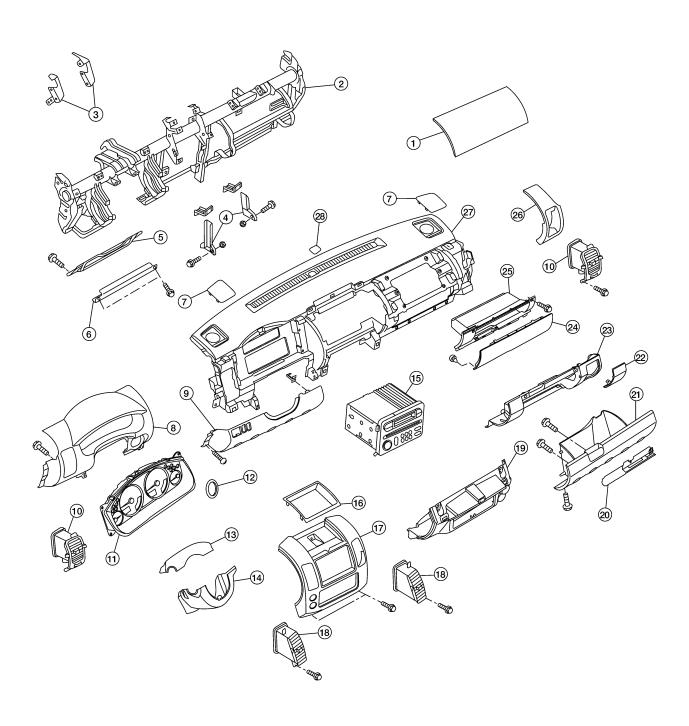
LIIA2954E

- 1. Passenger air bag module cover
- 4. Instrument stay RH/LH
- 7. Speaker grille RH/LH

- 2. Steering member assembly
- 5. Knee protector
- 8. Cluster lid A

- 3. Center bracket RH/LH
- 6. Knee protector brace
- 9. Lower instrument panel LH

10.	Side ventilator assembly RH/LH	11.	Combination meter	12.	Steering lock escutcheon
13.	Steering column cover upper	14.	Steering column cover lower	15.	Audio unit
16.	Storage tray	17.	Cluster lid C	18.	Center ventilator assembly RH/LH
19.	Cluster lid D	20.	Lower glove box latch assembly	21.	Lower glove box assembly
22.	Fuse block cover	23.	Lower instrument panel RH	24.	Upper glove box door
25.	Upper glove box bin	26.	Instrument side finisher	27.	Instrument panel and pad assembly
28.	Cover

- 1. Disconnect battery negative terminal.
- 2. Disconnect battery positive terminal.
- 3. Remove the center console. Refer to IP-14, "CENTER CONSOLE".
- 4. Remove the combination meter. Refer to IP-13, "COMBINATION METER".
- 5. Remove front pillar upper finisher. Refer to EI-28, "FRONT PILLAR UPPER FINISHER" .
- 6. Remove audio unit. Refer to AV-49, "AUDIO UNIT".
- 7. Remove cluster lid D. Refer to IP-12, "CLUSTER LID D".
- 8. Remove the passenger air bag module. Refer to SRS-46, "FRONT PASSENGER AIR BAG MODULE".
- 9. Remove the instrument stay RH/LH bolts.
- 10. Remove instrument panel.
 - Disconnect all remaining harnesses.

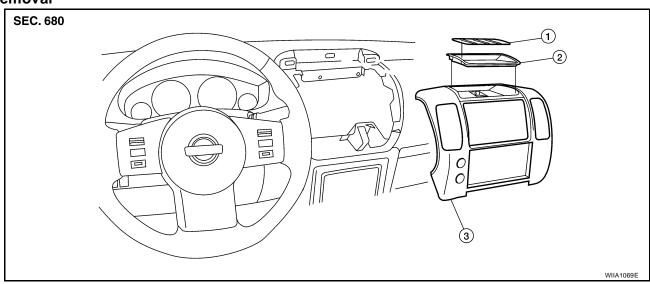
1. Storage tray liner

2. Storage tray

3. Cluster lid C

- Disconnect battery negative terminal.
- 2. Disconnect battery positive terminal.
- Pull cluster lid C rearward to release clips.
- 4. Disconnect electrical connectors and remove cluster lid C.

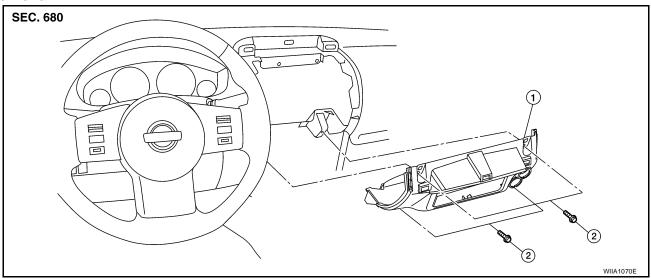
1. Cluster lid D

- 2. Screws
- 1. Remove center console.
- 2. Remove lower instrument panel LH. Refer to IP-12, "LOWER INSTRUMENT PANEL LH".
- 3. Remove lower instrument panel RH. Refer to IP-14, "LOWER INSTRUMENT PANEL RH AND LOWER GLOVE BOX".
- 4. Remove cluster lid C. Refer to IP-11, "CLUSTER LID C".
- 5. Disconnect the cluster lid C connectors.
- 6. Remove cluster lid D screws.
- 7. Disconnect cluster lid D connectors and remove cluster lid D.

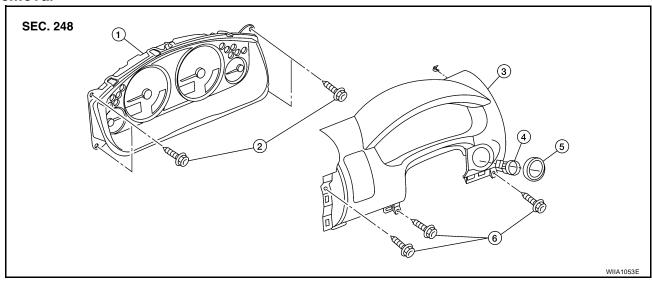
- 1. Combination meter
- 2. Screws
- 5. Steering lock escutcheon
- 3. Cluster lid A
- 6. Screw

- 1. Disconnect the negative battery cable.
- 2. Remove front pillar upper finisher. Refer to EI-28, "FRONT PILLAR UPPER FINISHER" .
- 3. Remove lower instrument panel LH. Refer to IP-12, "LOWER INSTRUMENT PANEL LH".
- 4. Remove steering lock escutcheon.

- 5. Remove cluster lid A, using power tool.
- 6. Remove combination meter, using power tool.
- 7. Disconnect combination meter electrical connectors.

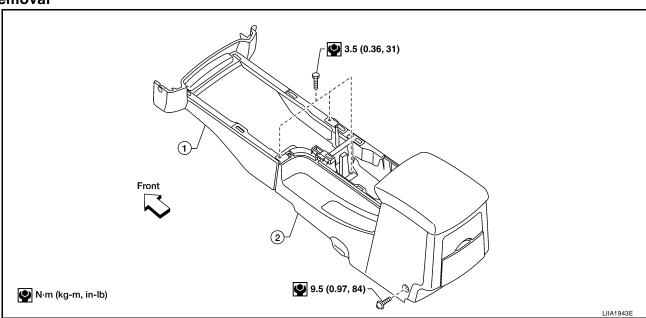
- Remove lower instrument panel RH. Refer to IP-14, "LOWER INSTRUMENT PANEL RH AND LOWER GLOVE BOX".
- 2. Remove cluster lid C.
- 3. Remove A/T or M/T finisher. Refer to IP-13, "A/T FINISHER" or IP-13, "M/T FINISHER".
- 4. Remove center console screws.
- Disconnect electrical connectors and remove center console. 5.
- Remove center console screws.
- Disconnect electrical connectors and remove center console. 7.

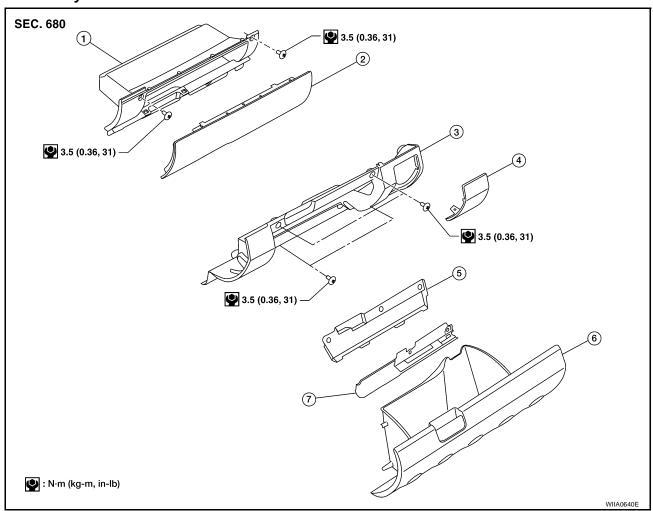
- Upper glove box 1.
- Upper glove box door
- Lower instrument panel RH

- Fuse block cover
- Lower glove box latch assembly cover 6. Lower glove box
- Lower glove box latch assembly
- 1. Remove fuse block cover.
- 2. Remove lower glove box latch cover.
- Remove lower glove box latch assembly.
- Remove lower glove box from lower instrument panel RH.

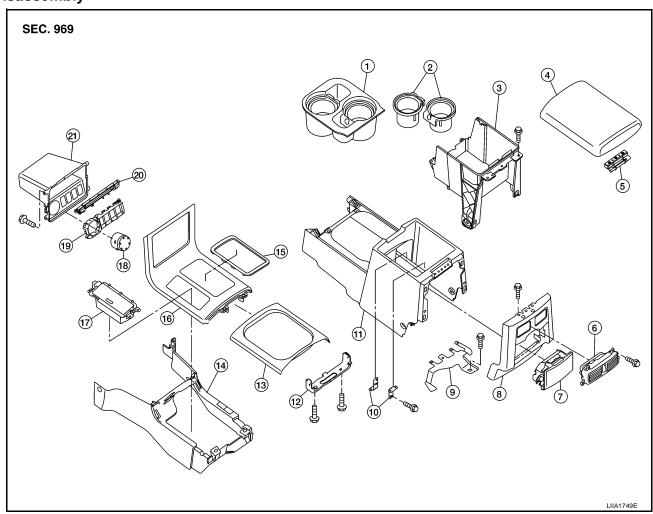
- 1. Cup holder assembly
- 4. Center console lid
- 7. Rear cup holder assembly
- 10. Bracket DVD
- 13. Cup holder finisher
- 16. A/T finisher
- 19. Switch finisher

- 2. Cup holder insert
- 5. Hinge
- 8. Rear finisher assembly
- 11. Center console rear base
- 14. Center console front base
- 17. Ash tray
- 20. CD changer door

- 3. Center console bin
- 6. Ventilator console grille
- 9. Wire harness bracket
- 12. Bracket
- 15. A/T finisher bezel
- 18. Switch assembly
- 21. Console bin
- 1. Remove center console. Refer to IP-14, "CENTER CONSOLE".
- 2. Remove center console lid.
- 3. Remove latch from center console lid.
- 4. Remove hinge from center console lid.
- 5. Remove rear finisher assembly.
- 6. Remove rear cup holder assembly.
- 7. Remove DVD player, if equipped.

- 8. Disconnect center console harness connectors.
- 9. Remove cup holder insert and cup holder assembly.
- 10. Remove center console bin.
- 11. Remove center console bracket.
- 12. Remove wire harness bracket.
