SECTION IP
INSTRUMENT PANEL

INSTRUMENT PANEL ASSEMBLY

Exploded View

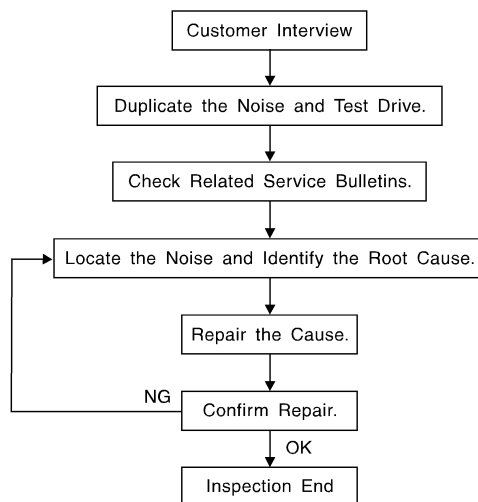
SBT842

Work Flow

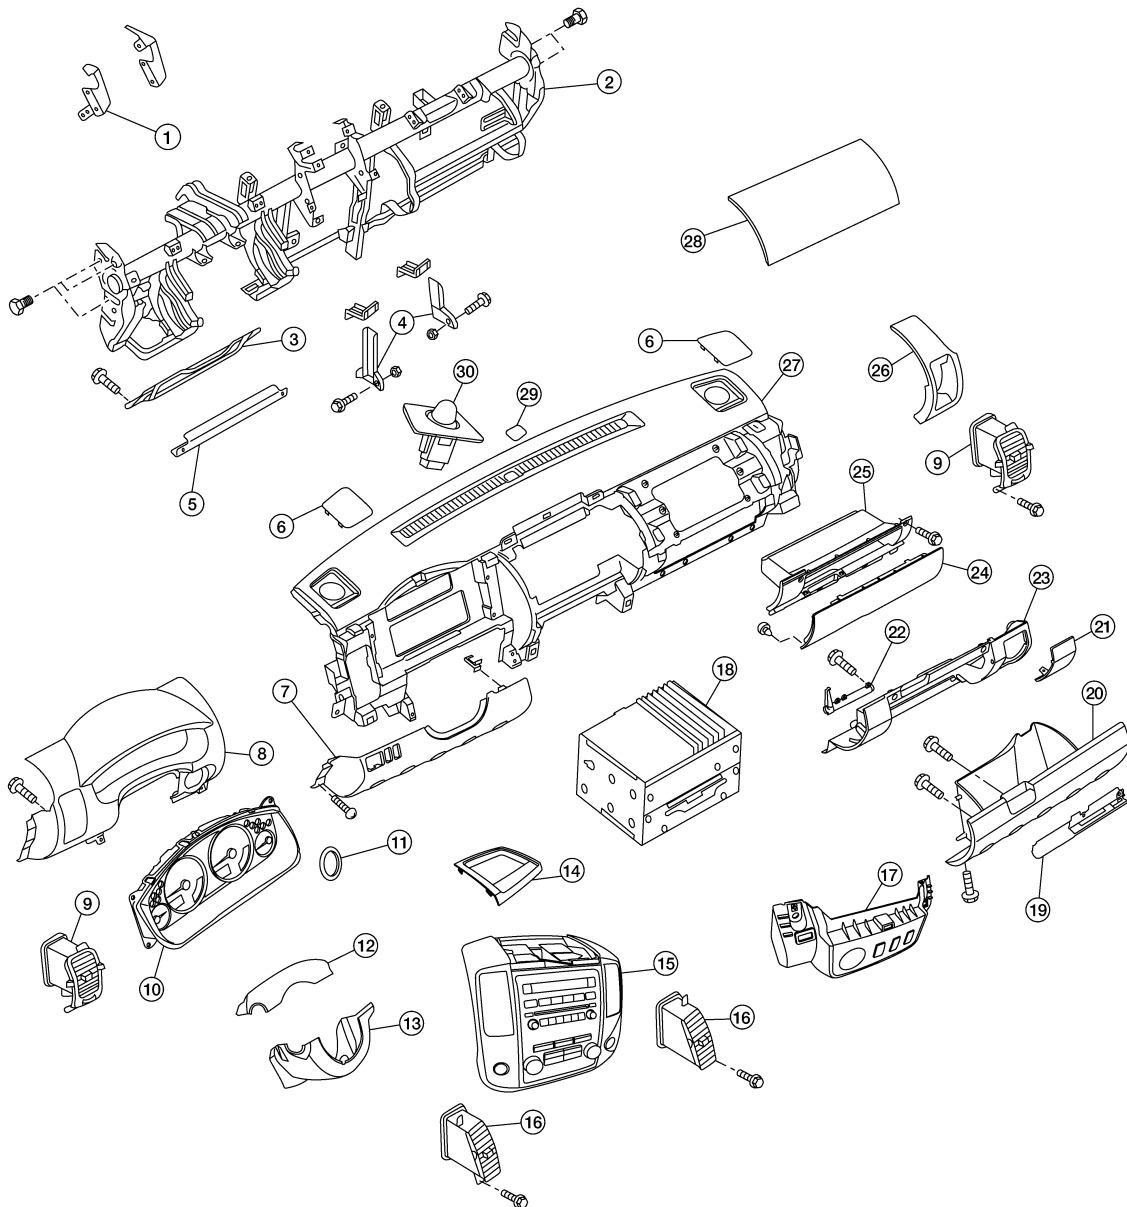
AWJIA1032ZZ

| 1. Display unit bracket (LH/RH) | 2. Steering member assembly | 3. Knee protector |
| 4. Instrument stay (LH/RH) | 5. Knee protector brace | 6. Speaker grille (LH/RH) |
| 7. Instrument lower panel LH | 8. Cluster lid A | 9. Side ventilator grille (LH/RH) |
| 10. Combination meter | 11. Steering lock escutcheon | 12. Steering column upper cover |
| 13. Steering column lower cover | 14. Storage tray | 15. Cluster lid C |

| 16. Center ventilator grille (LH/RH) | 17. Cluster lid D | 18. Audio unit |
| 19. Lower glove box latch assembly | 20. Lower glove box assembly | 21. Fuse block cover |
| 22. Lower glove box damper assembly | 23. Instrument lower panel RH | 24. Upper glove box door |
| 25. Upper glove box | 26. Side ventilator finisher | 27. Instrument panel and pad assembly |
| 28. Passenger air bag module | 29. Sensor cover | 30. Optical sensor (if equipped) |

REMOVAL

1. Disconnect both the negative and positive battery terminals, then wait at least three minutes. Refer to [PG-72, "Removal and Installation"](#).
2. Remove front pillar upper finishers. Refer to [INT-18, "Removal and Installation"](#).

3. Remove the center console. Refer to [IP-21, "Removal and Installation"](#).
4. Remove the combination meter. Refer to [MWI-84, "Removal and Installation"](#).

5. Remove audio unit (if equipped). Refer to [XX-XX, "*****" \(BASE AUDIO\)](#), [AV-108, "Removal and Installation" \(DISPLAY AUDIO WITHOUT AMPLIFIER\)](#), or [XX-XX, "*****" \(DISPLAY AUDIO WITH AMPLIFIER\)](#).

6. Remove AV control unit (if equipped). Refer to [AV-218, "Removal and Installation"](#).
7. Remove cluster lid D. Refer to [IP-16, "Removal and Installation"](#).

8. Remove the front passenger air bag module. Refer to [SR-15, "Removal and Installation"](#).
9. Remove the instrument stay bolts (LH/RH).
10. Disconnect all remaining harnesses and connectors.

11. Remove instrument panel and pad assembly.

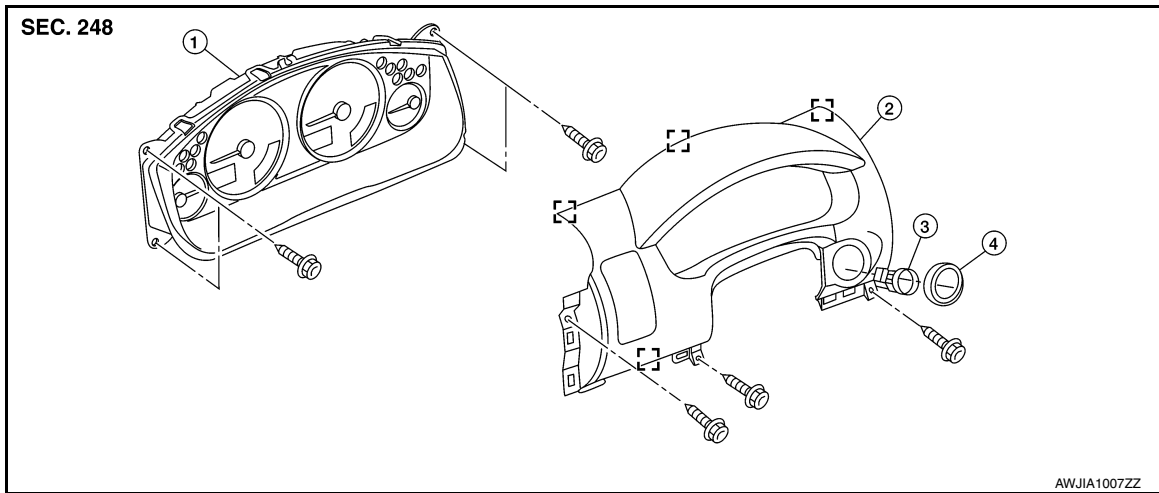
| 1. Combination meter | 2. Cluster lid A | 3. Ignition key lamp assembly |
| 4. Steering lock escutcheon | ☐ Metal clip | |

1. Remove instrument lower panel LH. Refer to [IP-14, "Removal and Installation"](#).
2. Using a suitable tool, remove the steering lock escutcheon.
3. Remove cluster lid A screws.
4. Release the cluster lid A clips using a suitable tool and remove.

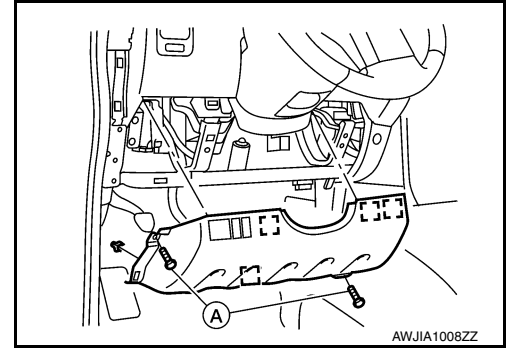
1. Remove front pillar upper finisher (LH). Refer to [INT-18. "Removal and Installation"](#).
2. Remove instrument lower panel LH screws (A).
3. Release the instrument lower panel LH metal clips using a suitable tool and remove.
☐: Metal clip
4. Disconnect the harness connectors from instrument lower panel LH and remove.

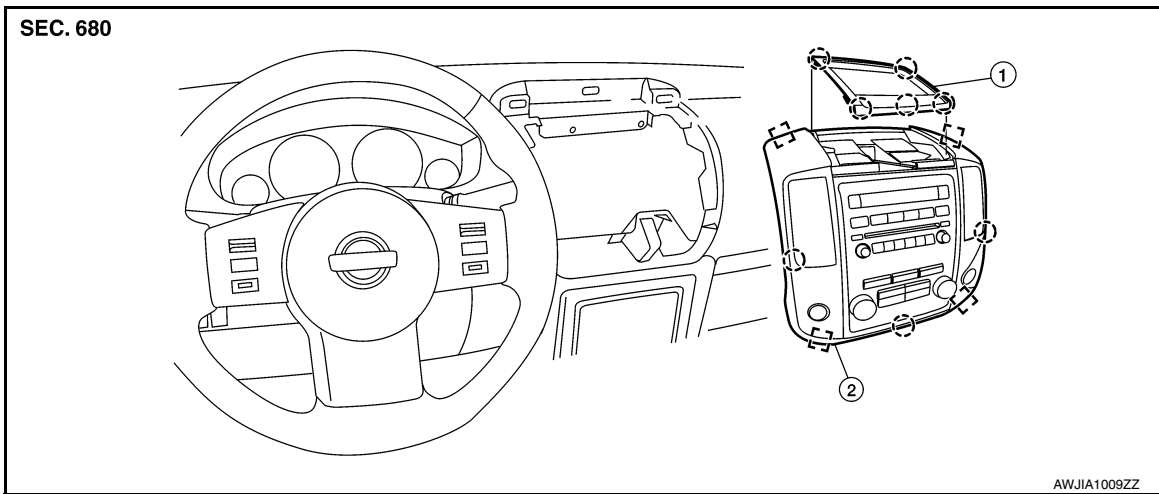
1. Storage tray

2. Cluster lid C

Pawl

1. Release the storage tray pawls using a suitable tool and remove.
2. Remove the cluster lid C screws (A).

3. Release the cluster lid C metal clips and pawls using a suitable tool and remove.
4. Disconnect harness connectors from cluster lid C and remove.
5. Remove the audio unit from cluster lid C, if necessary. Refer to [AV-48, "Removal and Installation"](#).
6. Remove the front air control from cluster lid C, if necessary. Refer to [VTL-7, "Removal and Installation"](#).
7. Remove the hazard switch from cluster lid C, if necessary. Refer to [EXL-162, "Removal and Installation"](#).
8. Remove the passenger air bag indicator lamp from cluster lid C, if necessary. Refer to [SR-19, "Removal and Installation"](#).

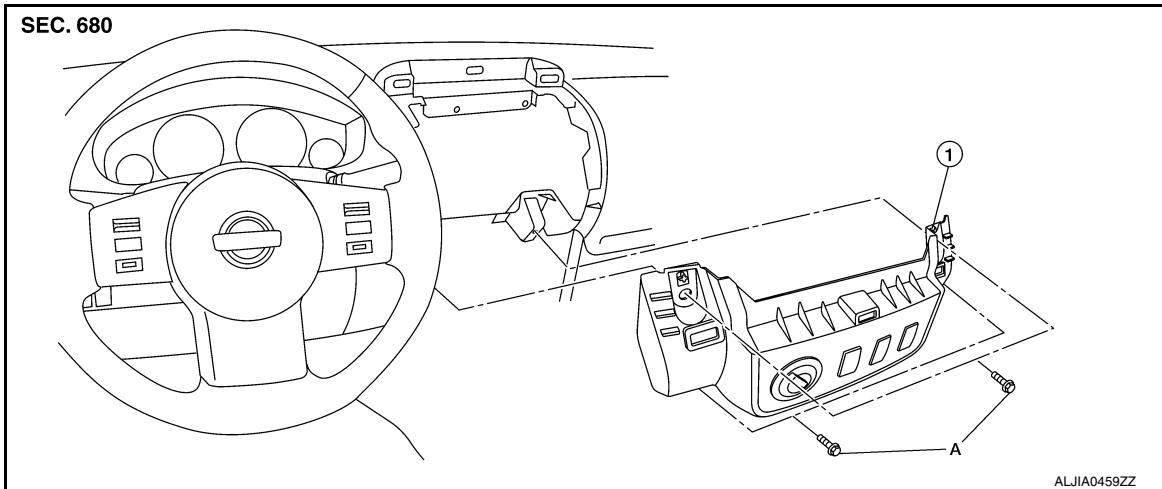
TYPE 1

1. Cluster lid D

A. Cluster lid D screw

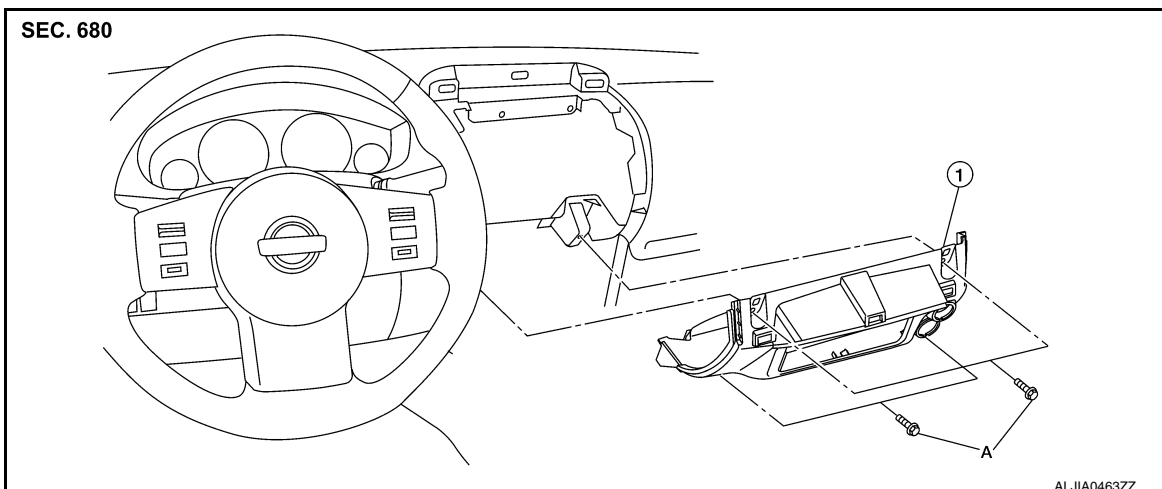
TYPE 2

1. Cluster lid D

A. Cluster lid D screw

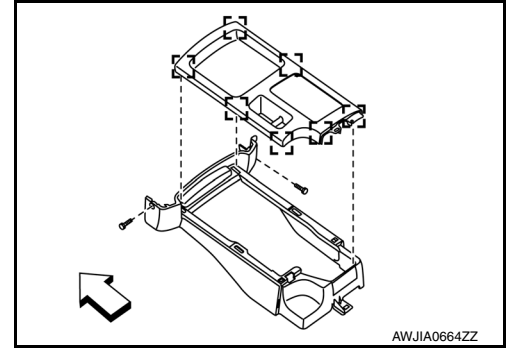
A/T shift selector finisher shown; M/T shift selector finisher similar.

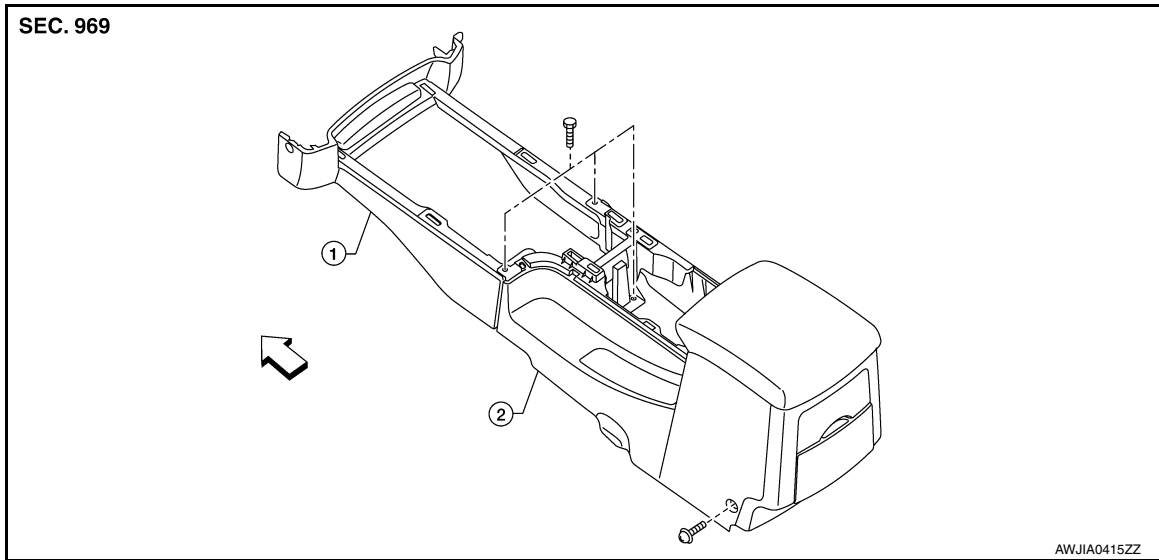
CENTER CONSOLE

1. Center console front base 2. Center console rear base ← Front

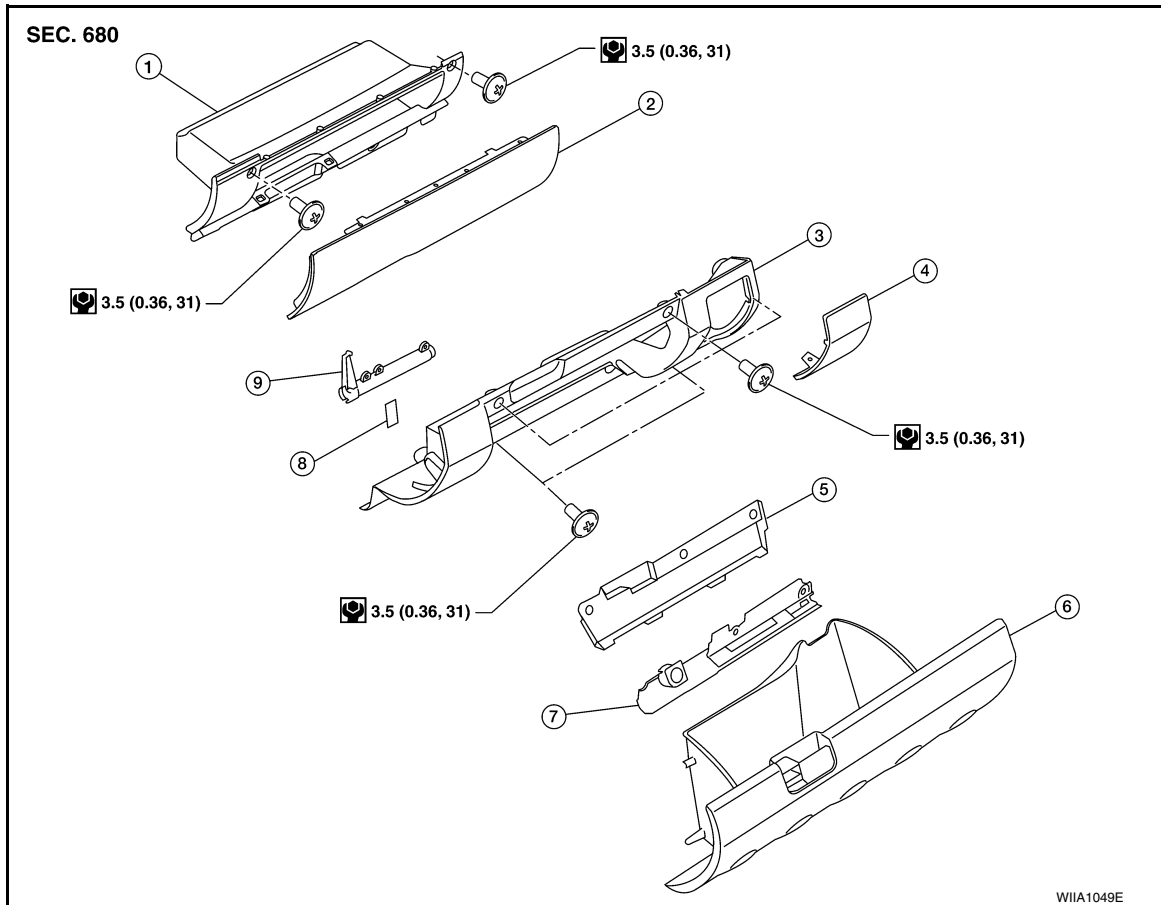
| 1. Upper glove box | 2. Upper glove box lid | 3. Lower instrument panel (RH) |

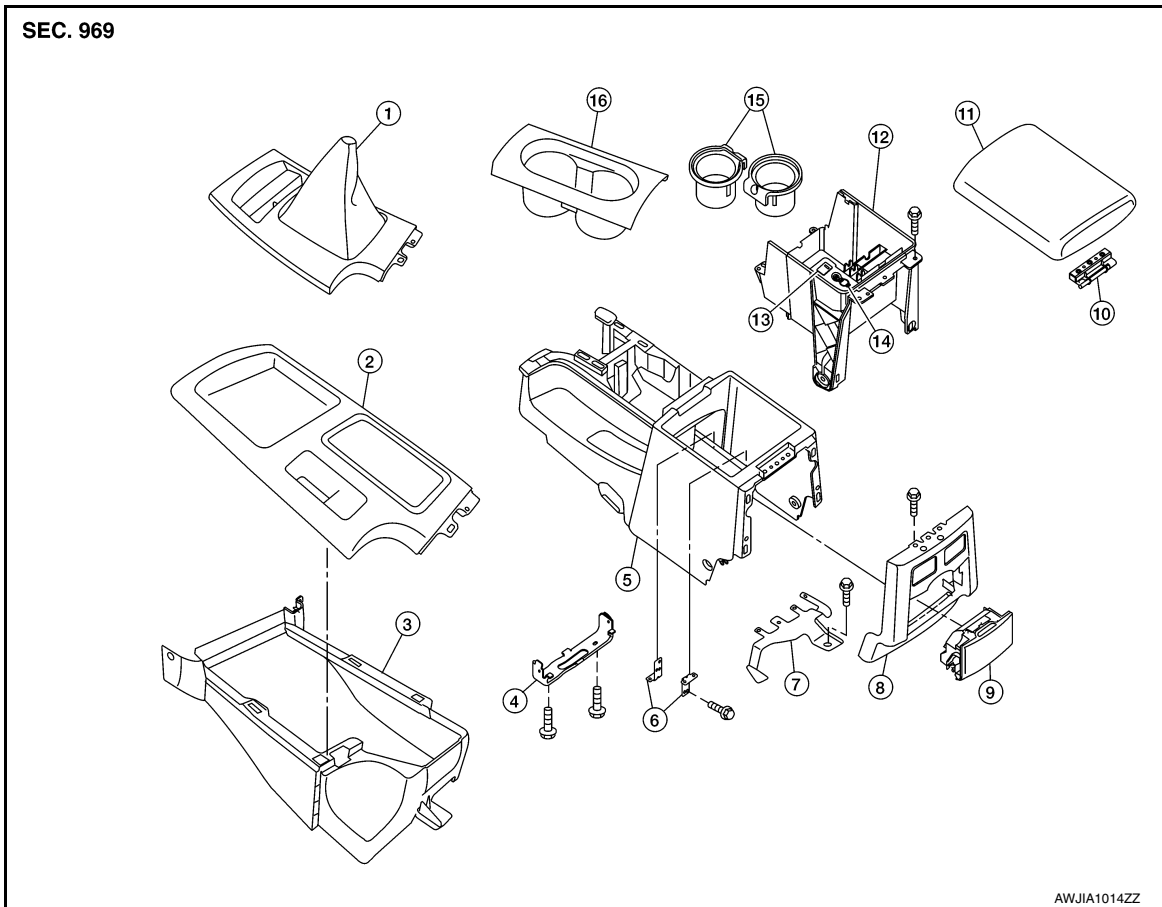
| 1. Shift selector finisher (M/T) | 2. Shift selector finisher (A/T) | 3. Center console front base |
